# 2023 Annual Site Inspection and Monitoring Report for Uranium Mill Tailings Radiation Control Act Title II Disposal Sites

December 2023

Legacy  
Management

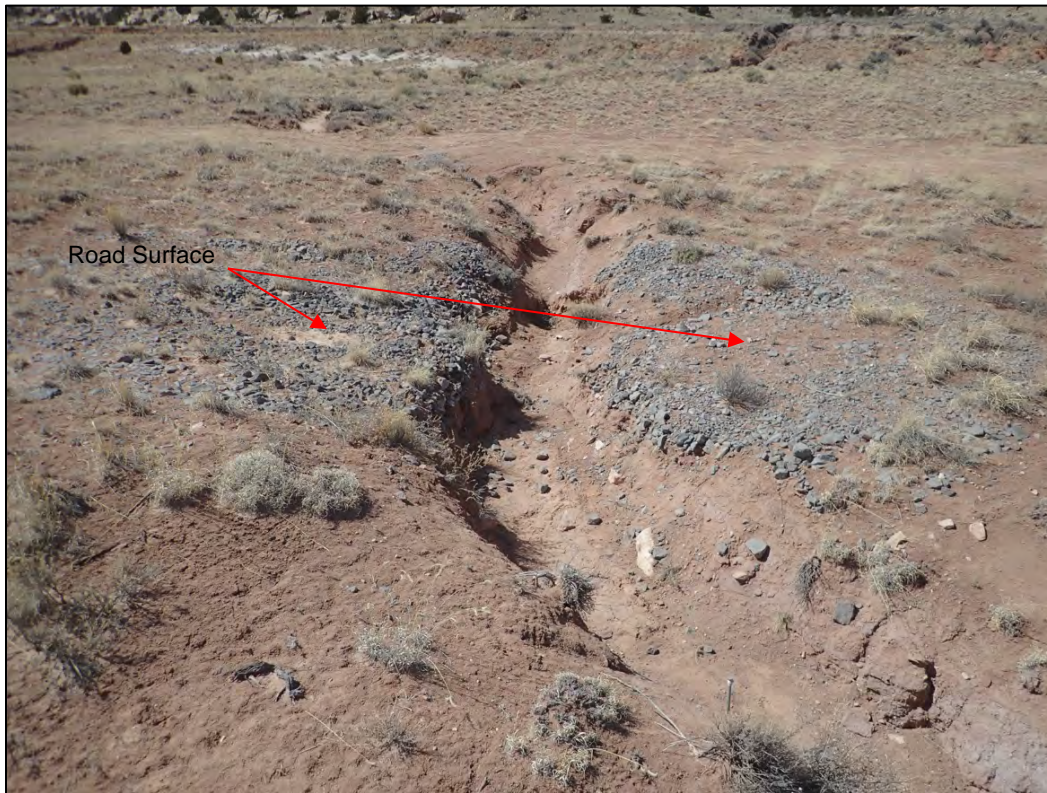
Interior roads used to access LM assets consist of a dirt track covered at places with crushed basalt. The roads are susceptible to erosion and are repaired when they become impassable. Erosion on the road northwest of the main tailings disposal cell continues to be an issue (PL-1). In 2017, riprap was added to repair a gully intersecting this section of the road. Additional erosion was noted along the road parallel to the northern perimeter of the site. Thirteen road repair areas were identified around the site perimeter road. LM is planning to repair the roads in spring 2024 through the interagency agreement with the U.S. Army Corps of Engineers (USACE). Minor areas of erosion on the site road along the west side of the site were identified during the 2023 inspection. These minor areas were top dressed with gravel to prevent further erosion during routine maintenance work in 2023. No other maintenance needs were identified.

*PL-1. Erosion of Site Road Along Northwestern Corner*

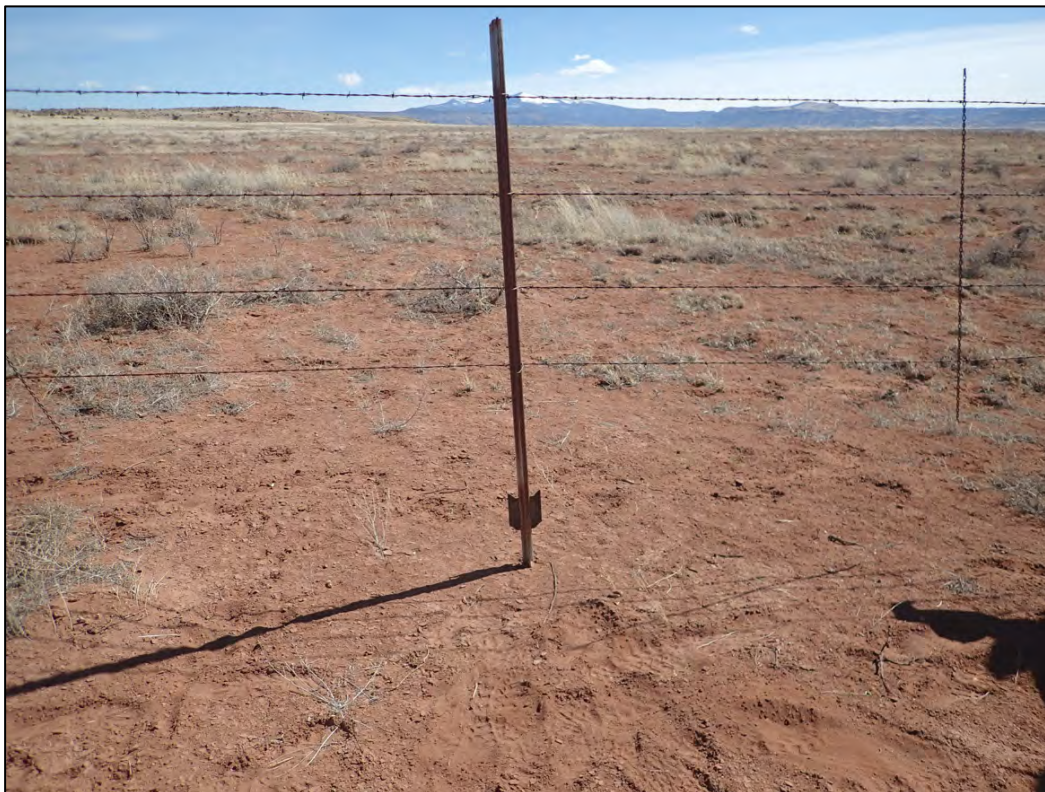
*PL-2. Wind Erosion on Eastern Fence Line (Hanging T-Post)*

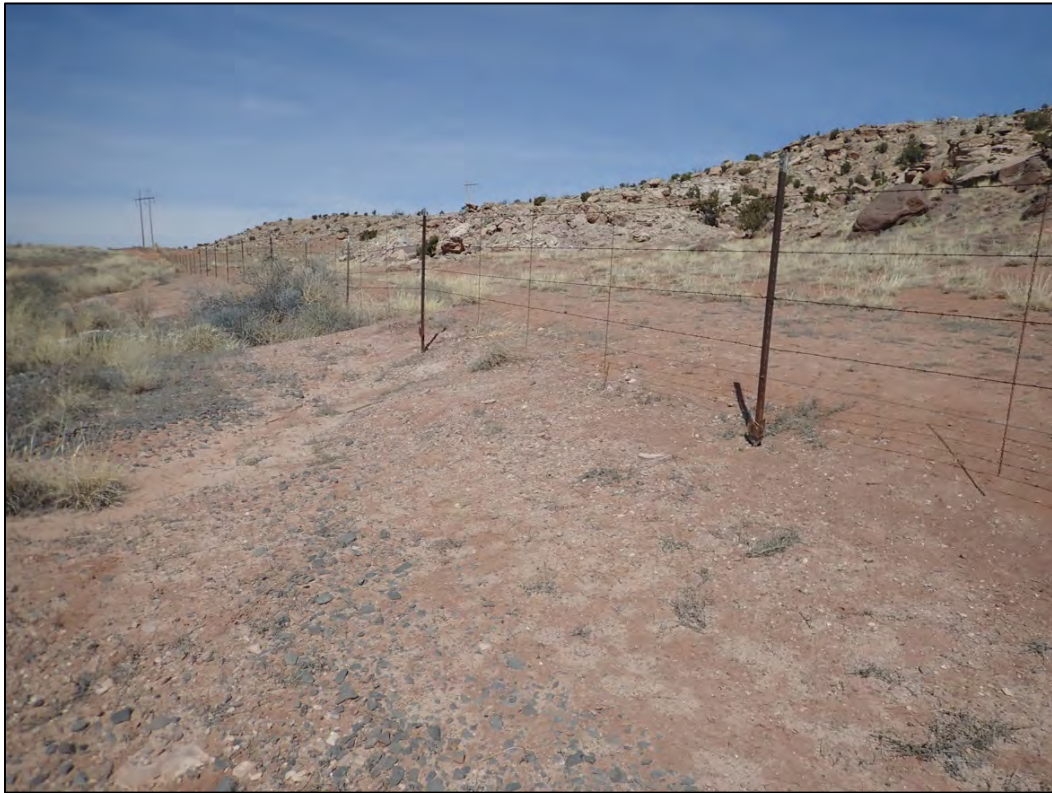
*PL-3. Hanging T-Posts Between Boundary Monuments BM-12 and BM-11*

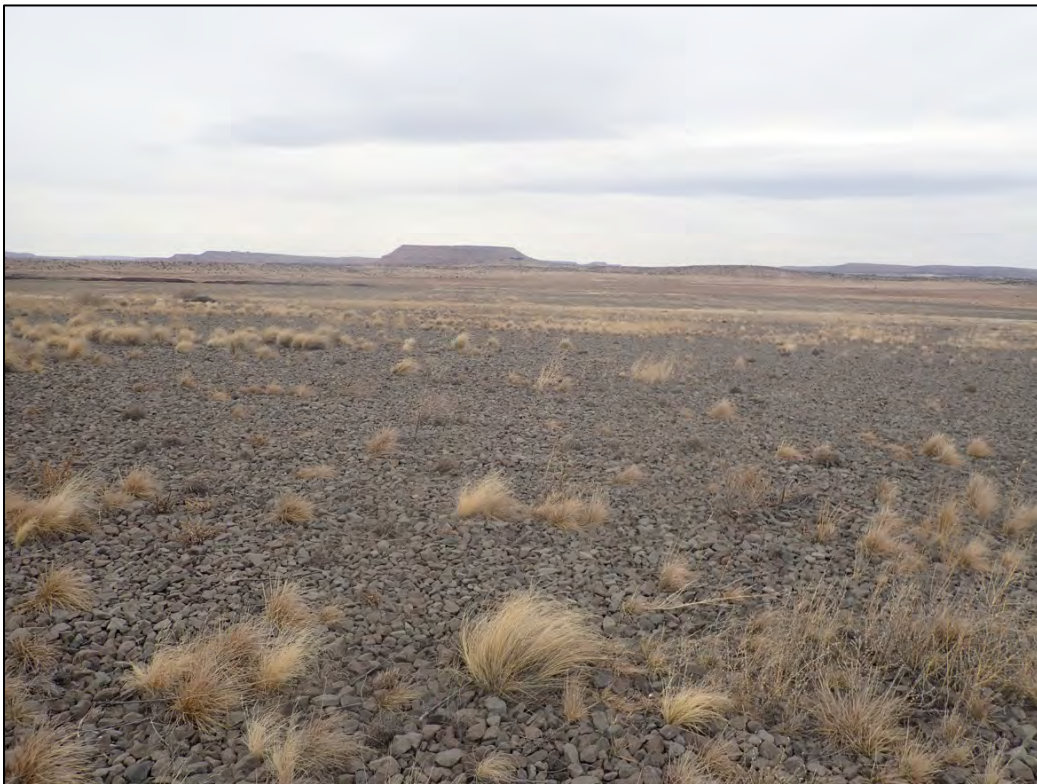
Plant encroachment (by annual weeds, perennial grasses, forbs, and scattered perennial shrubs) continues on the main tailings disposal cell top and side slopes (PL-10). Siberian elm saplings on the top slope are periodically treated with herbicide to prevent the establishment of trees that could damage the main tailings disposal cell cover materials. No live elms were observed during the inspection.

*PL-10. Main Tailings Disposal Cell Top Slope Vegetation*

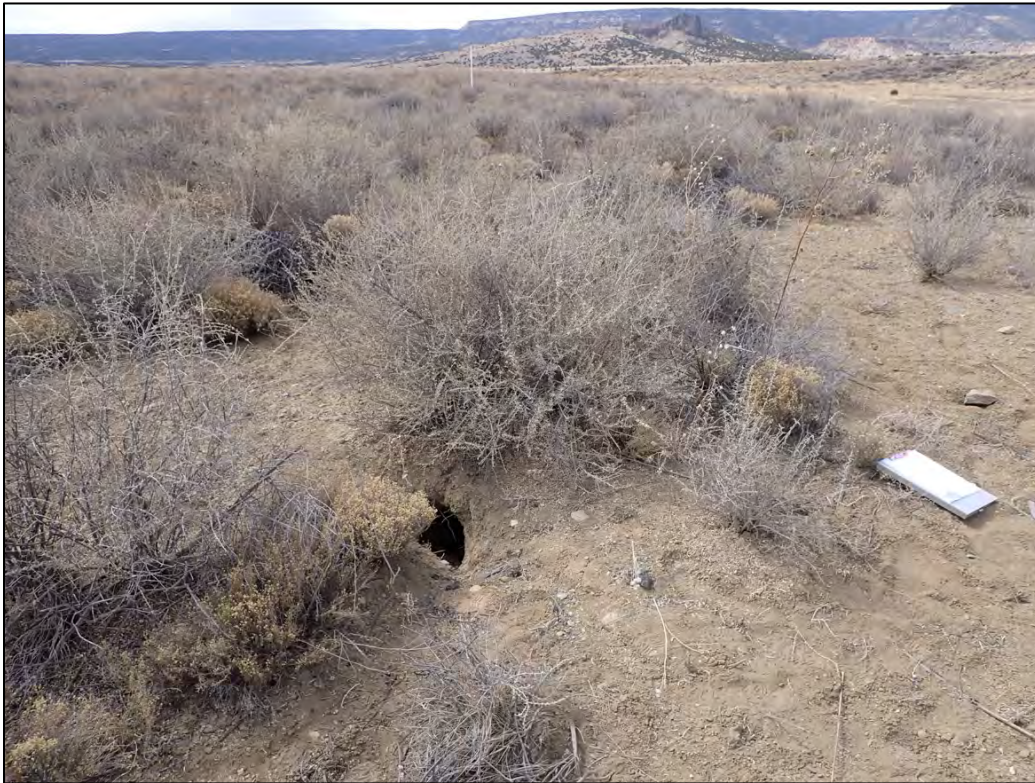
*PL-9. Degradation Feature Roughly 120 Feet East of Erosion Monitoring Location A1*

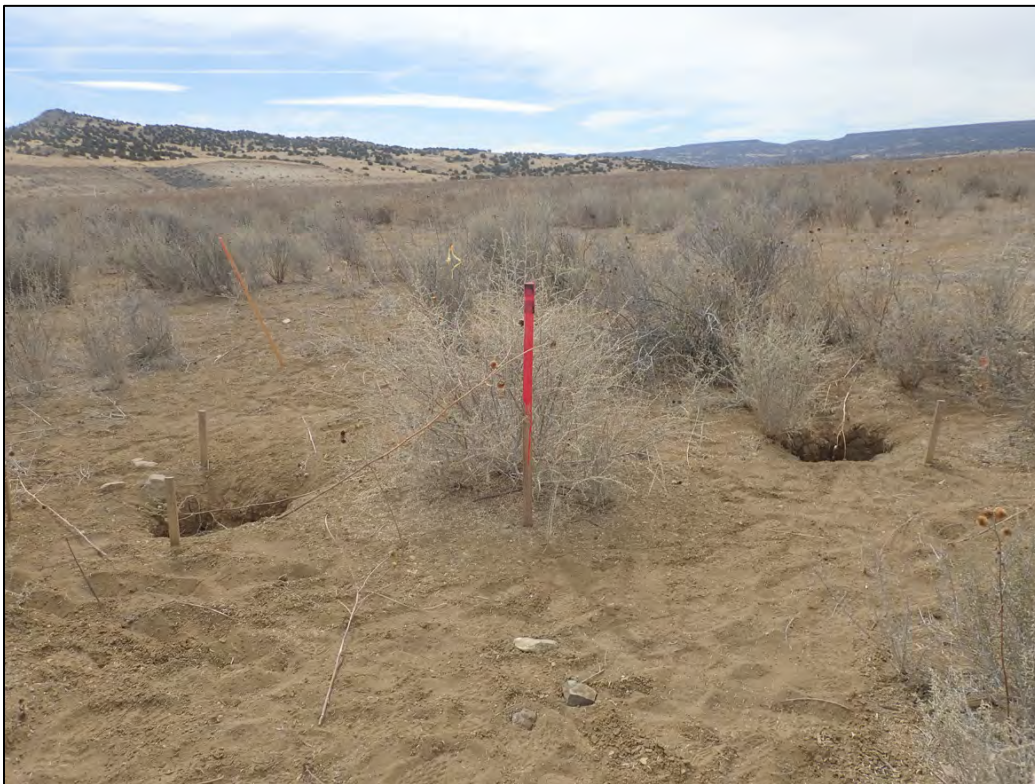
*PL-10. Degradation Feature E-004 on Disposal Cell Top Slope*

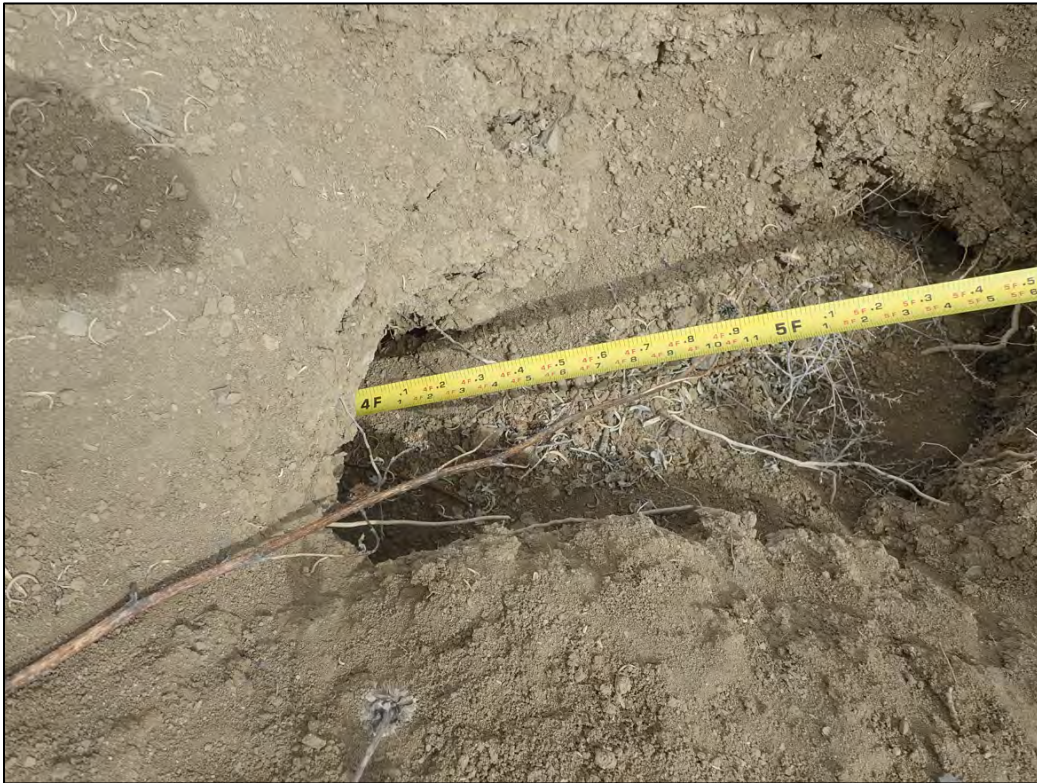
*PL-11. Degradation Feature E-004 Horizontal Piping*

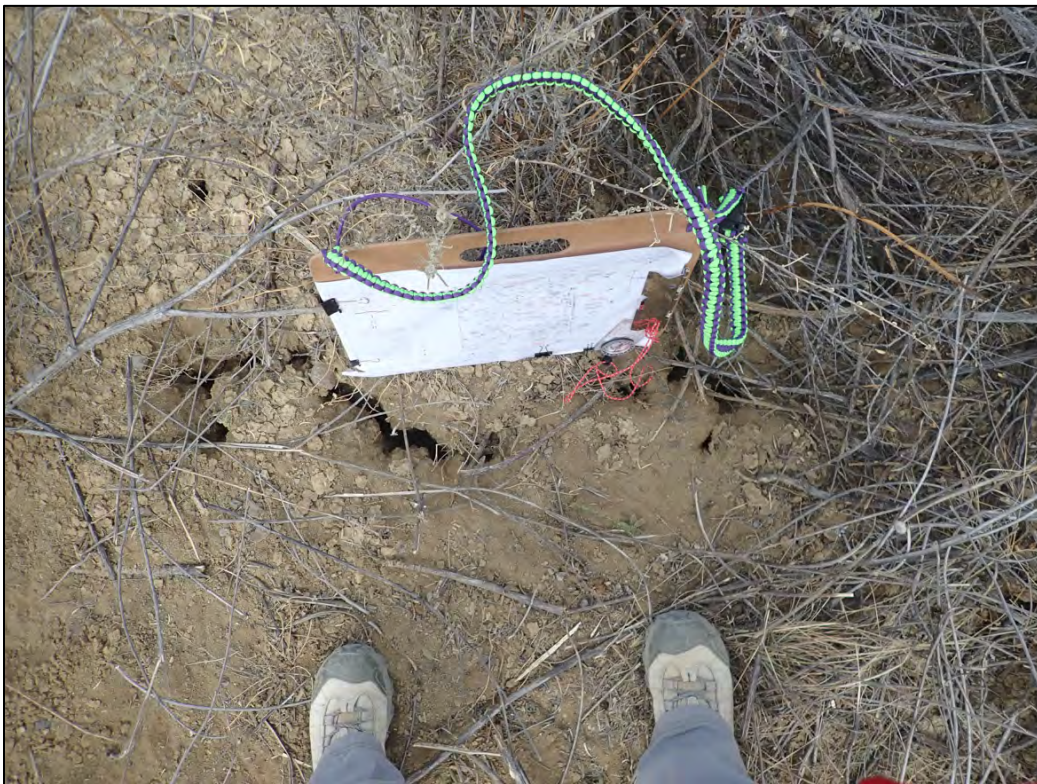
*PL-12. Deep Desiccation Cracking of Surface Soils*

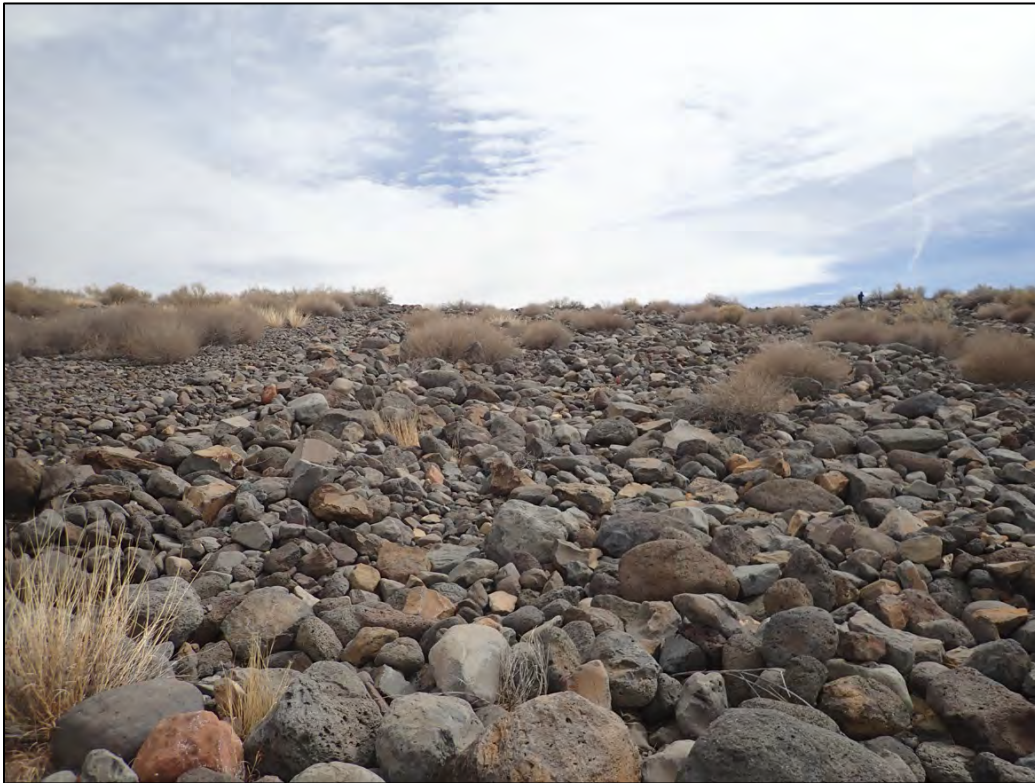
*PL-13. Overview of Stormwater Route in Spillway with Cattails Noted at Base*

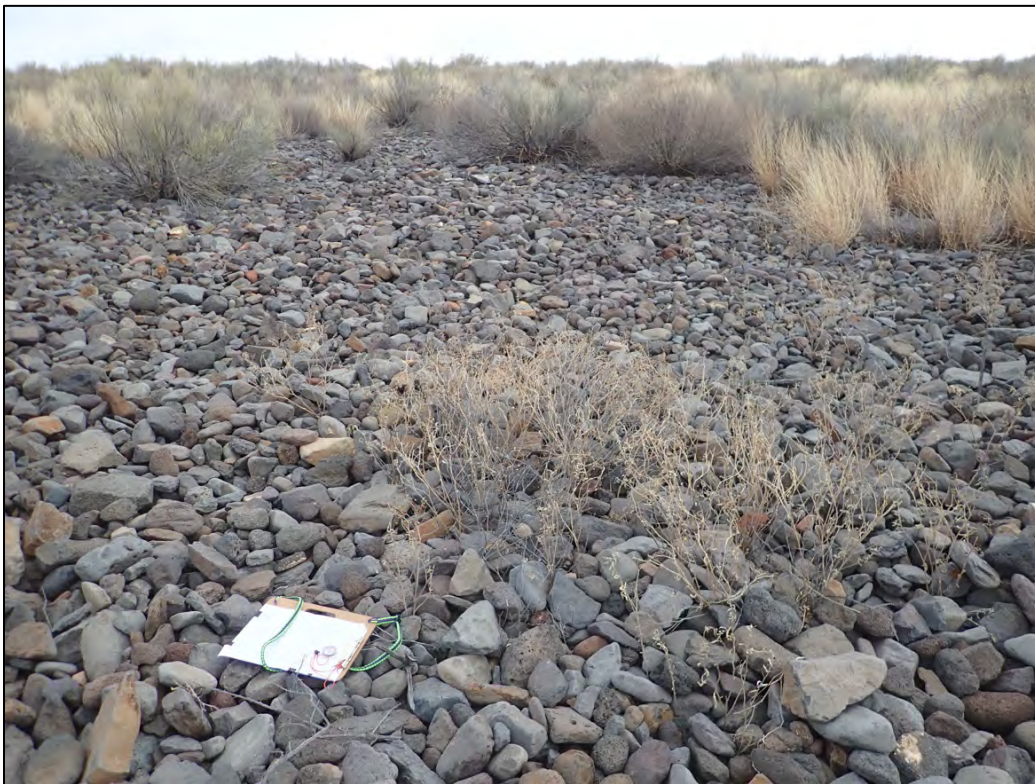
*PL-14. Additional Overview of Potential Depression Formation*

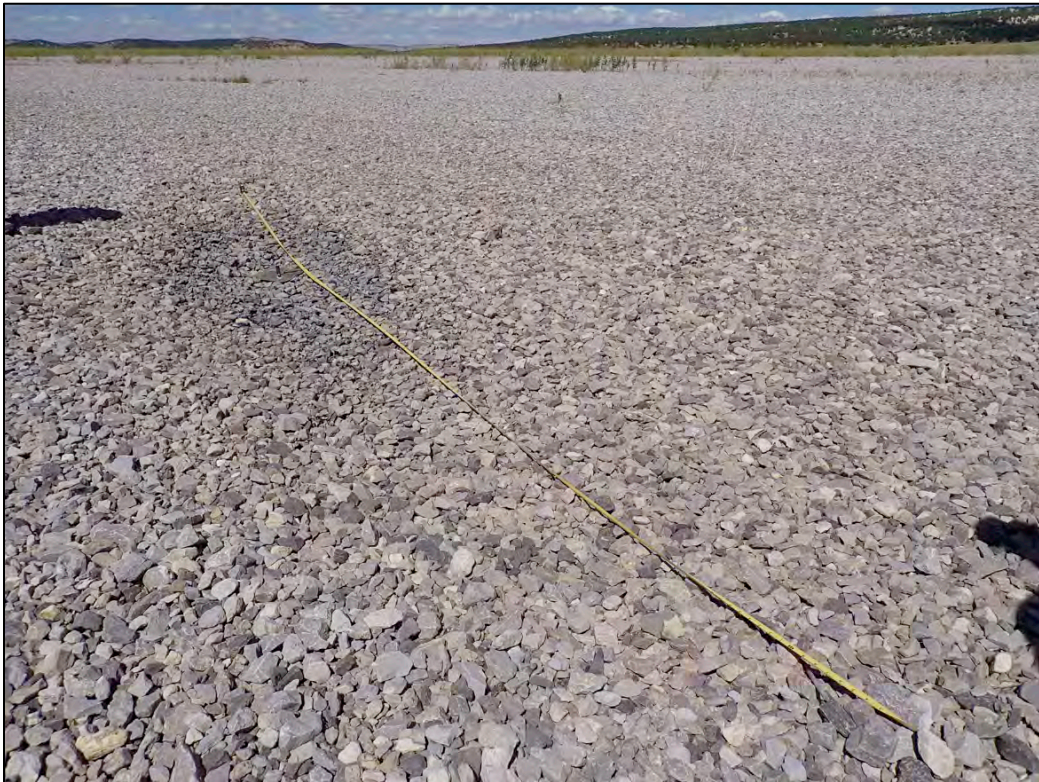
*PL-4. Shallow Depression No. 2*

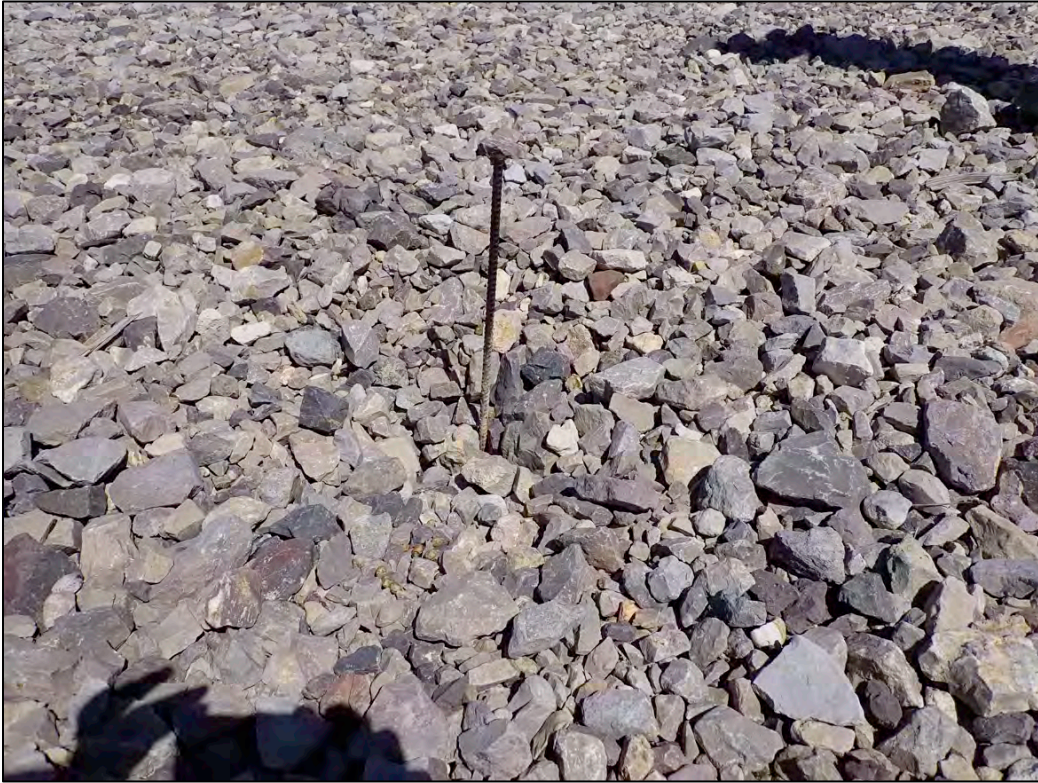
*PL-5. Shallow Depression No. 3*

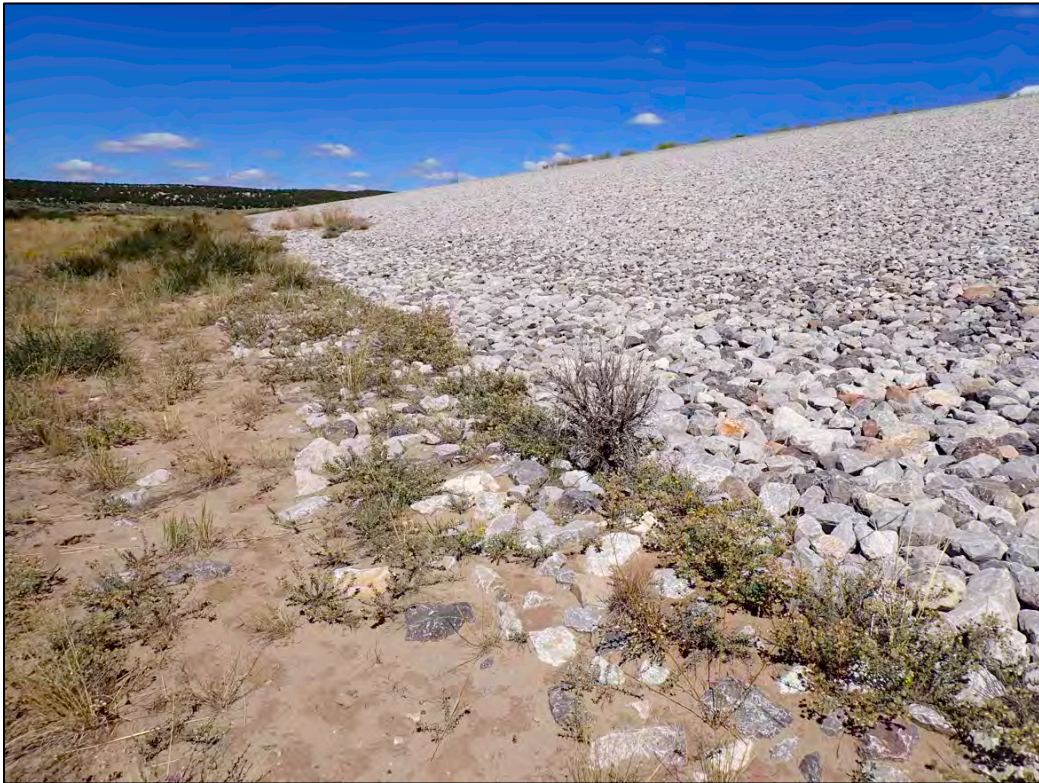
*PL-7. Windblown Sediment Accumulation at Toe of Side Slope*

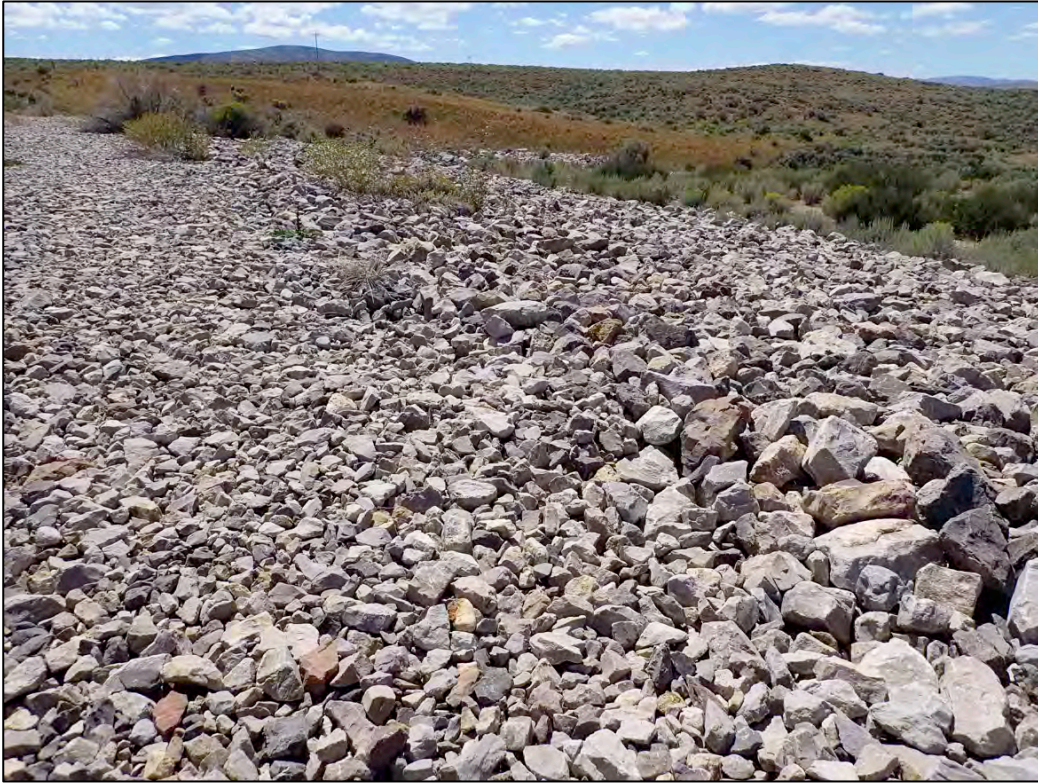
*PL-9. Depressions on Crest of Ancillary Cell*

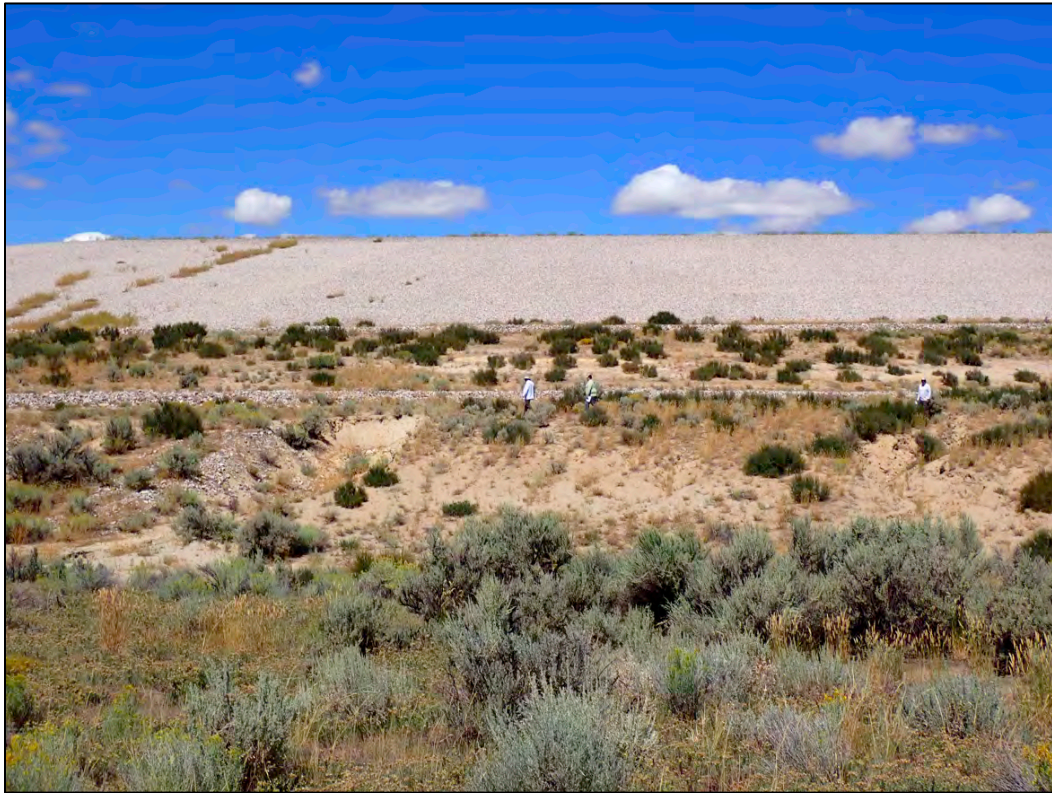
*PL-15. Erosion Below Rock Berm*

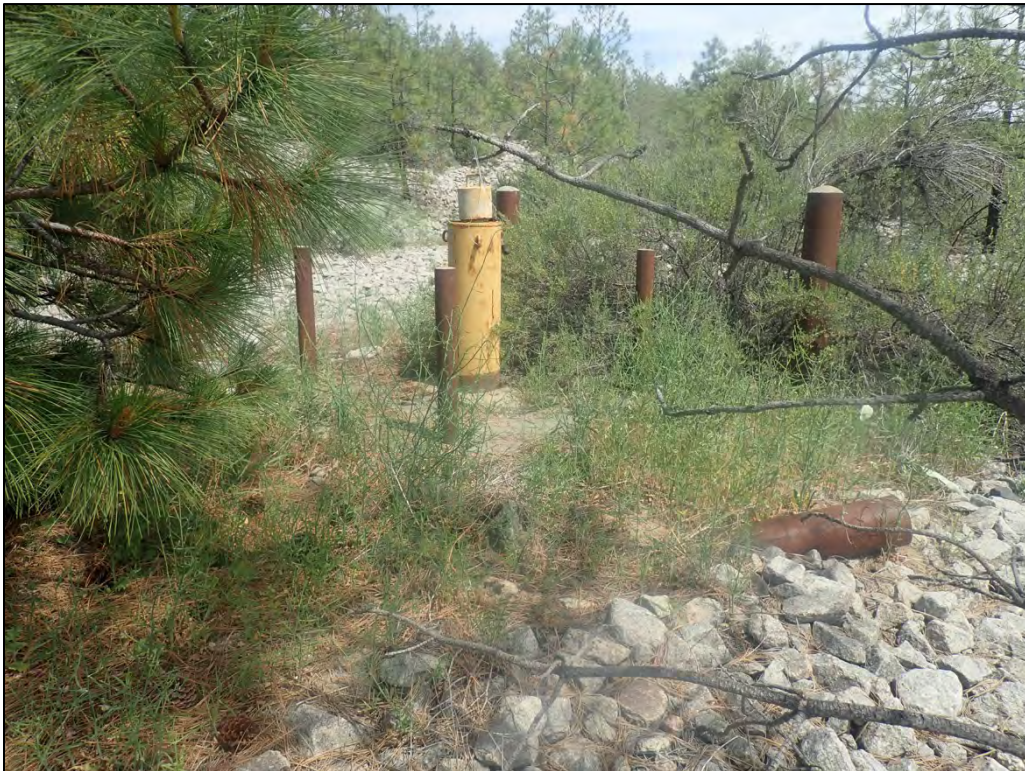
*PL-4. Monitoring Well MW-4 with Damaged Bollard*

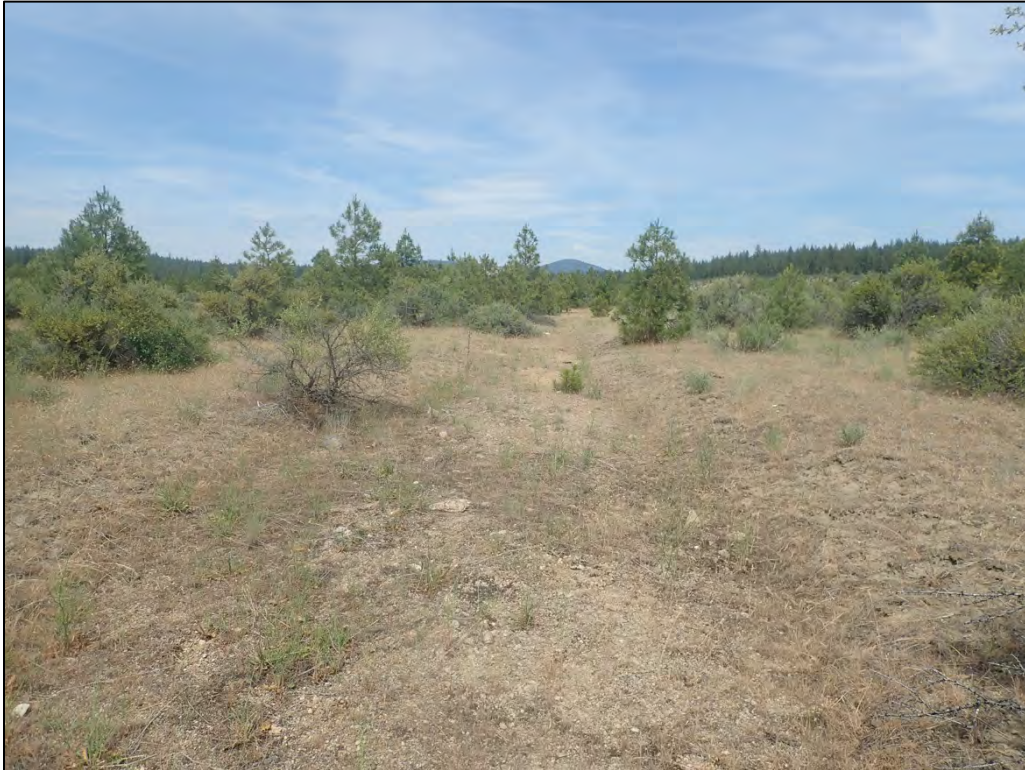
*PL-5. Runoff Channel on Southeast Area of Disposal Cell*

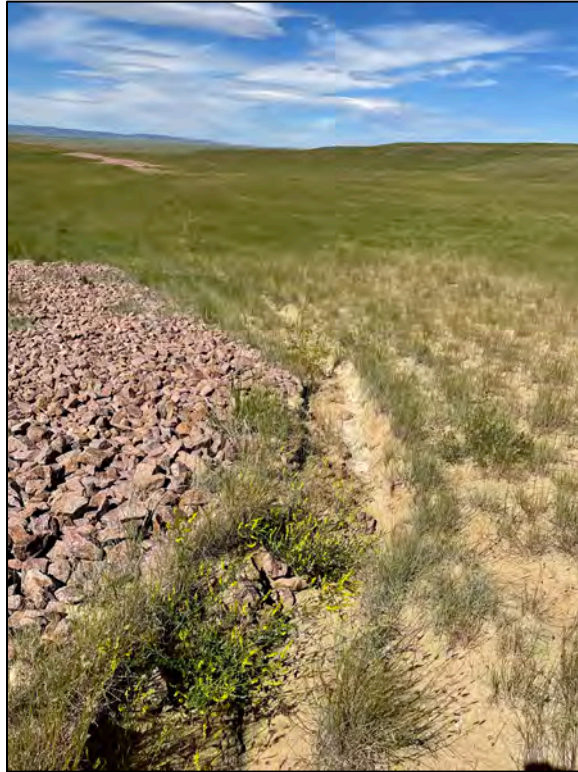
*PL-7. Erosion Caused by Animal Trail North of Upper Riprap Slope*

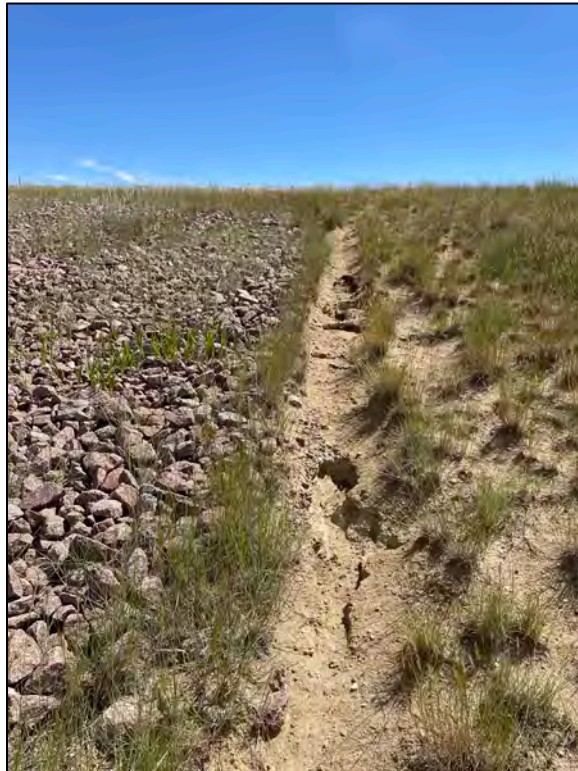
*PL-8. Erosion Caused by Animal Trail South of Upper Riprap Slope*

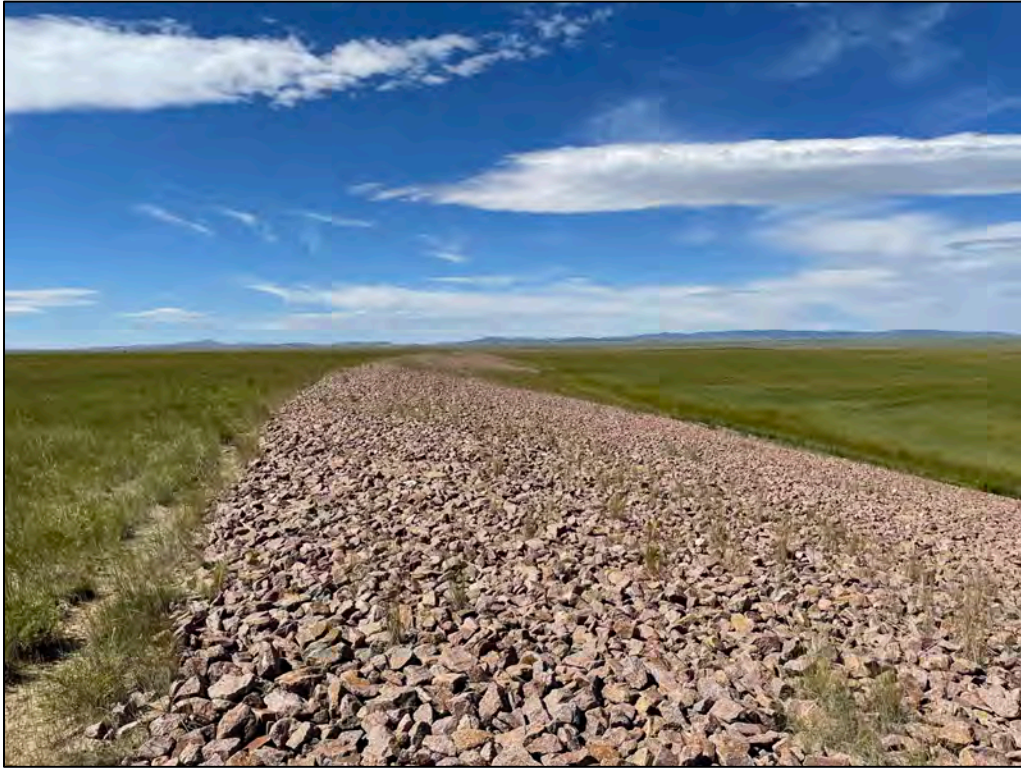
*PL-9. Vegetation Encroachment on Upper Riprap Slope*

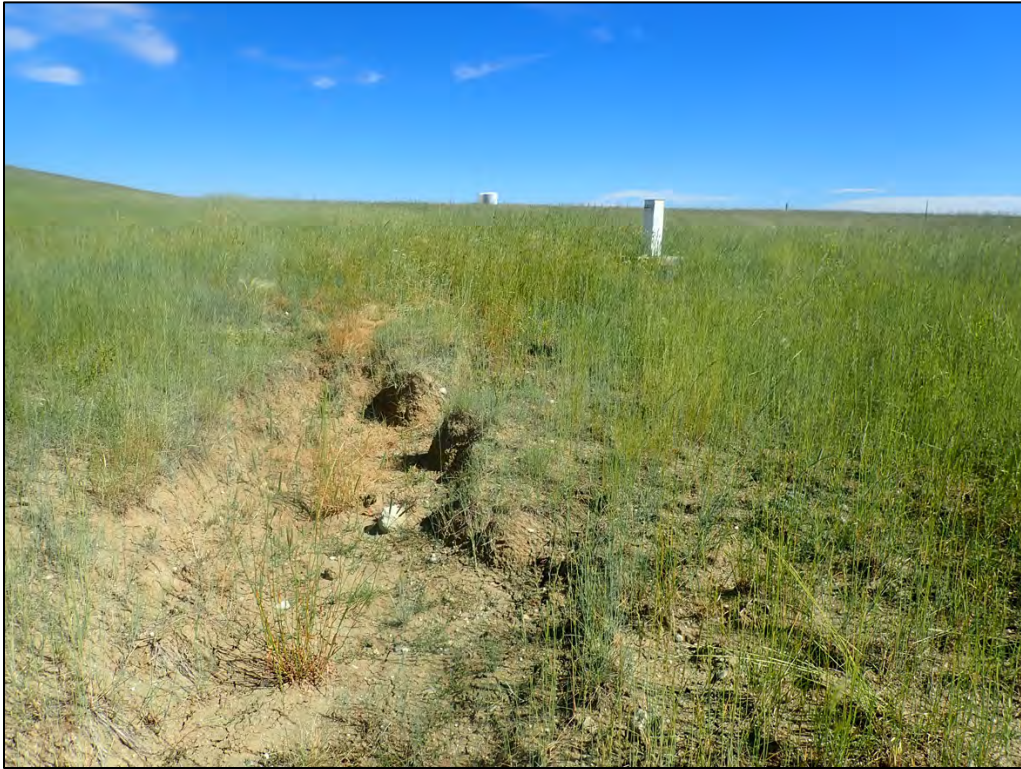
*PL-14. Erosion Caused from Overflowing Water Storage Tank*
