Swiss Federal Nuclear Safety Inspectorate ENSI

Event sequences Fukushima 11032011

in Fukushima Dai-ichi and Dai-ni following
the Tohoku-Chihou-Taiheiyou-Oki earthquake
on 11.03.2011

ENSI-AN-7999
Published 26.08.2011

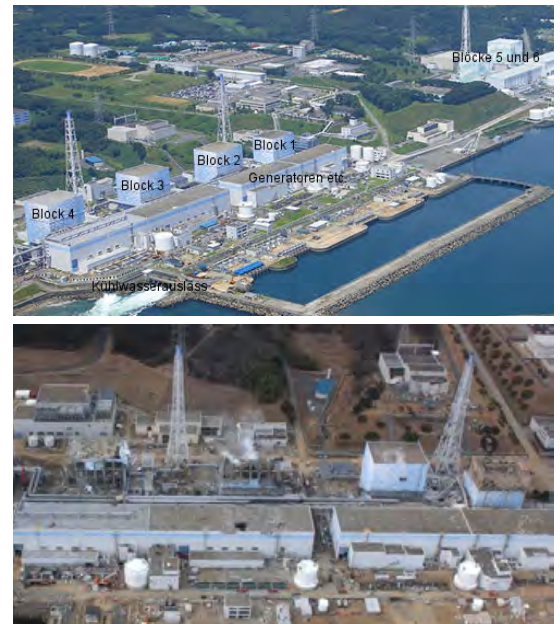
Figure 1:
View of Fukushima Dai-ichi, before/after;
source: TEPCO

On **11.03.2011 at 15:27**, the first tsunami reached the plant site. At **15:35**, parts of the plant site were flooded by the second tsunami (see Ref. 44). This led to the destruction of the infrastructure and the equipment as well as to the loss of the ultimate heat sink (see Ref. 1) and a common-cause failure (CCF) of the auxiliary service water supply and also the destruction of the circulating water structure. Furthermore, a common-cause failure (CCF) of the diesel generators and thus, the failure of safety-related electrical power-consumers was a direct result of the flooding. The diesel generators of Units 1 to 5 are all arranged on the lowest level of the turbine building. The failure of the water-cooled emergency diesels would also have occurred indirectly by the loss of cooling (circulating water structure).

By means of photographs dated **11.03.2011 at approximately 15:57** it can be seen that the water had already withdrawn to a large extent from the plant site (see Ref. 31). This means that the flooding lasted for about 22 minutes.

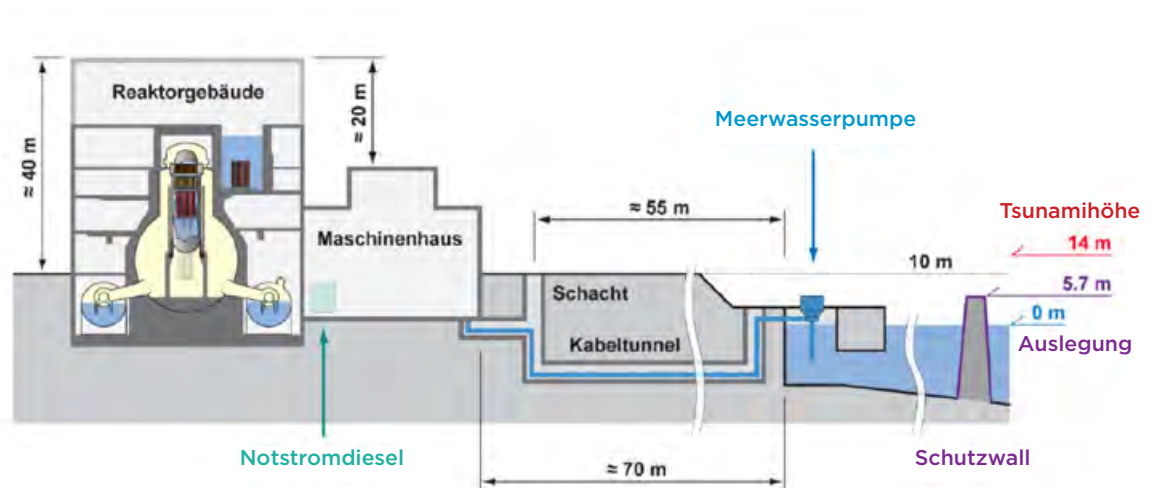
Figure 5: Sectional view with heights above sea level, Units 1 – 4; source: VGB

In 2002, the tsunami protection wall of Fukushima Dai-ichi had been raised from the original height of 3.1 m (design tsunami: Chile 1960 magnitude 9.3 m, height in Japan 3.2 m) to the maximum wave height of 5.7 m. It should be noted that the foundation level is set to 10 m resulting in an additional 4.3 m safety margin for the equipment located at that height.

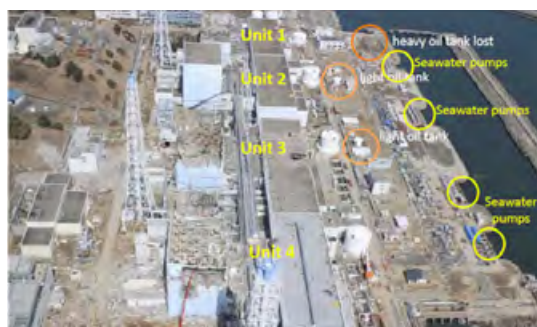
Figure 6:
Failure of cooling water supplies (Dai-ichi);
source: University of Japan

On 11.03.2011 at 15:35, the second tsunami damaged the circulating water intake, leading to the loss of the ultimate heat sink (mechanically). Additionally, there was a failure in the emergency power diesels (flooding),

which lead to an electrical failure of the trains necessary for residual heat discharge to the ultimate heat sink (sea water cooling system), and at 15:37 a station blackout (SBO) occurred (see Ref. 43). Thus there was only the torus available for taking up the residual heat. (The isolation condenser had been taken out of operation manually and continued to be operated manually before the tsunami-induced flooding).

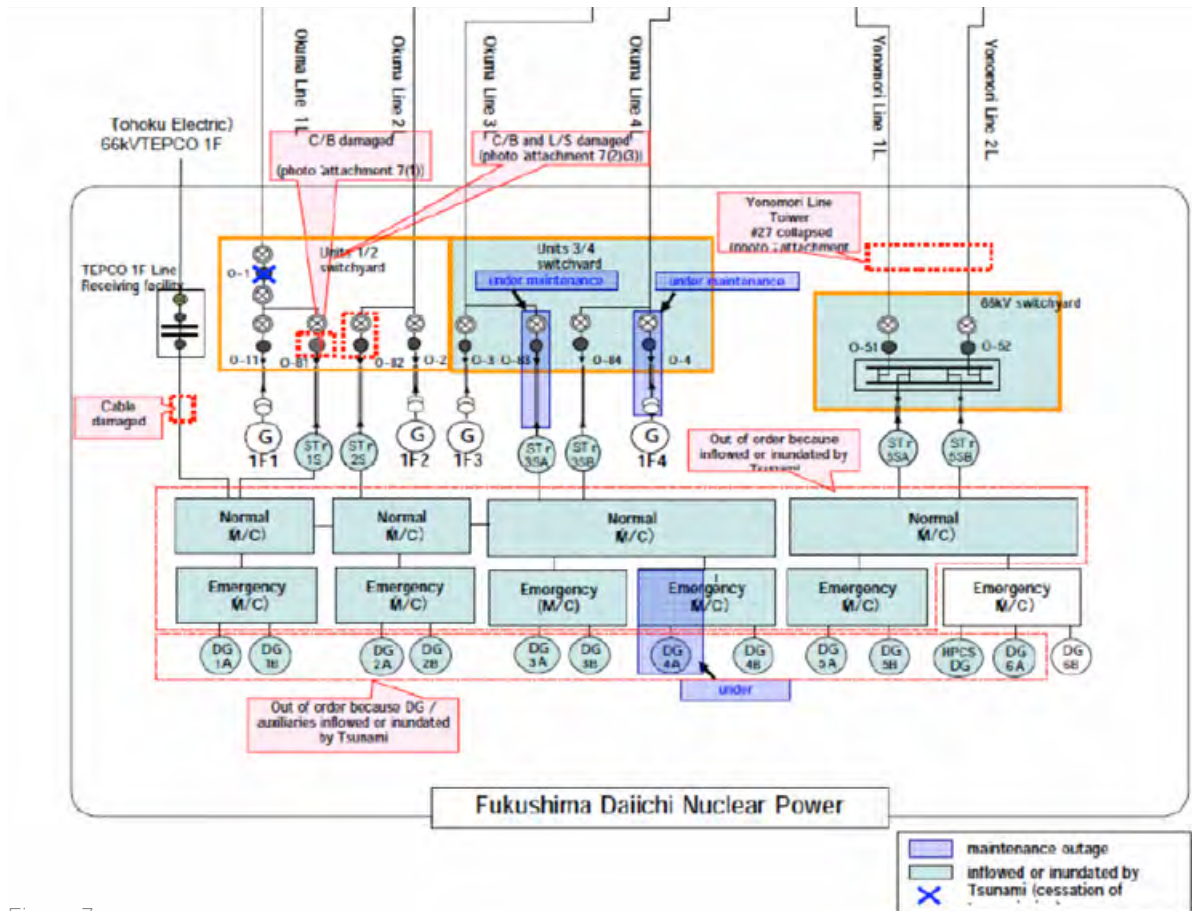
Figure 7:
Failure of auxiliary power supply (Dai-ichi);
source: TEPCO

The failure of the power source and subsequently, the failure of the diesel generators sets led to a total loss of AC power and thus to a station blackout (SBO).

It was not possible to carry out emergency actions immediately. The necessary power supply vehicles were available and ready for operation. One reason for the delay could be due to damaged switchgears. However, a lack of adequate emergency training could also be a reason as TEPCO arranged for training in this area for all the plants shortly after the accident (e.g. Dai-ni, see Ref. 41).

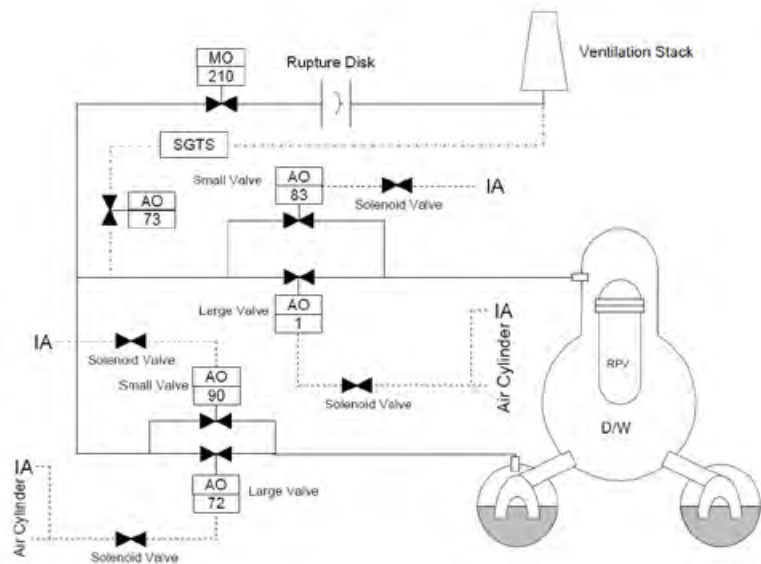
Figure 8:
Diagram of the venting system of Unit 1;
source: Ref. 43

On 12.03.2011 at 09:04, 2 operators were sent to manually open the main valve upstream of the rupture disk (MO) to a degree of 25 %. This took place at 9:15. At 9:24, a second group was sent to open the “small” valve for pressure relief of the torus (AO90). Due to the high local dose rate (LDR), this work was stopped at approximately 9:30. In the scope of this preparatory work for the venting, one worker obtained a radiation dose of > 100 mSV (see Ref. 3). The manual opening on site was interrupted because of the high LDR. It was tried to open the valves from the control room with compressed air. Between 10:17 and 11:15, it was tried to open valve AO90 (see Ref. 44). Thereupon on 12.03.2011 at 14:00, a compressor for the pressure relief of the torus was connected in order to open the “large” valve AO72 (see Ref. 44).

The venting system at the GE plants is designed as an “active” system. Auxiliary power is needed to open the valves. Due to the effects of the flooding, auxiliary power no longer existed. Due to the high activity (this also applies for the loss-of-coolant within the drywell), manual opening became problematic. Presumably, there were no measures for the reduction of radiation exposure for the on-site options to open the venting valves manually. Apparently, a sufficiently dimensioned recombiner for the case of a core

meltdown did not exist. Even if it had existed, (electrical) auxiliary power would presumably have been required.

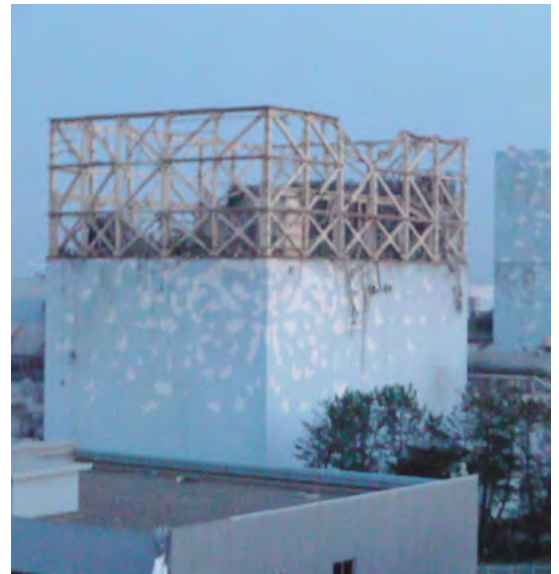
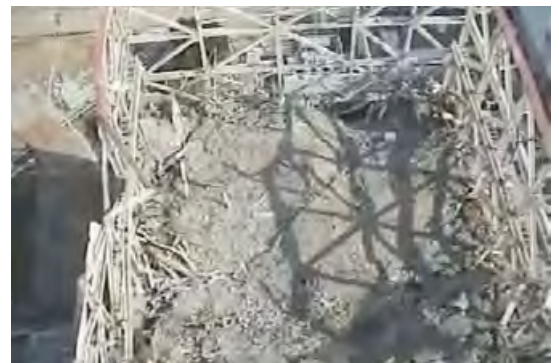
Figure 9:
View of Unit 1 after the hydrogen explosion;
source TEPCO

Nothing is known about the condition of the 392 FA and the spent fuel pool. It is also not clear whether parts of the loading machine or parts of the crane fell into the pool after the explosion or earthquake. Owing to the high masses of debris (Fig. 9), no conclusion on the present condition is possible.

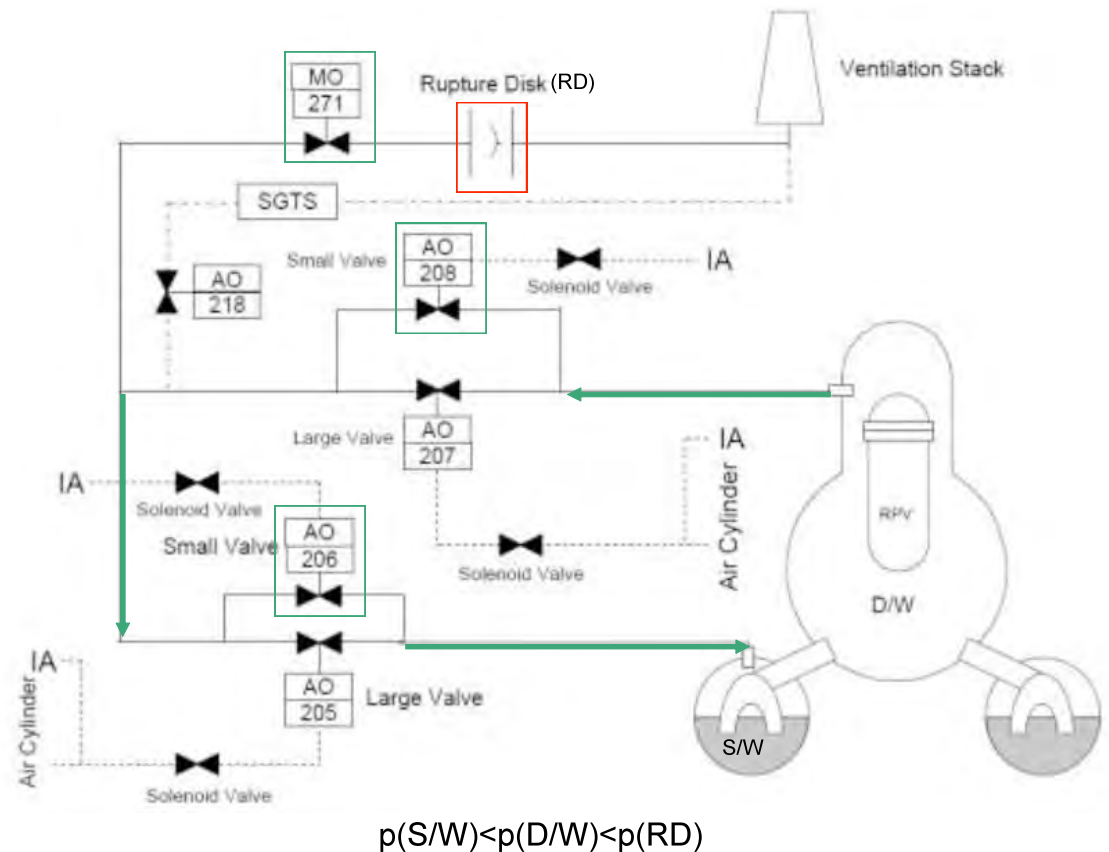
Figure 12:
Venting system of Units 2 and 3;
source: Ref. 43

On 13.03.2011 at 08:10, the main valve upstream of the rupture disk (MO271) opened up to 25 % (see Fig. 12). At 11:00, the 'large' valve (AO205) upstream of the torus was opened for pressure relief, thus pressure relief of the primary containment was actuated upstream of the rupture membrane. According to Ref. 44, the actuation pressure amounted to 4.27 bar (over-pressure), thus making it 5.28 bar_{abs}.

On **14.03.2011 at 11:01**, the explosion in Unit 3 caused the closure of the 'large' valve (AO205) upstream of the torus for the pressure relief as it had lost its actuation (pressurised air). Moreover, the explosion caused a loss of the prepared feed water injection line and damaged the necessary fire extinguishing vehicle (see Ref. 43 and Ref. 44). The drywell pressure amounted at that time to 4.5 bar_{abs} (3.5 bar overpressure).

On 14.03.2011 at 21:00, the 'small' valve (AO206) upstream of the torus was opened to relieve pressure (see Ref. 44). In the period between 21:20 and 22:50, RPV pressure relief was again carried out by safety relief valves (SRVs). The drywell pressure was lower at 22:50 than the actuation pressure of the rupture disk (4.27 bar as overpressure). The drywell pressure at that moment was stable within the range of 3 to 4 bar_{abs} (see Ref. 44).

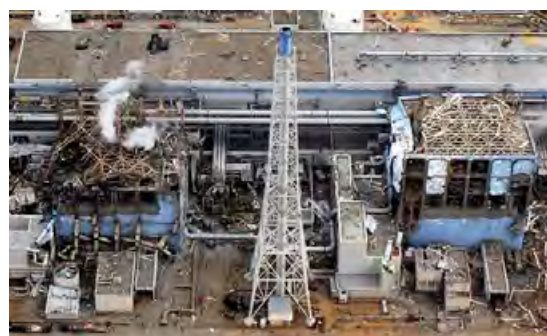
Figure 14:
Units 3 and 4 after the hydrogen explosion;
source: TEPCO

On **15.03.2011 at 06:14**, an explosion occurred in the reactor building of Unit 4 which caused damage to the building structures. The root cause of the explosion is yet disputed. It is hardly plausible to assume in this case, as it was with Units 1 to 3 that a hydrogen explosion occurred due to the oxidation of the fuel cladding tubes, taking into consideration the event progress and the amount of water present in the spent fuel pool. The assump-

tion of the analysis team that the earthquake caused the damage to the fuel pool was refuted according to Ref. 9, in which TEPCO confirms the integrity of the spent fuel pool.

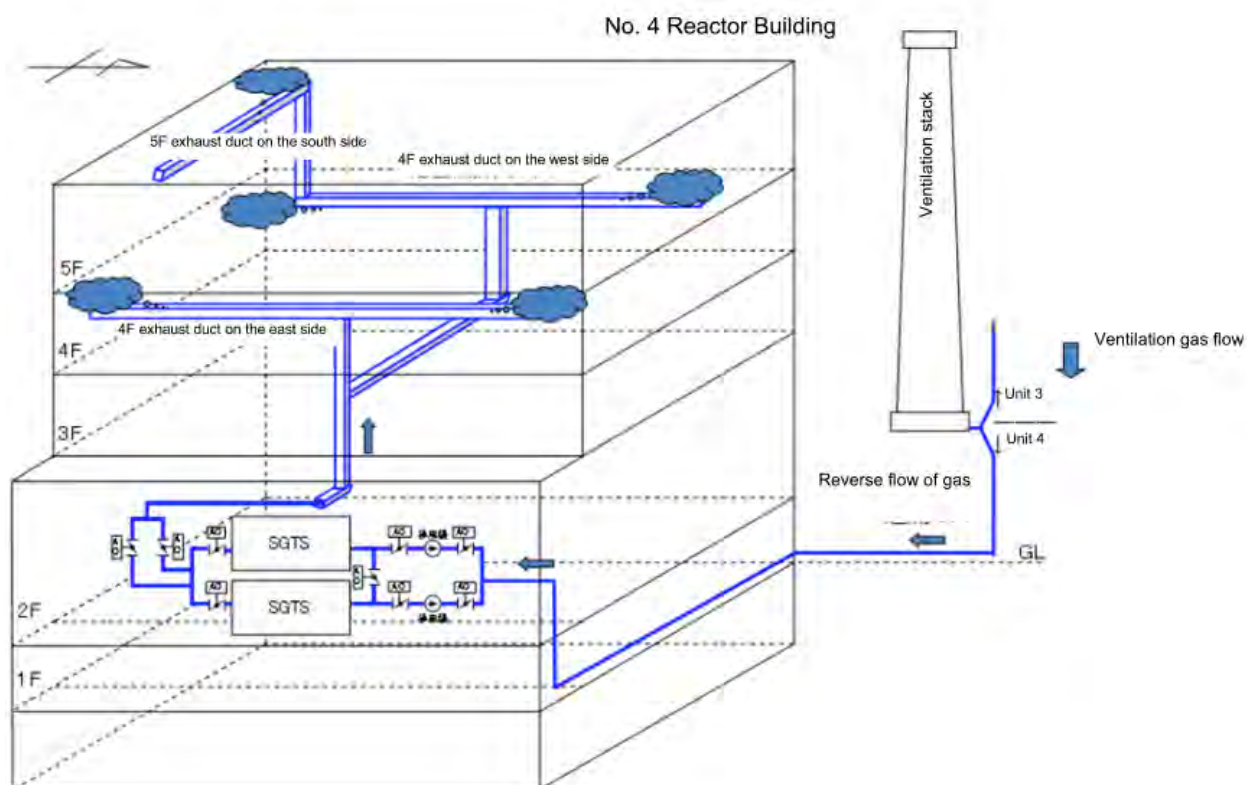
Figure 15:
 H_2 overflow from Unit 3 to Unit 4;
 source: Ref. 43, Fig. IV 5-10

Hypotheses that the hydrogen could be accounted for by other sources, like the venting of Unit 3 (see Sec. 1.4.1) or surge lines of the ventilation of Units 3 and 4 at the bottom of the stack (see Ref. 10) or the generation of an explosive mixture from the welding and cutting gas (shroud dismantling) cannot be proven explicitly (see Ref. 43). More recent reports assume, however, that the hydrogen from Unit 3 could overflow via the common exhaust air line and the 'emergency gas treatment plant' of Unit 4 into the upper part of the reactor building of Unit 4 (see Fig. 15). Apparently, the 'emergency gas treatment plant' does not possess any non-return valves to prevent such overflow (see IV-90/IV-96, Ref. 43).

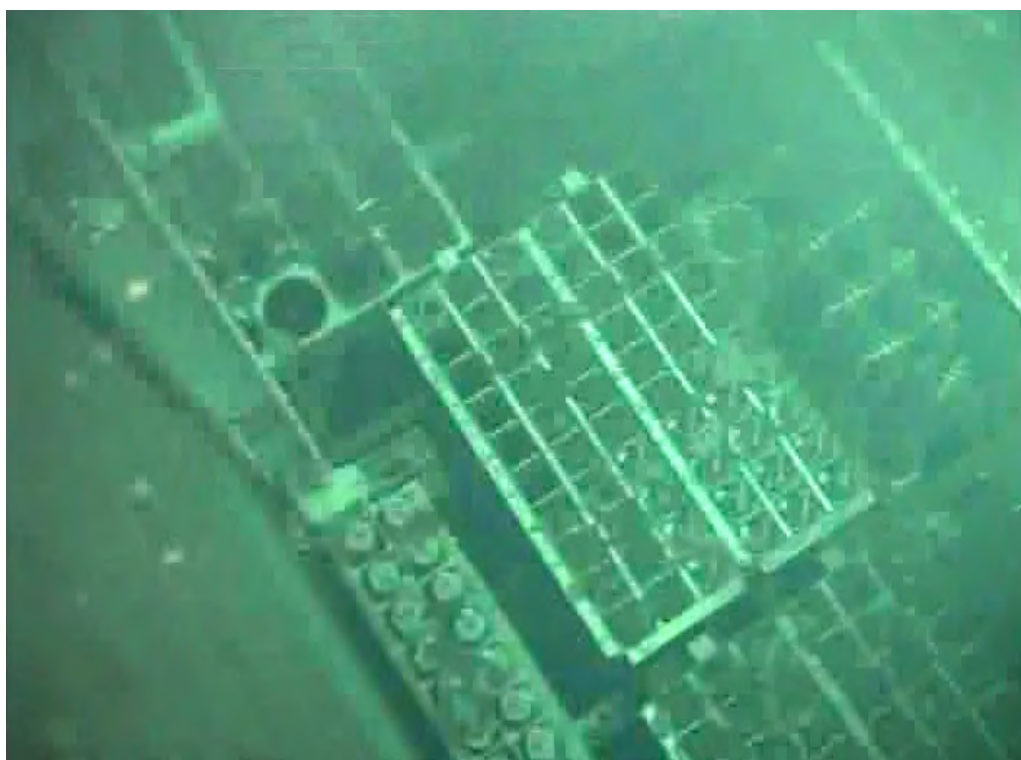
Figure 16:
Spent fuel pool, Unit 4, on 29.04.2011;
source: TEPCO

Ref. 21 gives evidence of a only a slight debris coverage in the spent fuel pool of Unit 4 due to the hydrogen explosion (see Fig. 16), while no mechanical damage of FA was discernible. A nuclide analysis from 08/09.05.2011 gives evidence of elevated concentration of radionuclides (mainly of Cs-134/137) in the pool as compared to the reference value of 04.03.2011 (see Ref. 38). The question whether these nuclides stem from the FA damage in Unit 4 or if they came from the ingress from the other units cannot be answered conclusively.

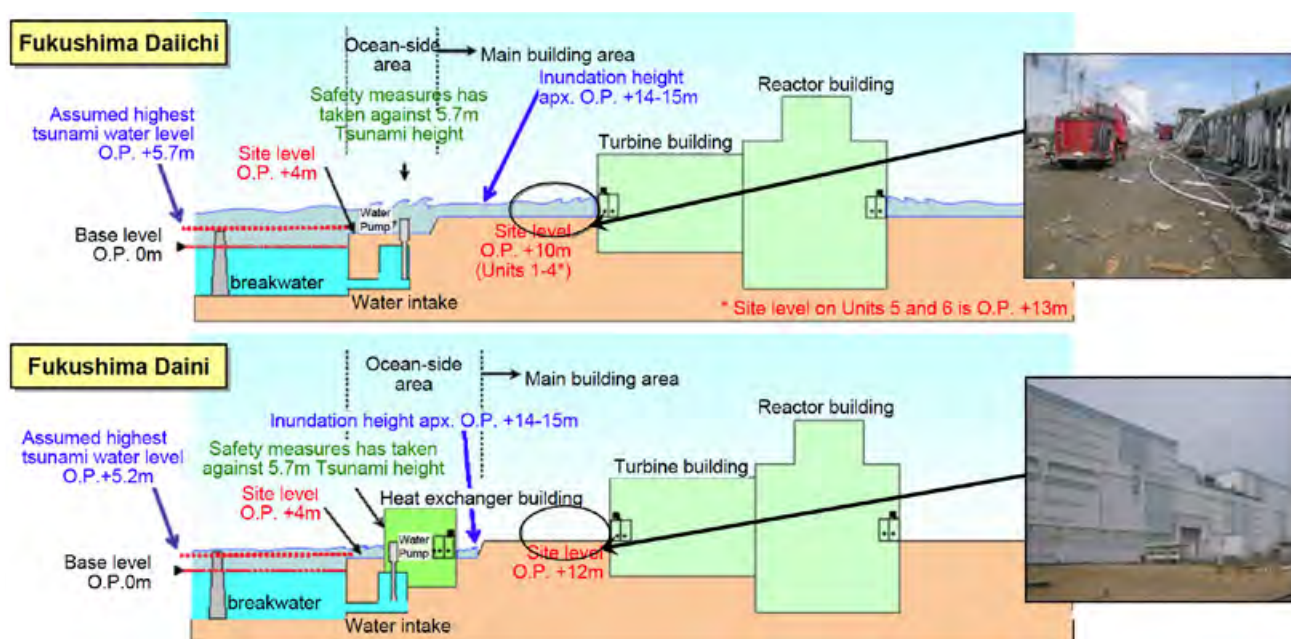
Figure 18: Flooding as compared between Dai-ichi and Dai-ni; source: TEPCO

At this site, the damage turned out to be less severe owing to the siting (located 2 m higher) and the slightly more favourable layout of the buildings. (see Fig. 18).
