Swiss Federal Nuclear Safety Inspectorate ENSI

The Impact Fukushima 11032011

Radiological Effects
of the Nuclear Accidents
in Fukushima on 11 March 2011

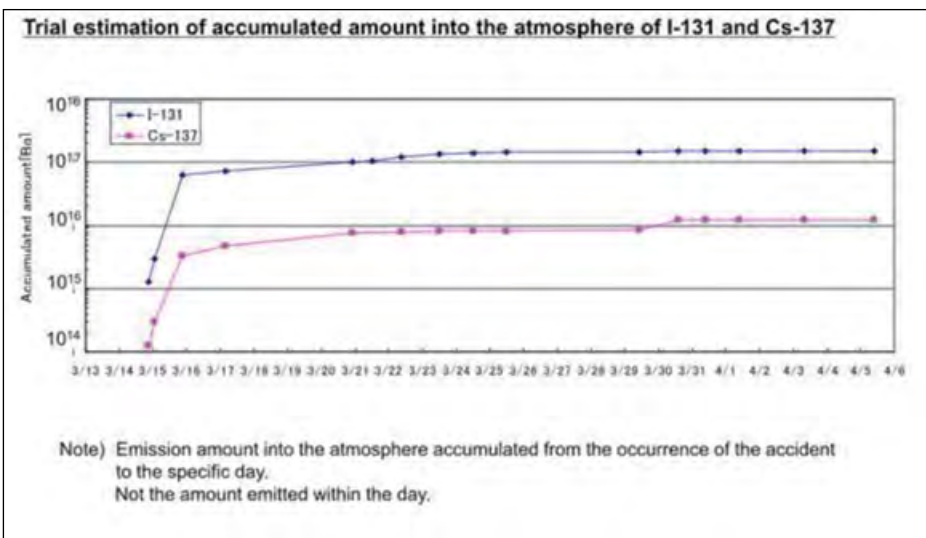
Figure 2-2 Cumulative release of I-131 and Cs-137 according to NSC calculations in the period from 11 March 2011 to 5 April 2011 ⁶

Figure 2-2 below shows the accumulated releases over the aforementioned period as calculated by NSC (publication dated 12 April 2011), in graphic form (cf. /4/).

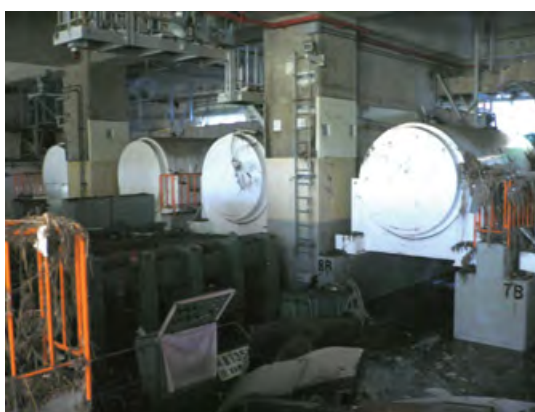
Figure 2-3 Situation in the dry storage facility at the Fukushima Dai-ichi nuclear power plant ⁷

Inspection of the spent fuel pools in units 2, 3 and 4, including associated nuclide measurements, have so far provided no grounds for assuming major damage to the fuel assemblies (FA) stored there. It is concluded from this that the main releases took place via the containment venting operations or leakages. No statements are yet available regarding the spent fuel pools belonging to units 1, 5 and 6. However, it may be assumed that no releases took place from units 5 and 6, which were less seriously affected by the tsunami and whose reactor buildings remained intact (cf. /11/). Both the fuel assembly wet storage facility and the storage containers in the dry storage facility remained intact and did not contribute to the release of activity into the surrounding area. The dry storage facility, which is located near the turbine hall of unit 5, was damaged by the tsunami (cf. Figure 2-3). As it was not possible to determine any releases of activity by means of measurements /3/, it is assumed that the containers remained intact.

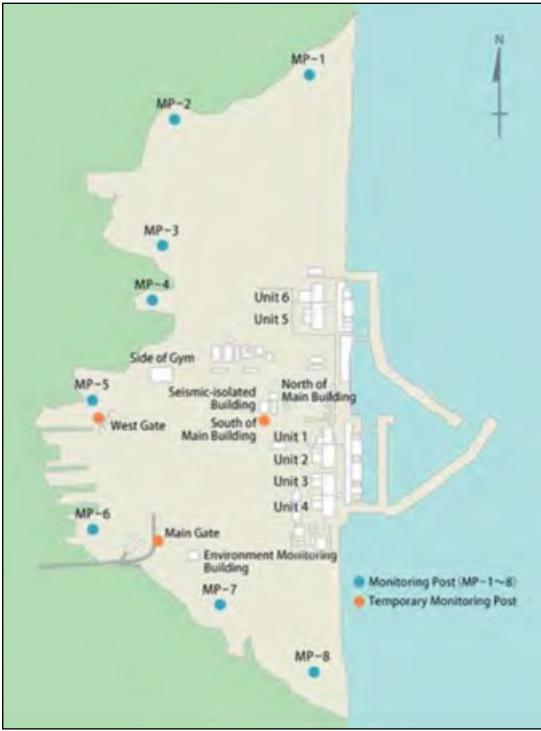
Figure 3-1 Locations of ADR monitoring posts on the Fukushima Dai-ichi plant site ¹⁴

Extensive values measured by the operators are available for the plant site. Figure 3-1 shows the permanently installed monitoring posts (measurement points) used to register the ambient dose rate (ADR) in blue. In some cases, the function of these monitoring posts was impaired by the earthquake and/or the tsunami. Damage was inflicted on the power supply, the data lines and the computing units in the main building. Partially, the probes were then supplied from mobile batteries and the measured data were evaluated with the help of portable computers.

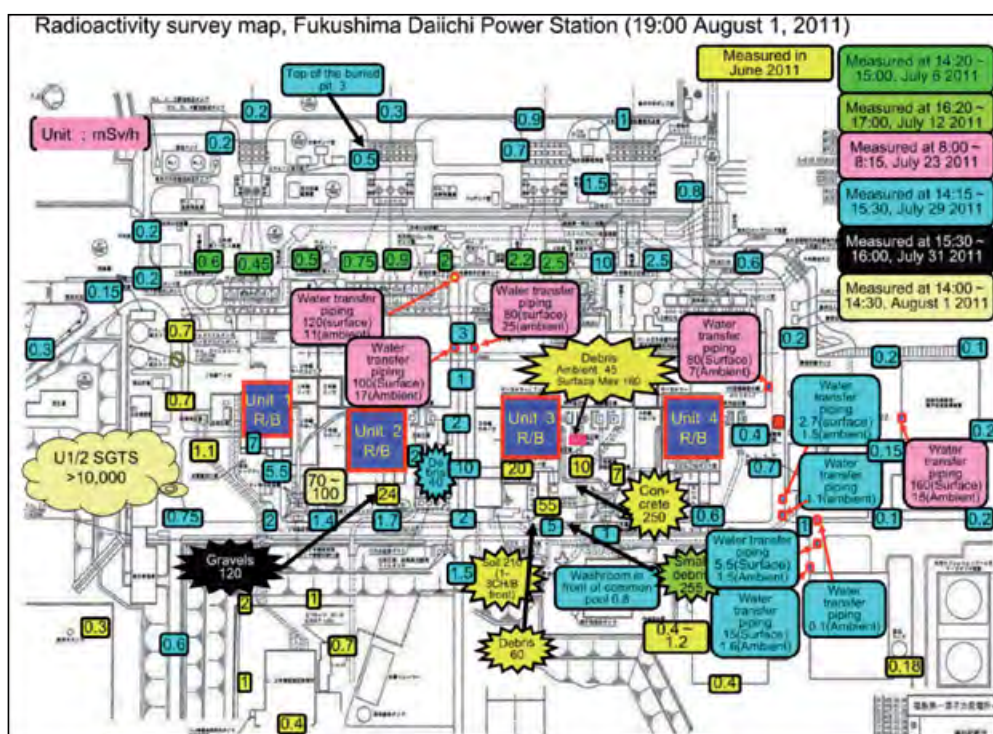
Figure 3-4 ADR values on the Fukushima Dai-ichi site on 1 August 2011¹⁷

The reduction in the ADR values in wide areas around the units is clearly recognisable. However, Hot Spots with very high dose rates are repeatedly discovered during the removal of the debris (U1/2 SGTS >10'000 mSv/h) (cf. Figure 3-4).

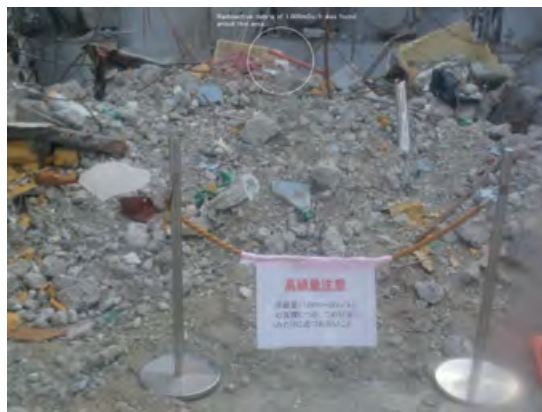
Figure 3-5 Radioactive debris near unit 1¹⁸

On 21 May 2011, for example, a dose rate of 1'000 mSv/h was measured in debris near unit 1 (cf. Figure 3-5).

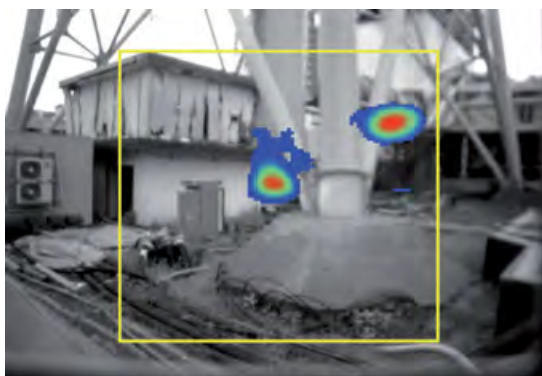
Figure 3-6 Base of stack, units 1 and 2, photographed with a gamma camera¹⁹

On 31 July 2011, TEPCO discovered by use of a gamma camera high gamma levels at the bottom of the vent stack shared by units 1 and 2 (cf. Figure 3-6).

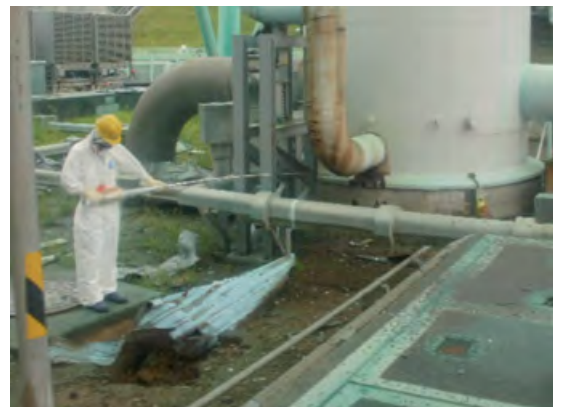
Figure 3-7 Base of stack between units 1 and 2, measurement with a telescopic detector²⁰

The pipes connect the Standby Gas Treatment System (SGTS), also known as the Emergency Gas Treatment System, to the stack.

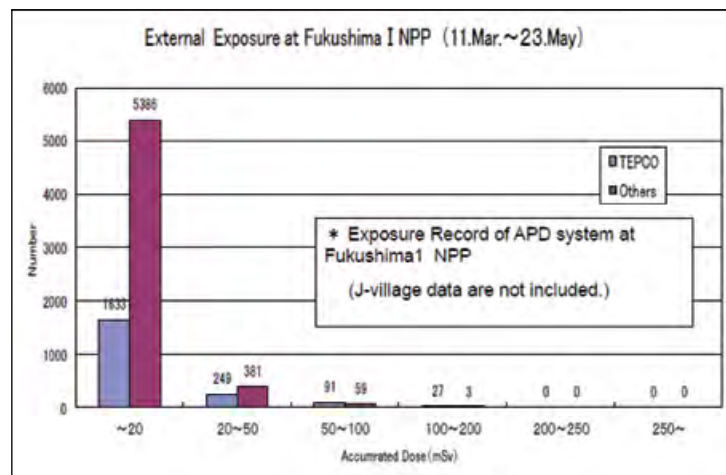
Figure 4-1 Distribution of accumulated radiation doses, 11 March until approx. 23 May 2011²²

By 23 May 2011, about 7,800 persons were involved in the emergency work at the Fukushima Dai-ichi nuclear power plant. Until then, the average individual dose due to external radiation exposure was approx. 7.7 mSv. 30 persons had accumulated individual doses of more than 100 mSv (cf. Figure 4-1).

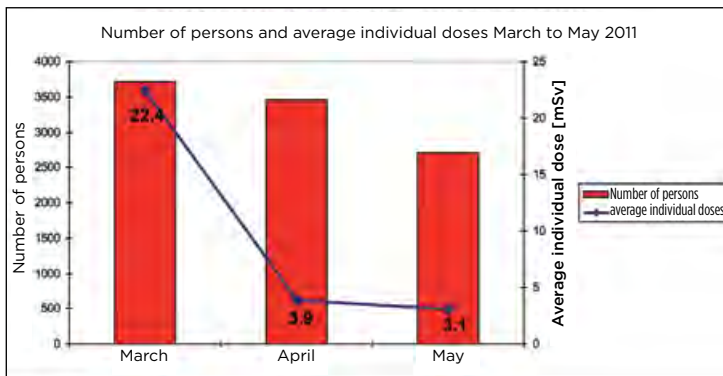
Figure 4-2 Number of persons and average individual doses, March to May 2011

External and internal radiation exposures taken into account, 3'715 persons had accumulated an average individual dose of 22.4 mSv, according to a report by the Japanese government /1/. In April 2011, 3'463 persons had accumulated an average individual dose of 3.9 mSv and in May 2011, 2'721 persons had accumulated an individual dose of 3.1 mSv on average (cf. Figure 4-2).

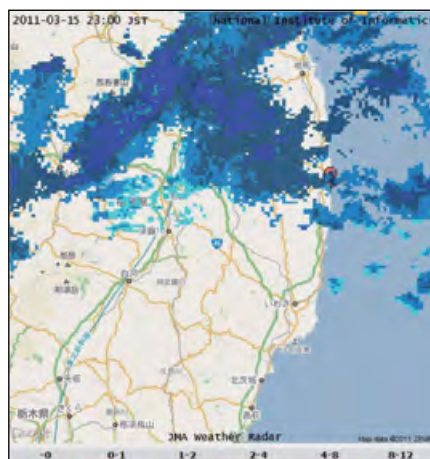
Figure 5-2 Figure 5-2 Weather situation on the evening of 15 March 2011 in the area surrounding the Fukushima Dai-ichi nuclear power plant ²⁴

The main discharges from Fukushima Dai-ichi from 15 March 2011 onwards were largely the consequence of the explosion in unit 2, as Figure 3-2 illustrates. On the evening of 15 March, there were prevailing winds from a south-easterly direction at an altitude of 100 m above the power plant site; and during the night from 15 to 16 March 2011, repeated precipitation (rain or snowfall) was recorded downwind (cf. Figure 5-2, top). As a result, there were substantial deposits of radioactive iodine and cesium isotopes (Cs-134 and Cs-137) in aerosol form in a north-westerly direction, at distances of up to about 50 – 60 km from the site (cf. Figure 5-2, bottom). By comparison, there were significantly smaller deposits of radioactive substances to the north, in the south-western quadrants and in particular along the coast.

In the course of 16 March 2011, the wind veered westerly again so the radioactive discharges from the site were conveyed over the Pacific Ocean.

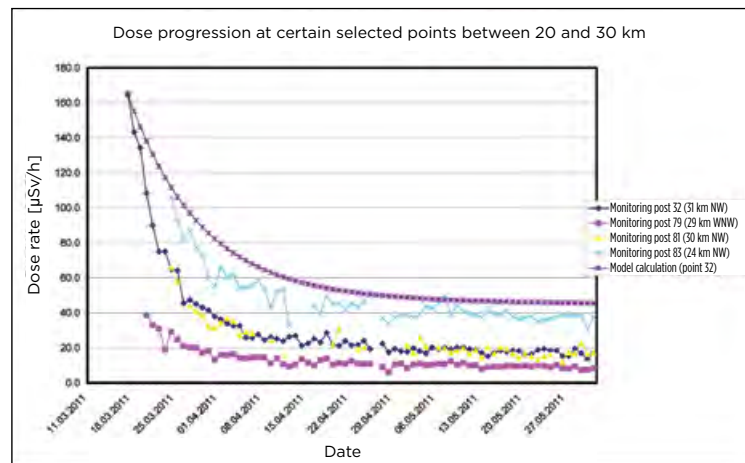
Figure 5-7 Progression at monitoring posts with the highest ambient dose rates directly after the accident

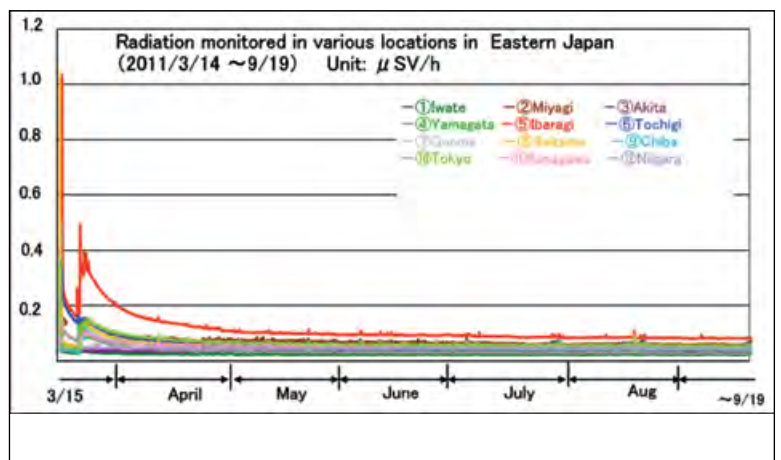
Figure 5-8 Progression of ambient dose rates in major cities in eastern Japan between 15 March and the start of September ²⁹

Figure 5-8 shows the ADR progression in larger eastern Japanese cities (including Tokyo). Several peaks due to I-131 deposits can be seen clearly; these occurred to the south of the site when the wind turned in this direction in the initial phase of the accident.

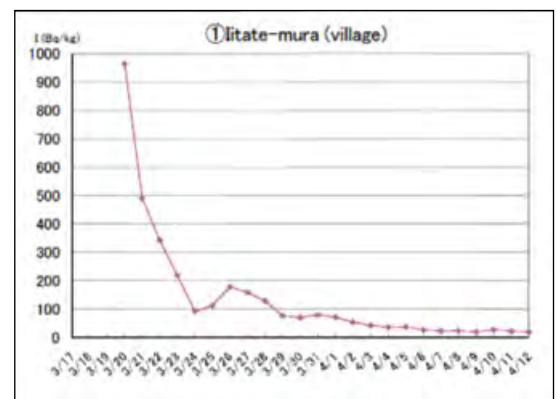
Figure 5-12 Violation of the I-131 activity limit in drinking water after the accident, using the examples of two waterworks in Iitate (prefecture of Fukushima) and Tokyo³⁹

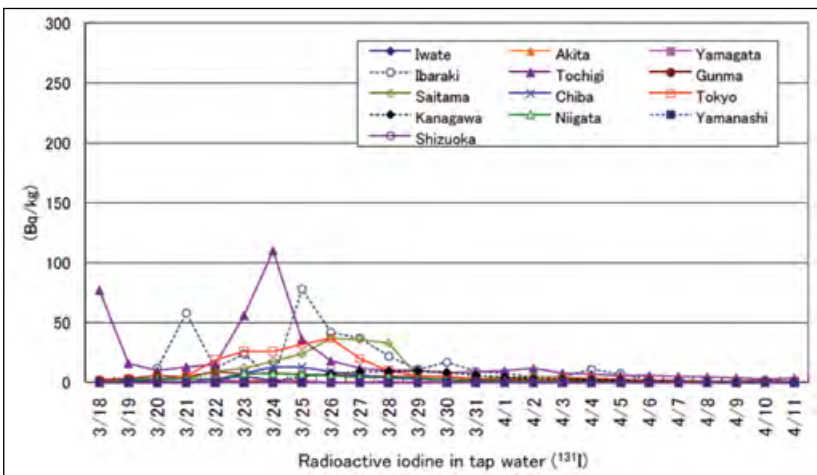
Figure 5-13 Activity concentration for I-131 in the drinking water systems of various prefectures in northern Japan ⁴⁰

Figure 5-13 and Figure 5-14 show the progression of activity in drinking water in various provinces for I-131 and Cs-134/137: from about mid-April 2011 onwards, the values returned to the level of those measured before the accident, they were therefore significantly below the limits again.

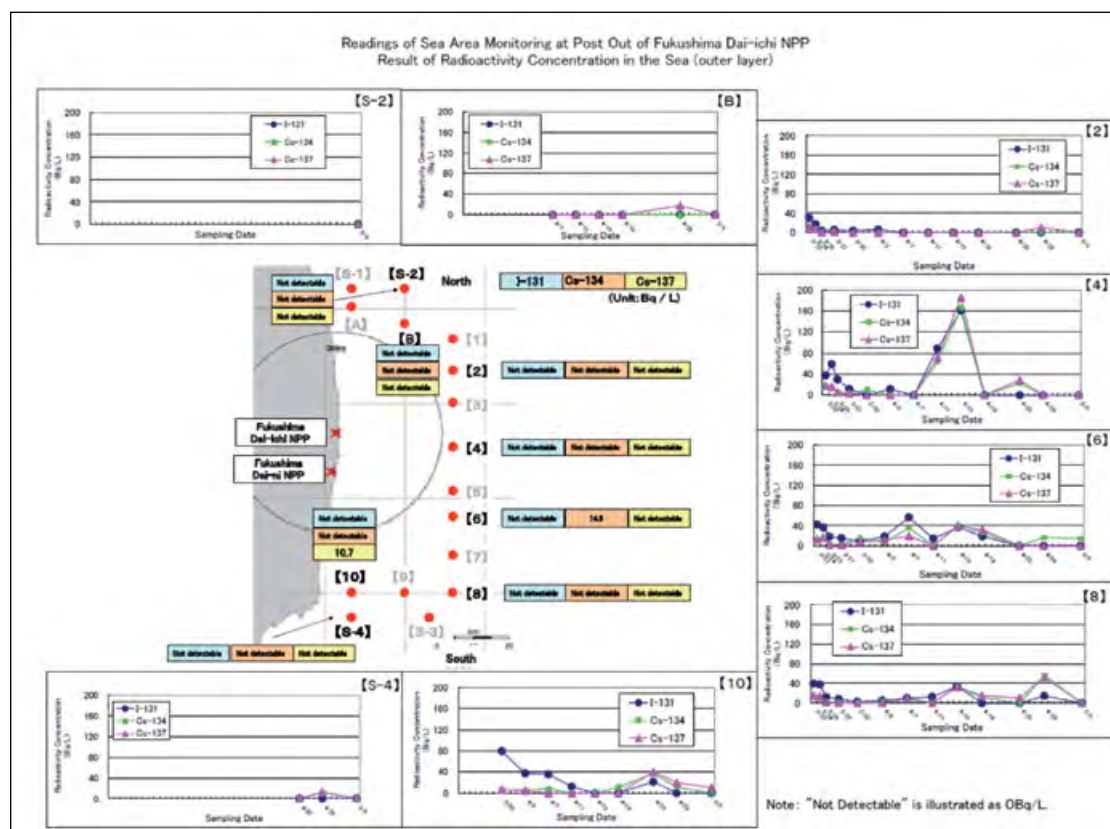
Figure 5-16 Activity concentration of I-131, Cs-134 and Cs-137 in the seawater around the Fukushima Dai-ichi nuclear power plant on 7 May 2011⁴³

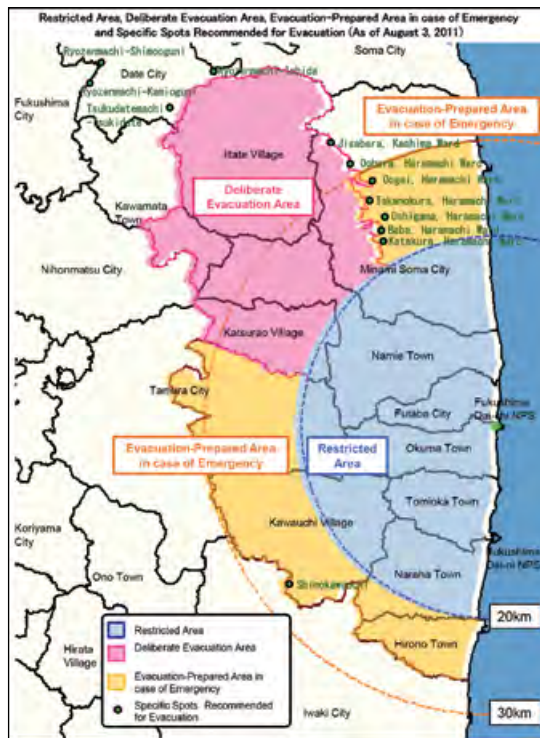
Figure 5-19 Evacuation zones around Fukushima Dai-ichi ⁴⁶

- On 12 March 2011 at 07:45 a.m., the government ordered people to evacuate the 3 km zone and to stay in their houses in the 3 to 10 km zone around the Dai-ni power plant.
- On 12 March 2011 at 5:39 p.m., evacuation of the 10 km zone was ordered.
- On 21 April 2011, the evacuation zone was reduced to 8 km. As a precaution, the population was initially evacuated within a radius of 20 km around Fukushima Dai-ichi (cf. Figure 5-19).

The authorities subsequently decided to extend the evacuation zone for specified areas (“Deliberate Evacuation Areas”) beyond the 20 km radius in cases where the population would accumulate a dose of more than 20 mSv by March 2012. The affected municipalities are located to the north-west up to a distance of approx. 40 km from the Fukushima Dai-ichi nuclear power plant. The 20 km zone around the Fukushima Dai-ichi power plant that had already been evacuated was converted into a prohibited zone (“Restricted Area”). Residents were recommended to leave the other contaminated areas between 20 and 30 km (“Evacuation-Prepared Areas in Case of Emergency”).

On 30 September 2011, the stipulation regarding “Evacuation-Prepared Areas in Case of Emergency” (orange zone in Figure 5-19) was lifted again by the Nuclear Emergency Response Headquarters.

to a few thousand km² (cf. Figure 5-19). This results in substantially lower radiation exposure for the population (cf. Table 7-3) and, with suitable decontamination measures, soon makes it possible for many residents to return to their home towns or villages.

Fukushima Dai-ichi: Figure 7-7 provides an overview of deposits of Cs-134/137 around Fukushima Dai-ichi and of the expected doses in the first year after the events of March 2011. The evacuation zones are shown in Figure 5-19 and Figure 5-20

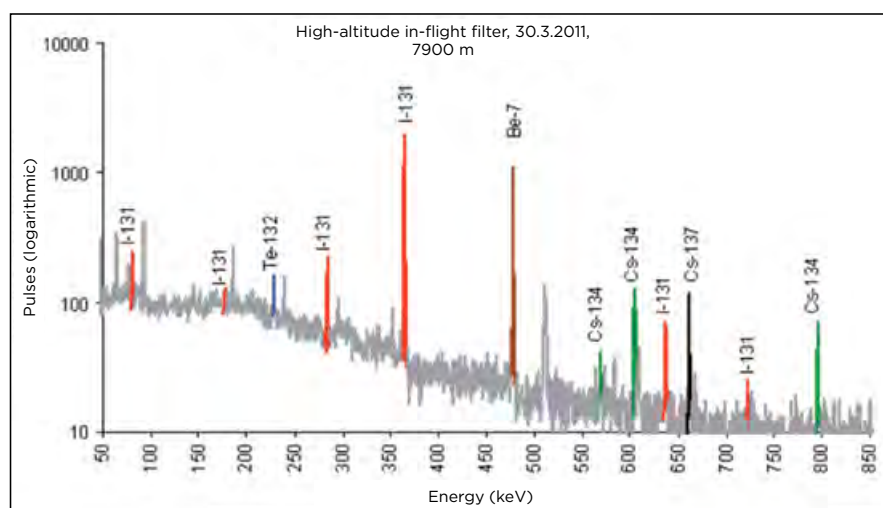
Figure 6-3 Gamma spectrum of an air filter from Switzerland with radioisotopes from the reactor accident at Fukushima ⁵³

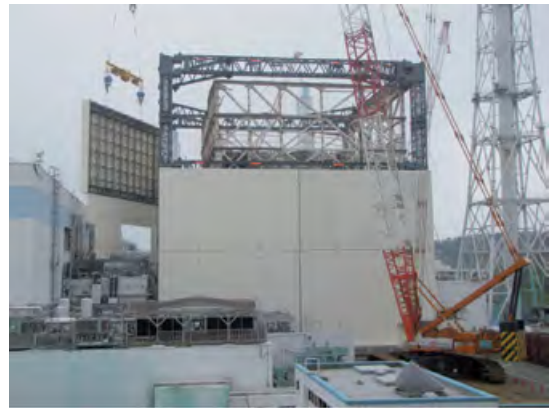
Figure 7-1 Enclosure for unit 1, view from the north ⁵⁶

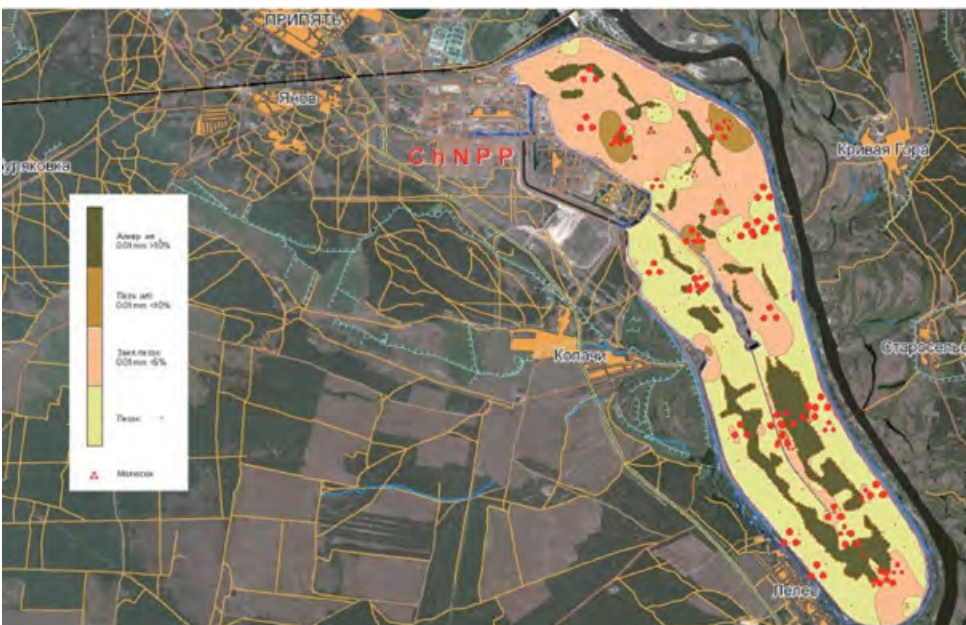
Figure 7-4 Cooling pond at the Chernobyl nuclear power plant with sediments drawn in⁵⁹

Chernobyl: Because the locations of the power plants at Chernobyl and Fukushima are very different, the impacts on the adjacent bodies of water also differ greatly. The Chernobyl nuclear power plant is situated in the interior of the country, on the river Prypyat. The cooling water was taken from the cooling pond located in the south-east of the site (cf. Figure 7-4). This is a significant feature in terms of ecology. With a length of 11.4 km, a width of 2 km and an average depth of 6 to 20 m, its water capacity is approx. 149 million m³. It was heavily contaminated by the accident. Radioactive particles and "Hot Particles" were introduced into the cooling pond by the radioactive cloud; in addition, approx. 5'000 m³ of heavily contaminated water was pumped into the cooling pond. The total intake is estimated at approx. 2'200 TBq. Measurements indicate that the contamination nowadays consists mainly of Cesium-137 and Strontium-90, about 90% of which is bound in the sediment. Each year, between 3.6 and 14 GBq of Strontium-90 flow into the river Prypyat from the cooling pond /27/.
