# Urban Challenge

BY PERRY HAUSMAN P.E., MEMBER ASHRAE

## CASE STUDY CORPORATION HALL

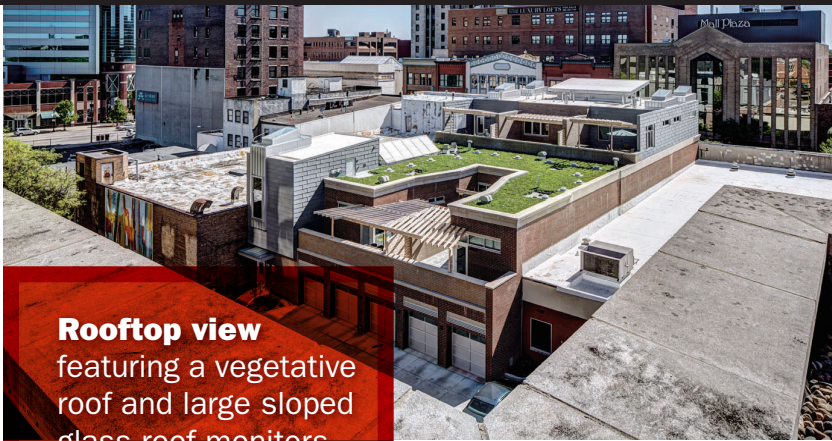
**Rooftop view** featuring a vegetative roof and large sloped glass roof monitors to capture natural light and bring it deep into the public zones.

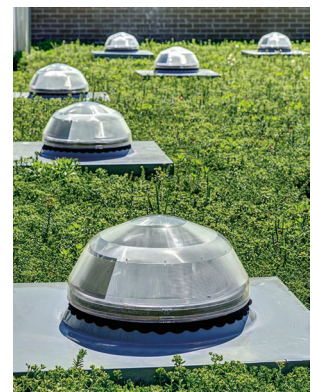
Solar light tubes on the vegetative roof provide natural light deep into the building.

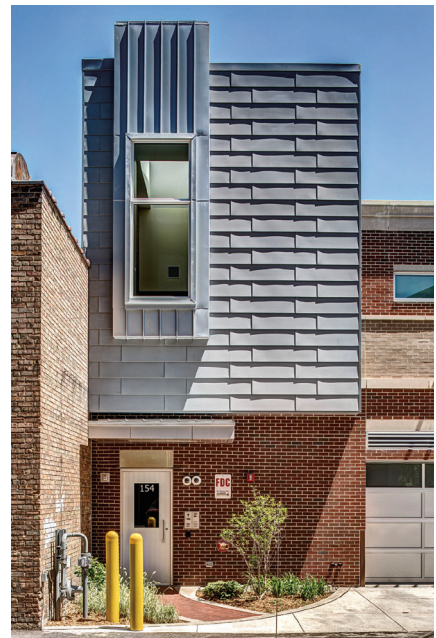
Rear entrance. The brick pavers and concrete driveway are each protected from snow and ice with a melting system using a weather predictive demand-control activation algorithm.

Another large savings comes from the demand-response snowmelt system, which is designed to prevent idling. The building automation system (BAS) initiates a query to the local weather forecast. When snow is predicted, a learning algorithm determines when the system should begin heating the thermally massive snowmelt area so

that the snow melts upon contact. Because the system detects when it needs to turn on and off, it provides savings of more than \$3,000 annually, with a payback time of 2.3 years.

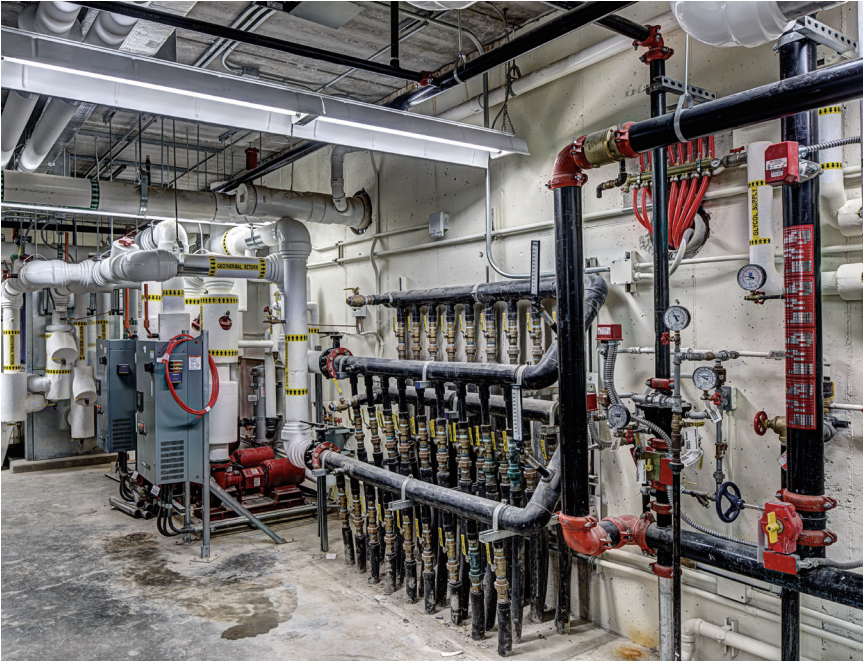
**LEFT** Fire protection (foreground) geothermal manifold (midground), and geothermal pump and heat pump (background). Each geothermal bore is piped as a “home run” to the geothermal manifold shown here. Each bore can be individually isolated in case of a catastrophic failure. This is a critical design since the geothermal field is located below the building.

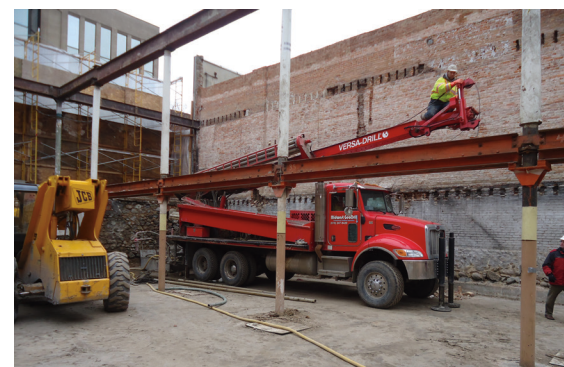
Maneuvering the drill rig into place for the first bore holes to be drilled.

The geothermal system is one of the biggest contributors to the project's energy efficiency, but installing it beneath an existing building in an urban location posed significant challenges. To accomplish this, the drill rig was driven down a temporary ramp leading into the existing basement where boreholes were drilled through the existing slab, extending an average of 400 ft into the ground.

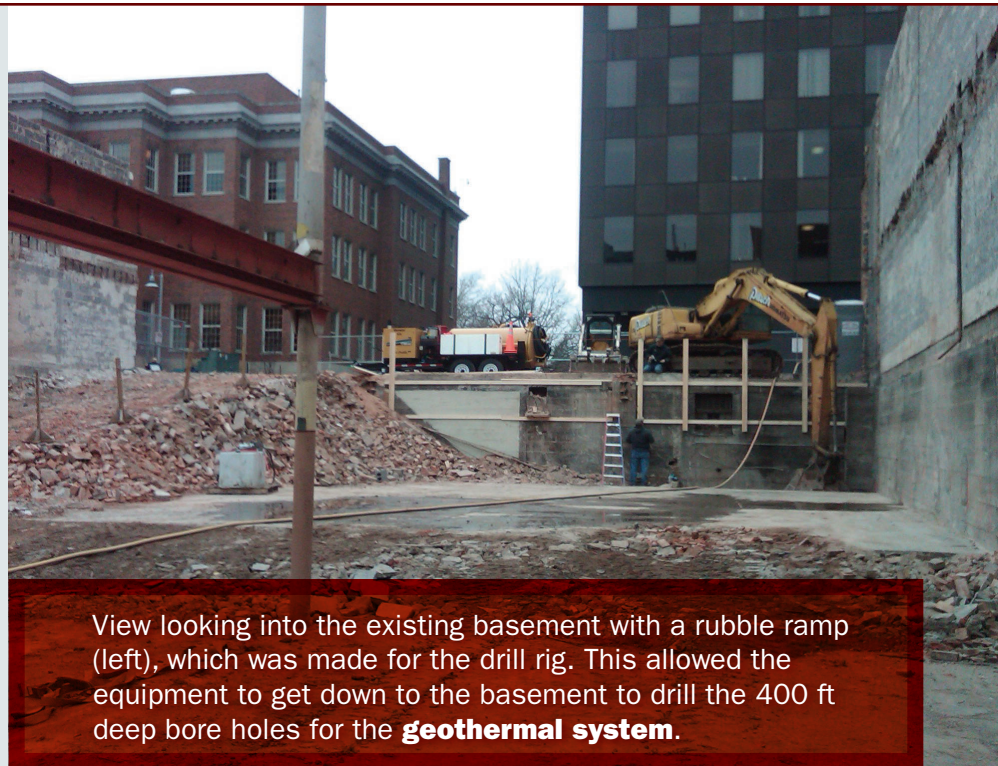
View looking into the existing basement with a rubble ramp (left), which was made for the drill rig. This allowed the equipment to get down to the basement to drill the 400 ft deep bore holes for the **geothermal system**.

It was then decided to move the geothermal bores to the front of the site, but the challenge of getting the installation equipment down into the basement still existed. The team created a ramp to get the machine down, but due to the limited space in the

urban setting, the ramp had to be taken apart after the equipment was in place so it could move around for installation. Then the ramp was reassembled to get the equipment back out. Had there been more coordination during design, a more efficient process may have been possible to save time and energy on the assembly and disassembly of the ramp.
