Emerson Commercial &
Residential Solutions
Professional Tools

IMPORTANT PRODUCT SAFETY NOTICE: AFFECTING KLAUKE TOOLS ESGM45CFM, ESGM45CFM0000, ESGM45CFM0001, ESGM45CFMBASF, ESGM45CL, ESGM45COB, ESGM45COM, ESGM45CFB- & ESGM452CFM PRODUCED FROM OCTOBER 2016 TO APRIL 2023

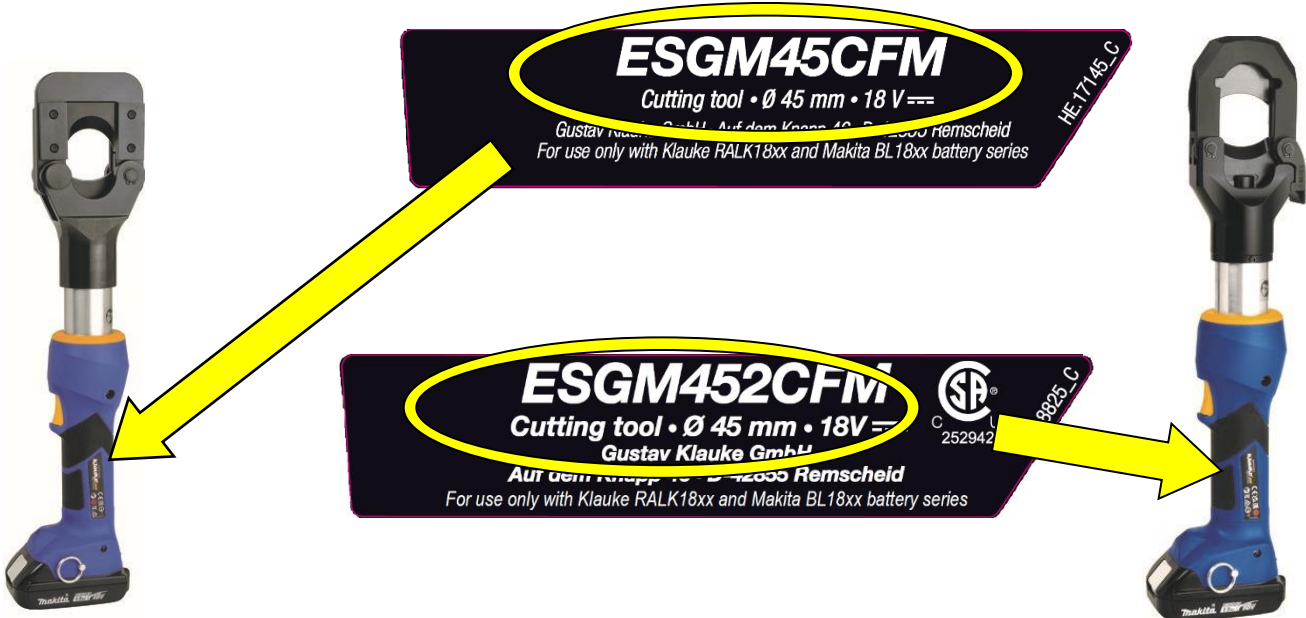
STEP 1 – Inspect the tool decal to determine tool’s model (see, Figure 1). If tool model is „ESGM452“ or „ESGM45“ continue to Step 2. No other Klauke tool model is affected by this Notice.

Figure 1 - Tool Model Identification and Decal Location

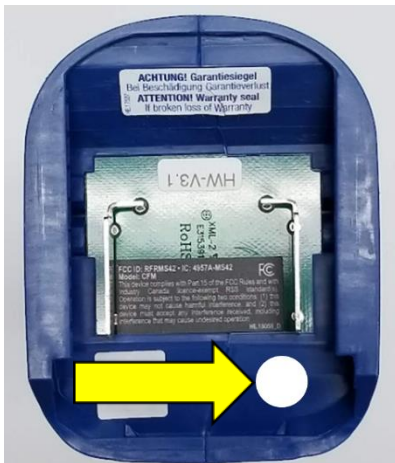
STEP 2 – Remove battery from tool. Look into the battery shoe area, to determine if there is a White Dot as shown in Figure 2. If there is a white dot, this tool has already been reworked and is not part of this notice. If there is no White Dot, continue to Step 3.

Figure 2 – Inspect Battery Shoe area to determine if White Dot Present (Arrow shows White Dot indicating Tool not affected)

If your tool has a matching Date Code (Step 3) and NO White Dot is present (Figure 2) **your Tool is affected and must be returned to Klauke. Do not continue to use or sell the affected Tool.** You must immediately contact Klauke Technical Service. The contact information for the Klauke Service Center in your region is available on our website <https://www.klauke.com/de/en/service-centre-and-repairs>.

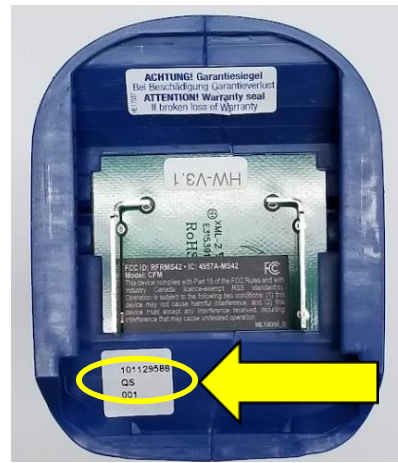
Figure 3 – Determine two-letter Tool Date Code (Circle shows “QS” in this example)

STEP 3 – If there is no White Dot, determine the two-letter tool Date Code by looking at the serial number label (See Figure 3). If serial number label is missing, contact Klauke for assistance. If the two letter Date Code listed on the tool serial number label is: KT, KW, KX, KY, KZ, K1, LN, LP, LQ, LR, LS, LT, LV, LW, LX, LY, LZ, L1, MN, MP, MQ, MR, MS, MT, MV, MW, MX, MY, MZ, M1, NN, NP, NQ, NR, NS, NT, NV, NW, NX, NY, NZ, N1, PN, PP, PQ, PR, PS, PT, PV, PW, PX, PY, PZ, P1, QN, QP, QQ, QR, QS, QT, QV, QW, QX, QY, QZ, Q1, RN, RP, RQ, RR, RS, RT, RV, RW, RX, RY, RZ, R1, SN, SQ, or SR and no White Dot is present your ESGM45 /ESGM452 is affected and must be returned to Klauke Do not continue to use the Tool. Contact Klauke using the information provided below.
