**Emerson Commercial &
Residential Solutions**
Professional Tools

March 16, 2023

**IMPORTANT SAFETY NOTICE: REQUIRED RETURN OF AFFECTED KLAUKE ORANGE TOOLS
PRODUCED FROM DECEMBER 2021 TO JANUARY 2023**

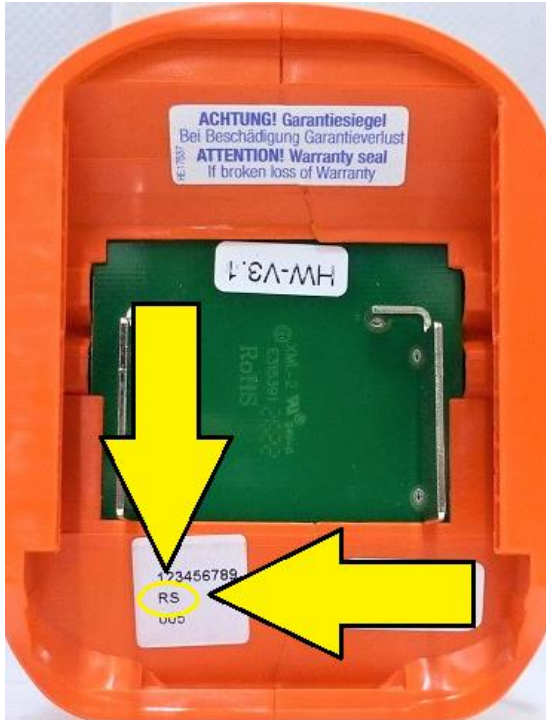
Figure 1 – Date Code Location

STEP 1 – Remove the battery from the Orange Tool unit in question and identify the two character Date Code listed on the second row on the serial number label, as pictured below (see, Figure 1).

STEP 3 – If the two characters Date Code listed on the second row of the serial number label appearing are: **Q1, RN, RP, RQ, RR, RS, RT, RV, RW, RX, RY, RZ, R1** or **SN**, and no Green Dot is present your Orange Tool is affected and must be returned to Klauke. Do not continue to use the Orange Tool. Contact Klauke using the information provided below.

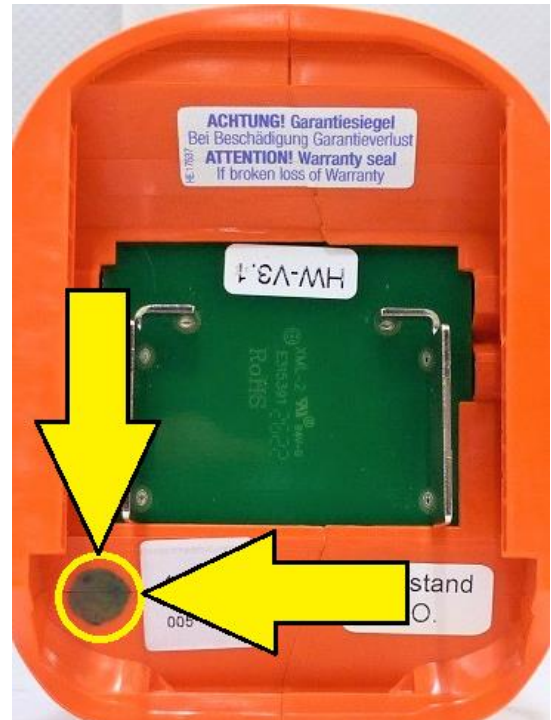
Figure 2 – Green Dot Location

STEP 2 – look for the presence of a Green Dot in the corner next to the serial number label (figure 2)

This announcement is not applicable if your unit contains a Green Dot in the corner next to the serial number label and your Orange Tool falls into the possibly affected product range. In this case your unit has already been reworked by Klauke. If your unit's date code does not fall into the above date range your unit is also not affected by this announcement.
