# 2023 Annual Site Inspection and Monitoring Report for Uranium Mill Tailings Radiation Control Act Title II Disposal Sites

December 2023

Legacy  
Management

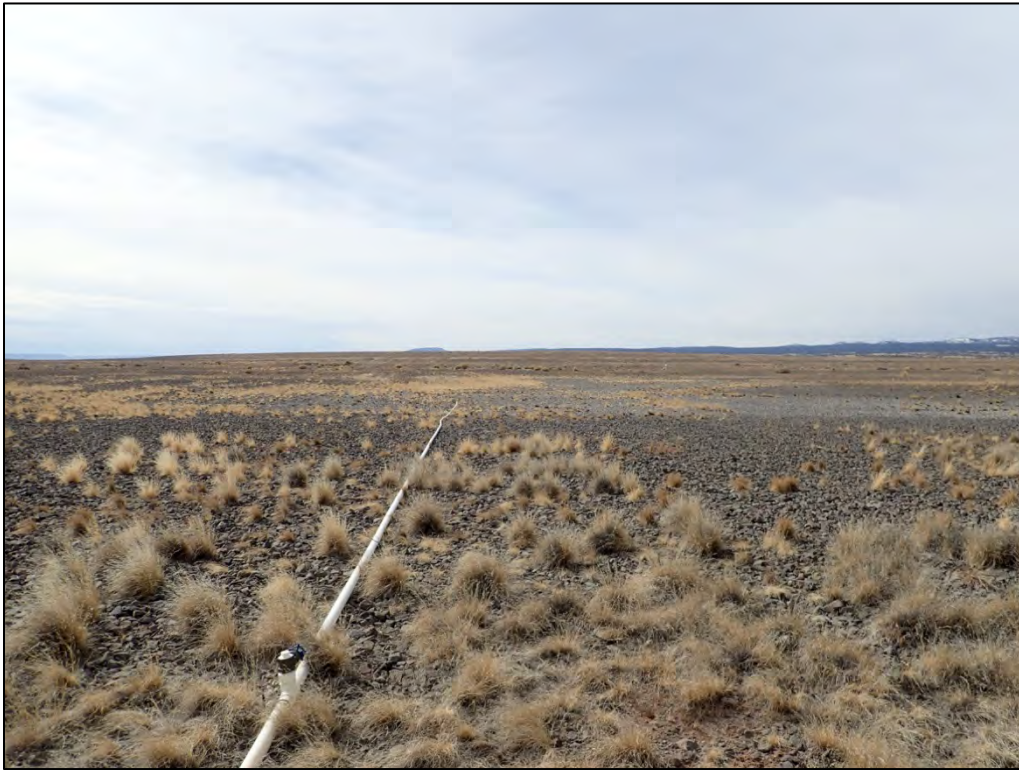
*PL-11. Overview of Siphon and Vegetation on Disposal Cell Top Slope*

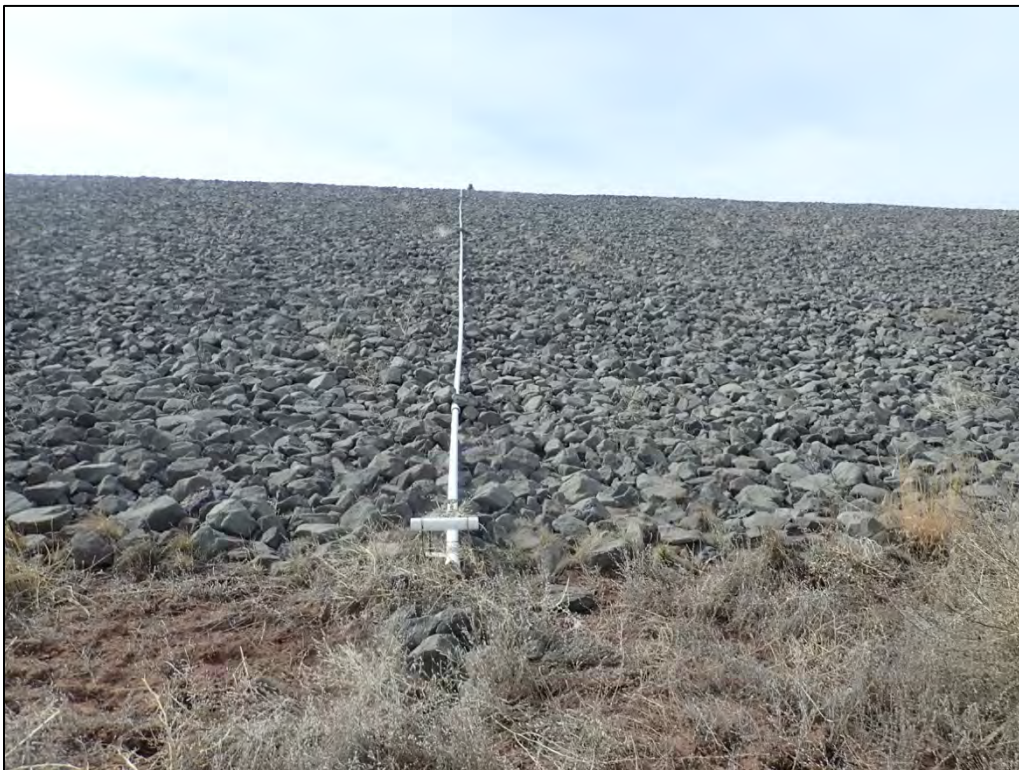
*PL-12. Siphon Outlet on Main Tailings Disposal Cell North Side Slope*

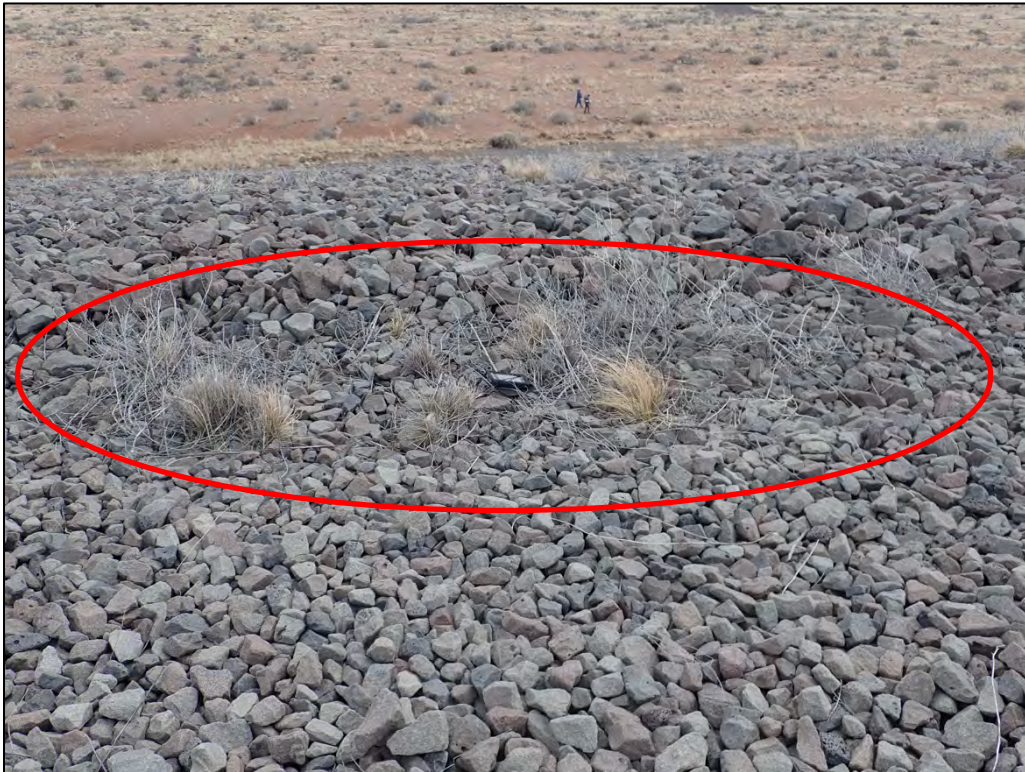
*PL-13. Potential Depression Area on Top Slope at Top Slope/Side Slope Boundary*

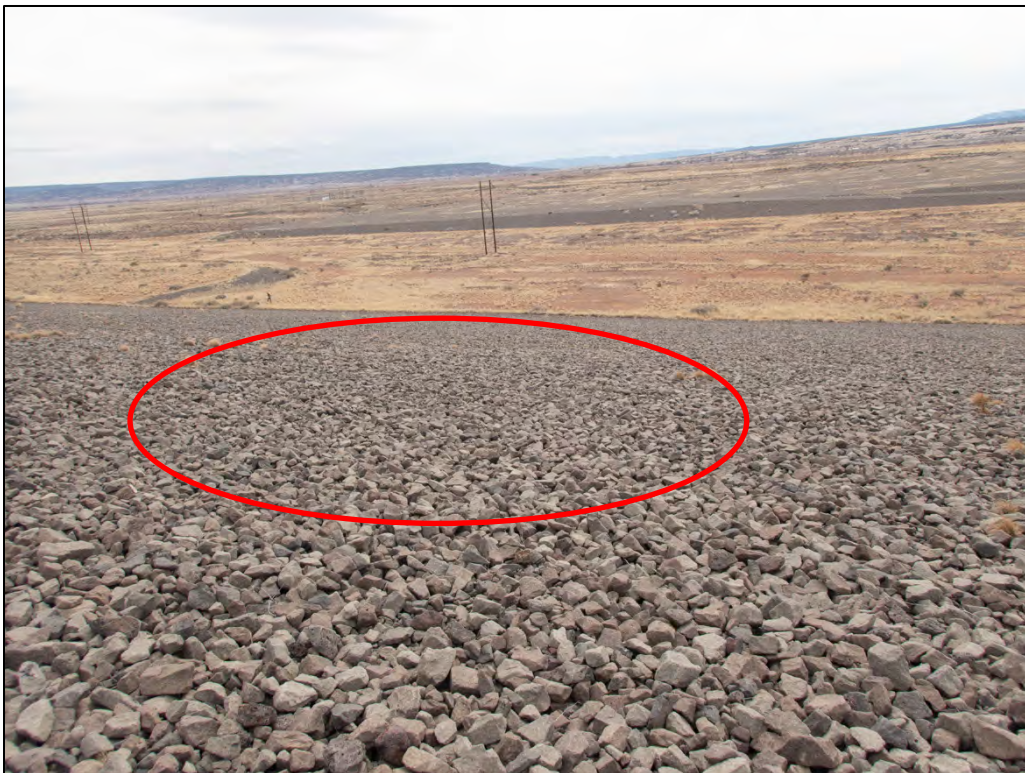
*PL-14. Potential Depression Area on Main Tailings Disposal Cell Southwest Side Slope*

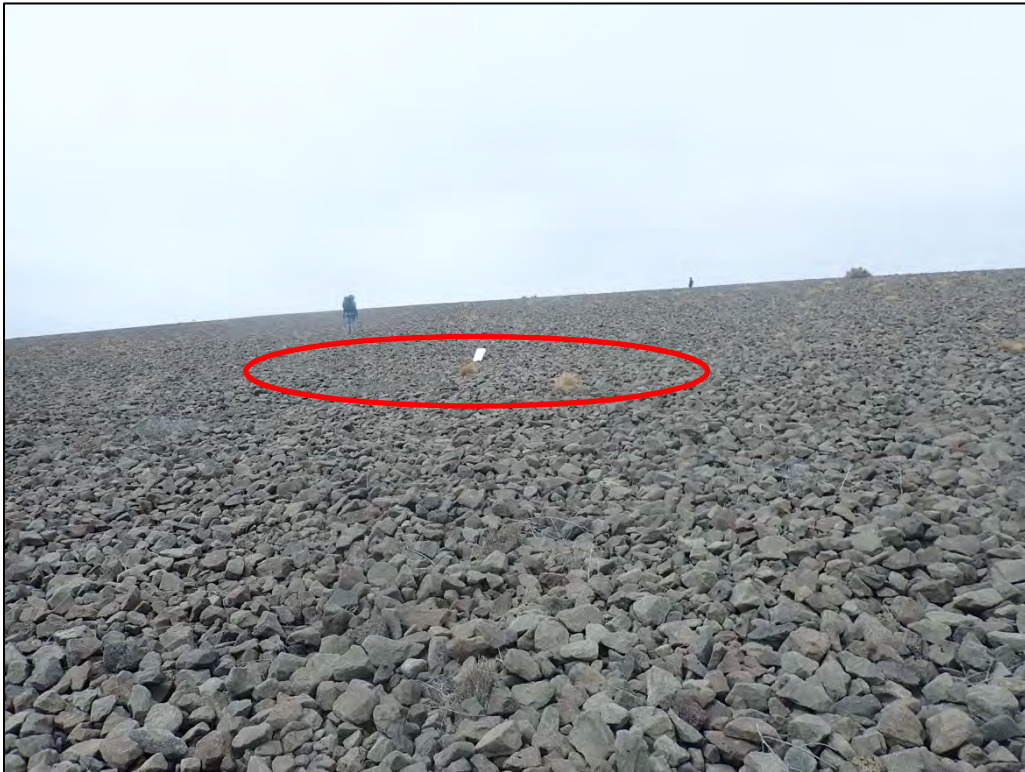
*PL-15. Minor Depression on Main Tailings Disposal Cell South Side Slope*

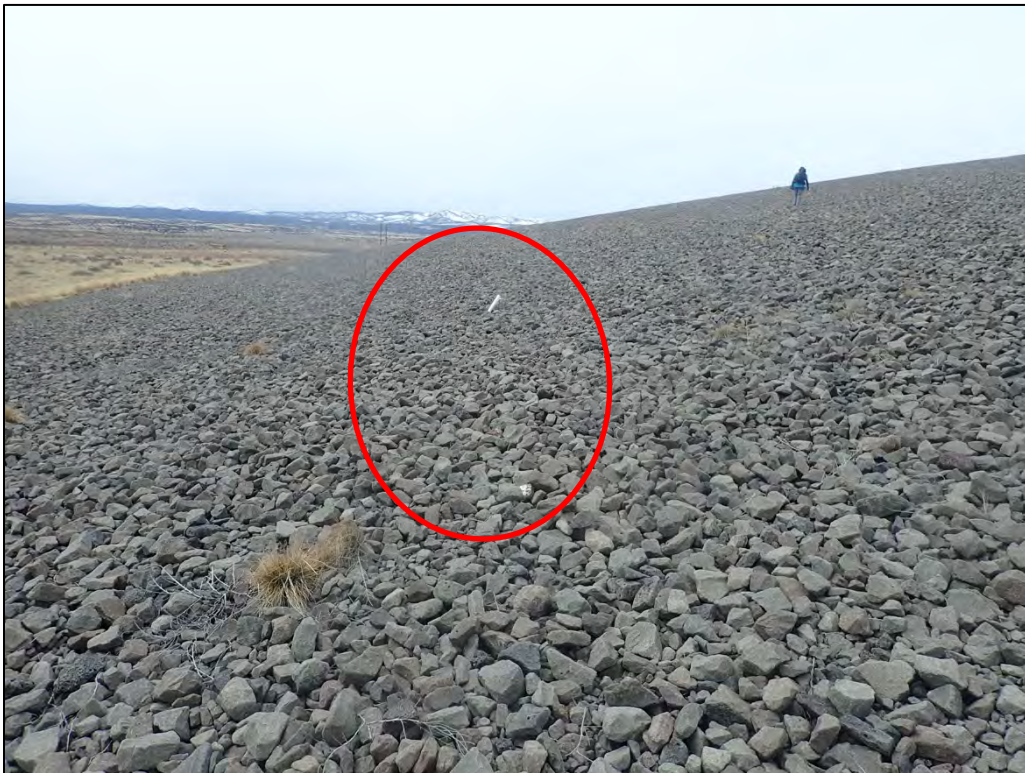
*PL-16. Minor Depression on Main Tailings Disposal Cell South Side Slope*

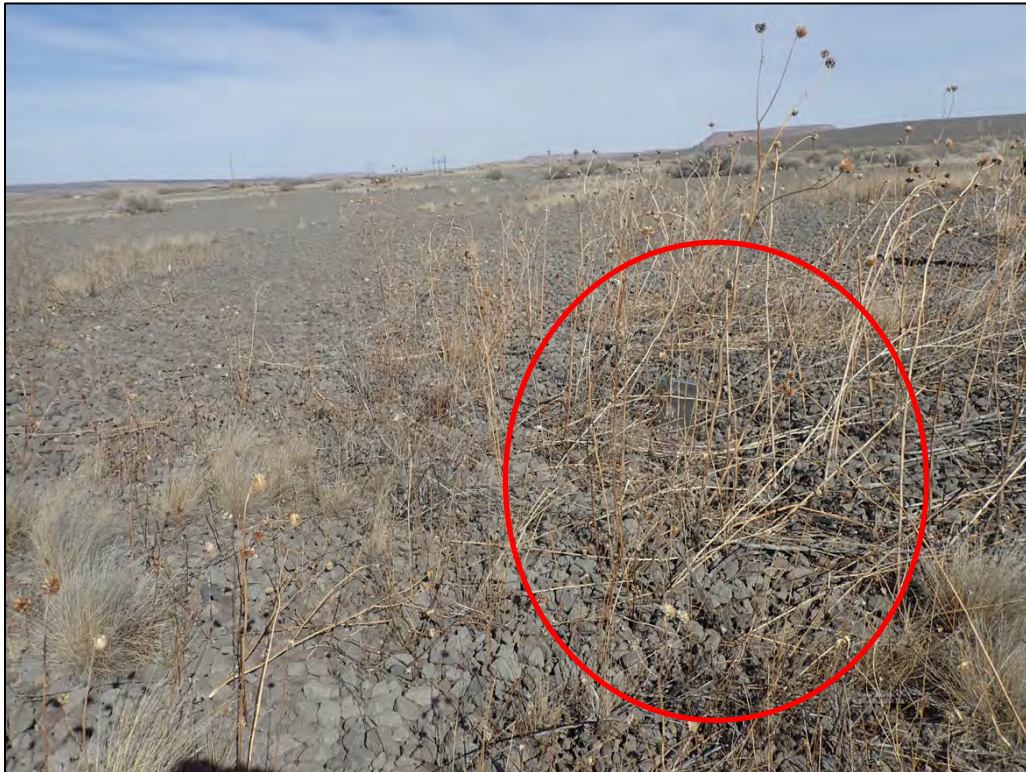
*PL-21. Minor Depression with Vegetation Growth on Carbonate Tailings Disposal Cell Top Slope*

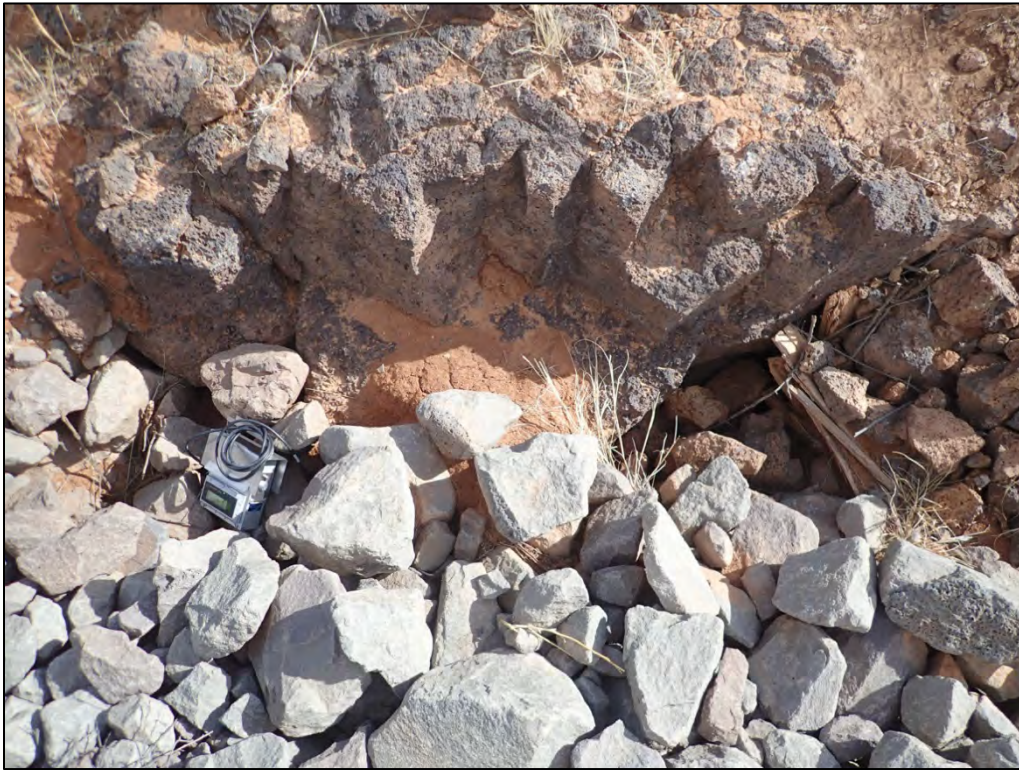
*PL-23. East Dump Minor Erosion Area*

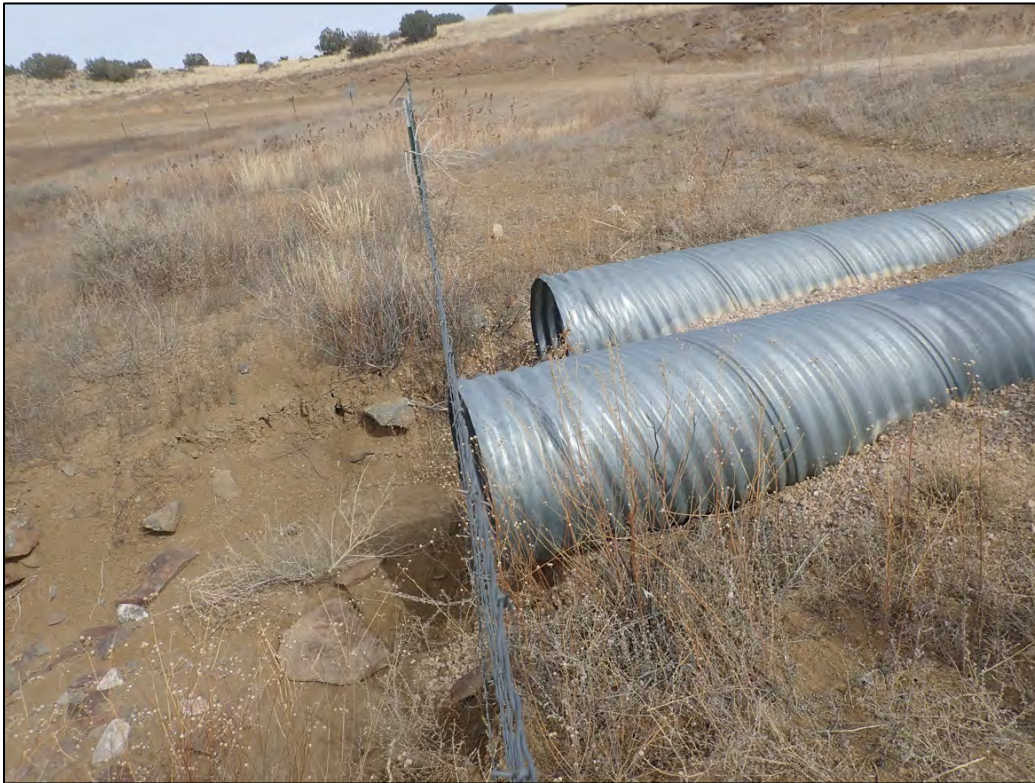
*PL-1. Culvert Outlets Along Access Road near Perimeter Sign P9*

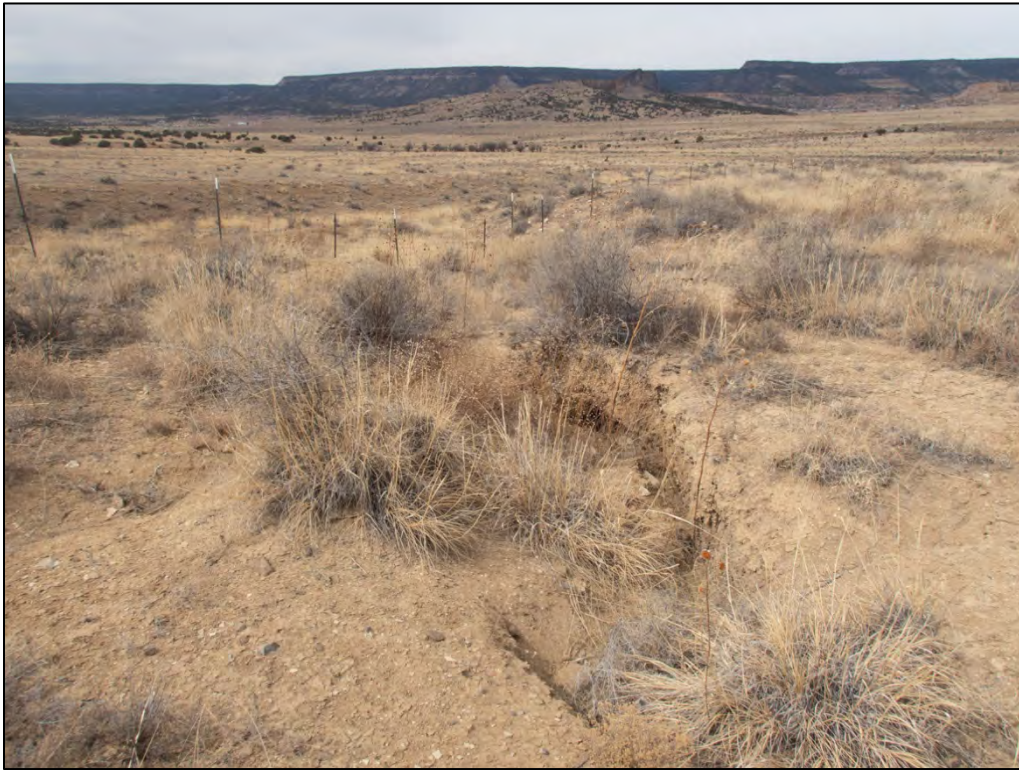
*PL-3. Erosional Feature on Southwest Fence Between Perimeter Signs P19 and P20  
(Looking from Top to Bottom)*

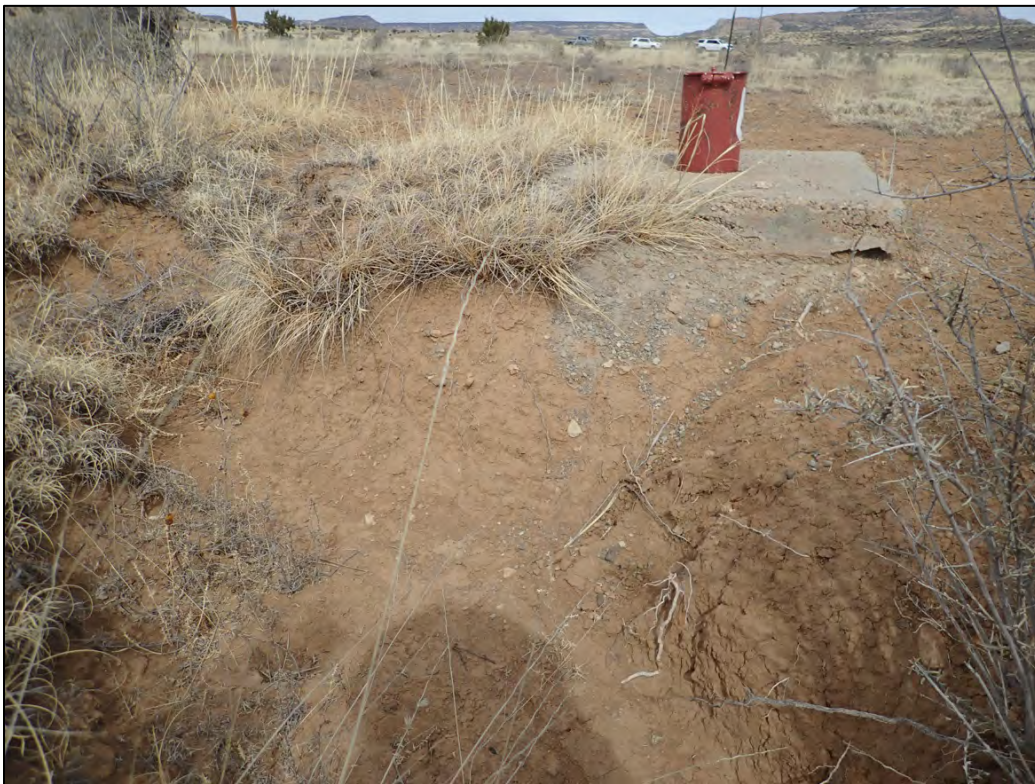
*PL-8. Erosive Channeling Around Monitoring Well 62*

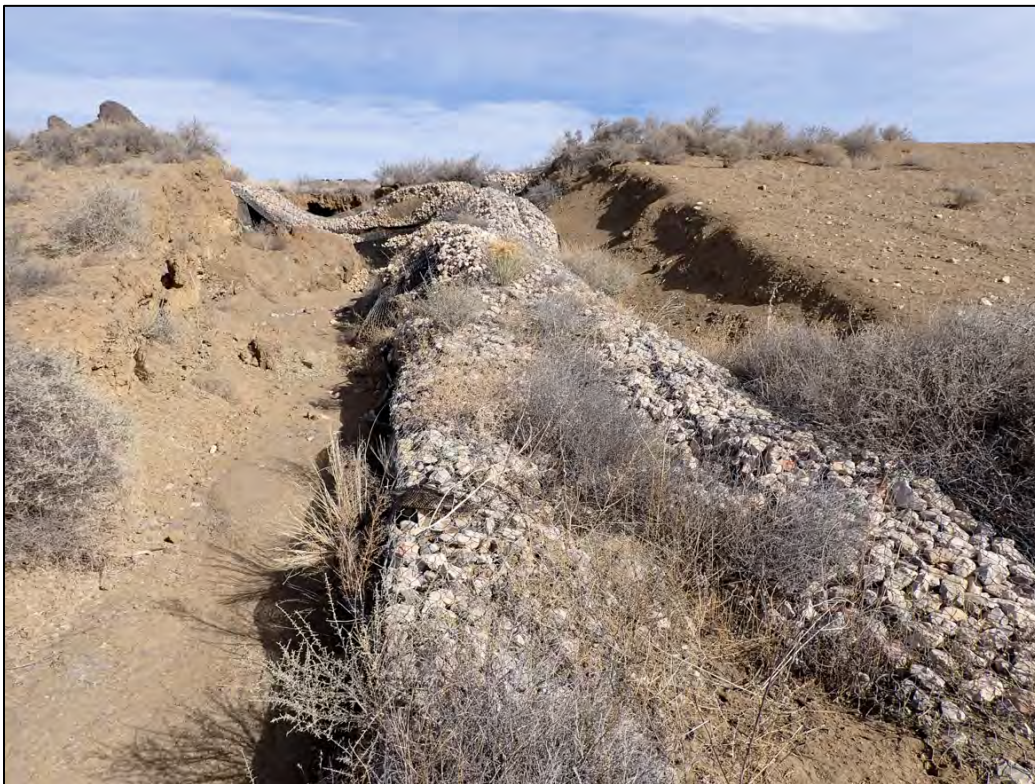
*PL-16. Gully Erosion at Erosion Control Structure G*

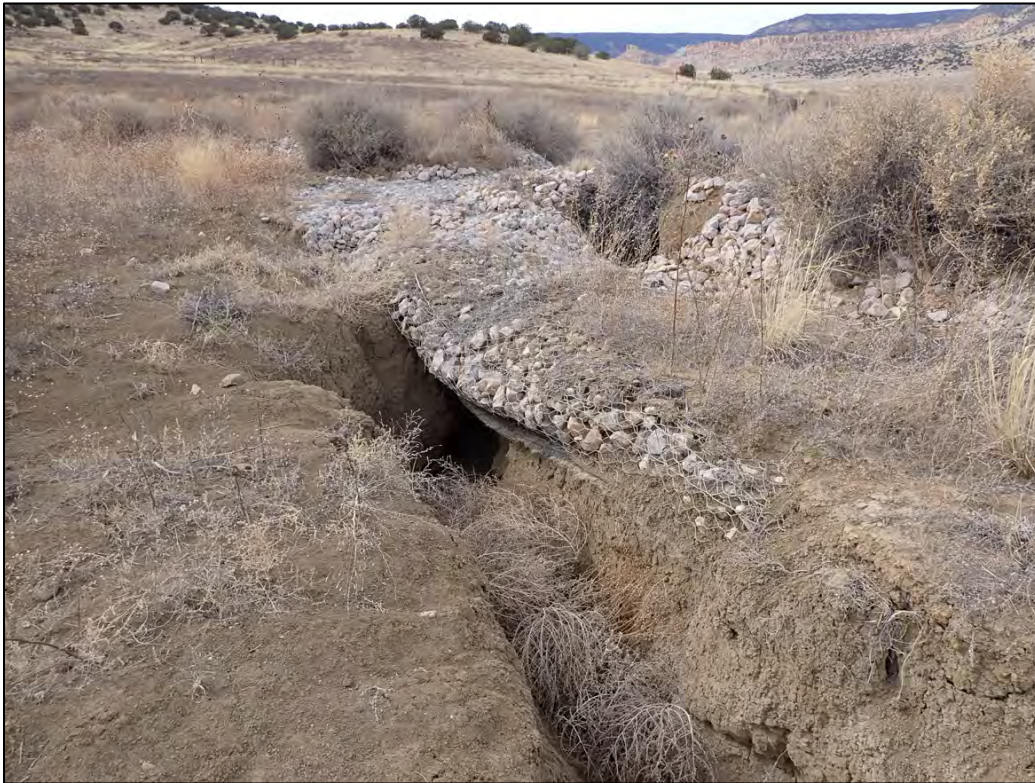
*PL-17. Erosion at Structure A*

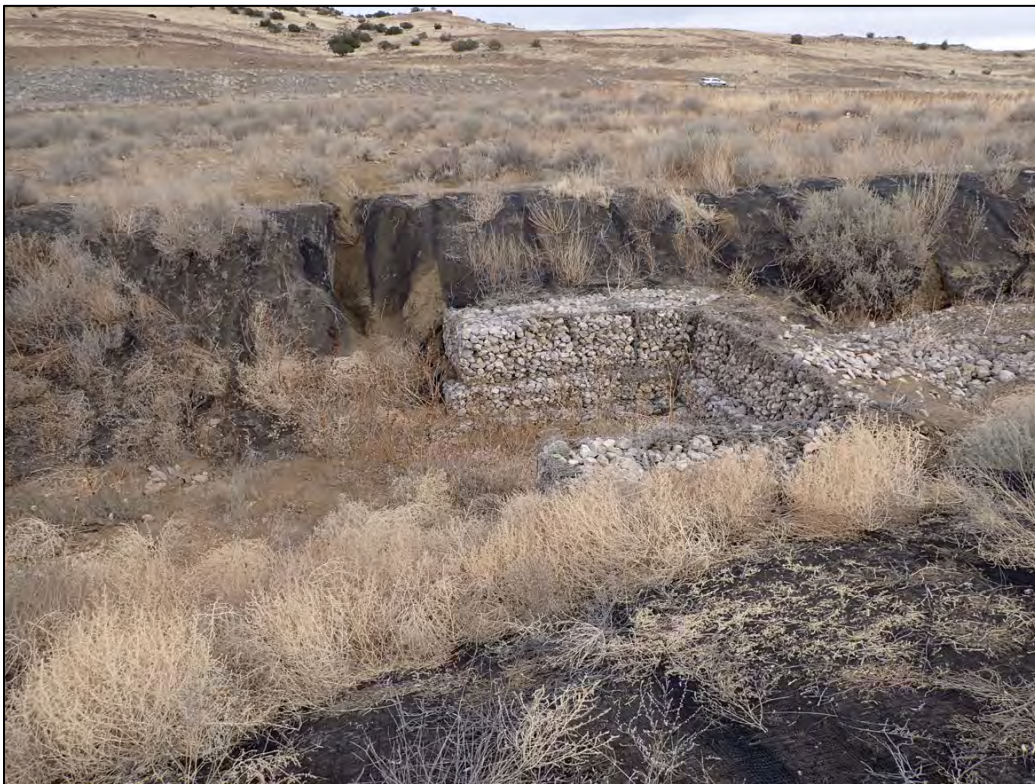
*PL-18. Erosion at Structure A Along Second Block Structure*

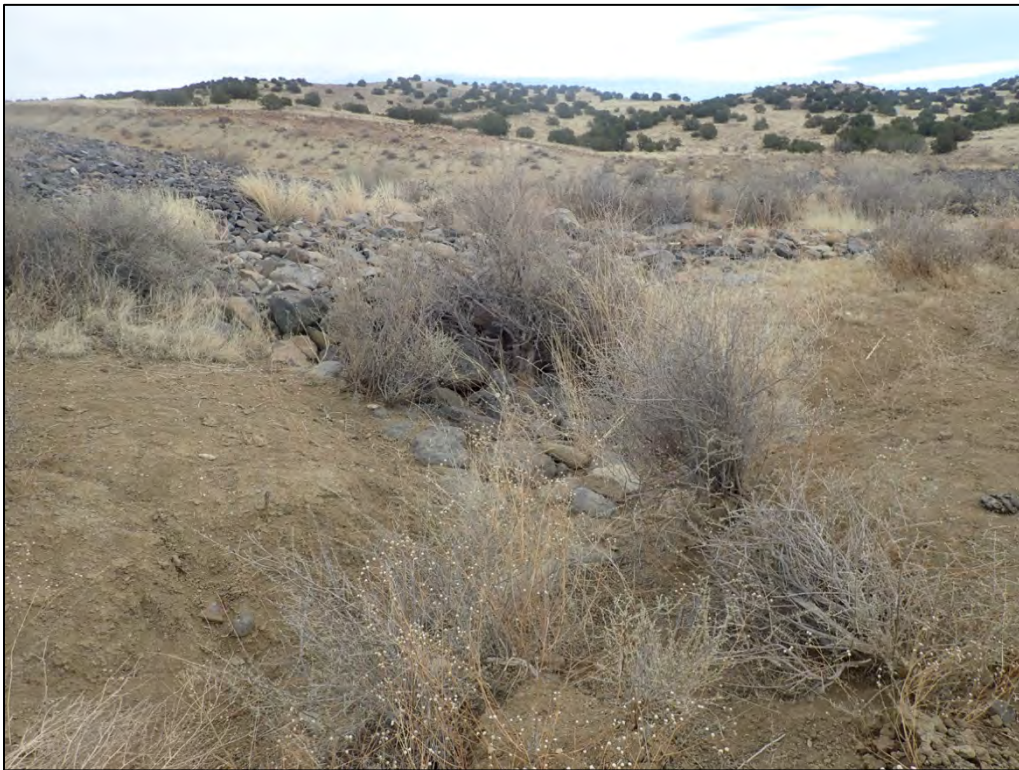
*PL-20. Rilling Contacting South Channel Cutoff Wall*

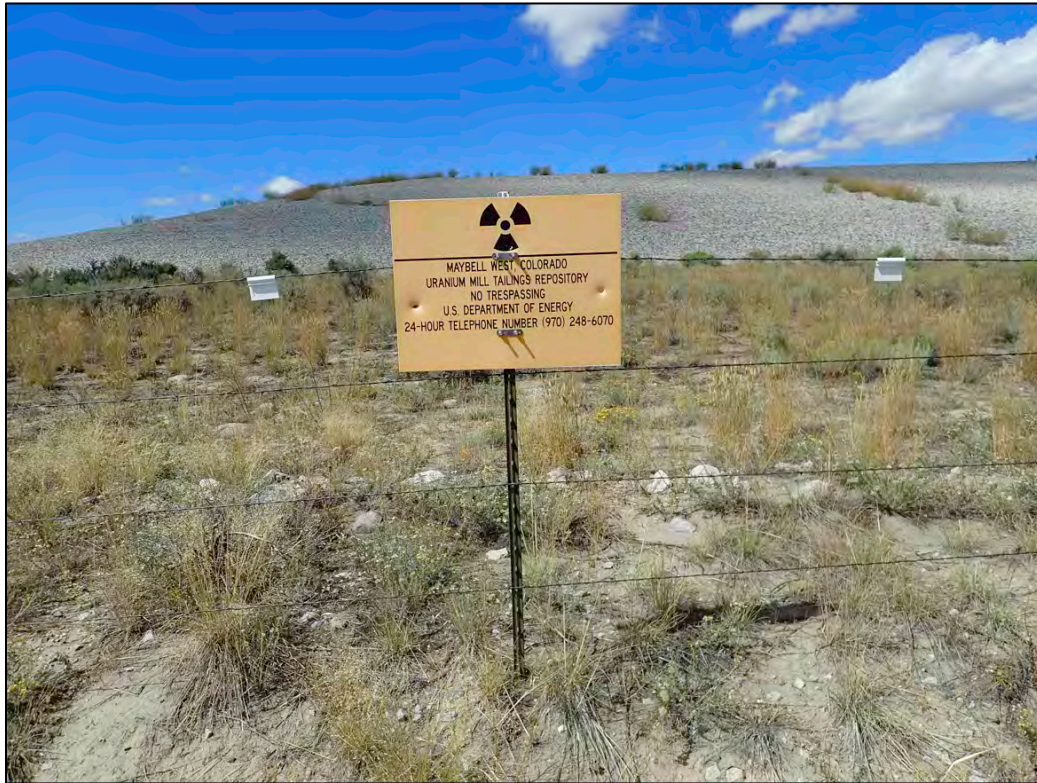
*PL-1. Perimeter Sign P1 with Bullet Holes*

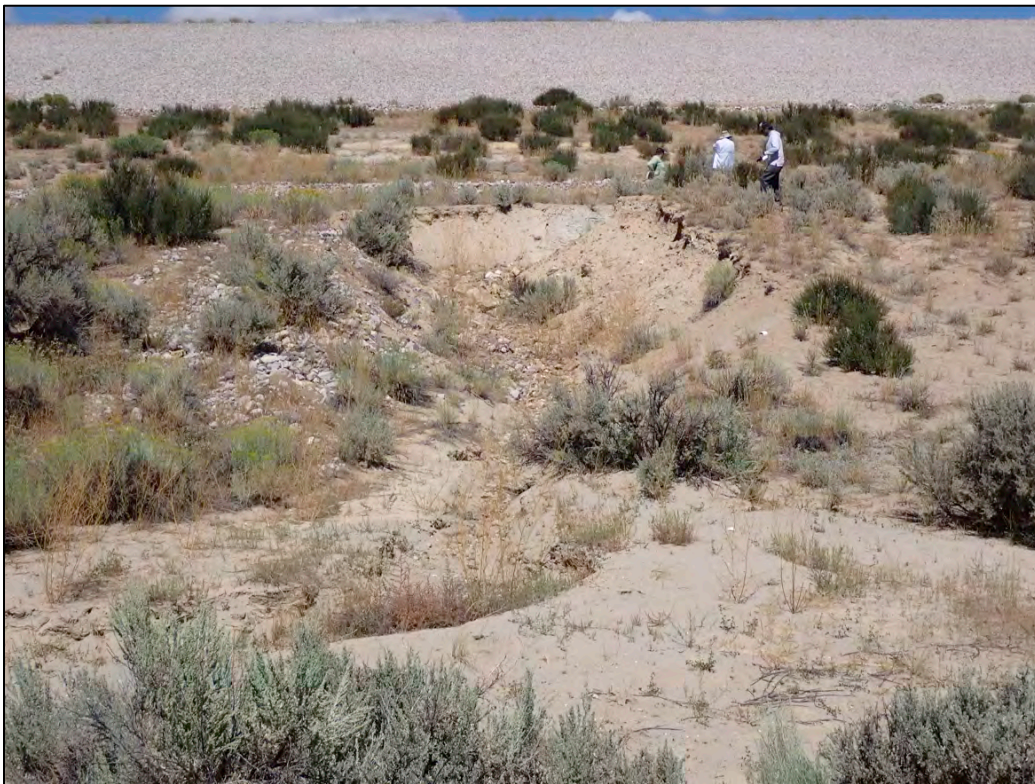
*PL-14. Largest Gully Below Rock Berm*

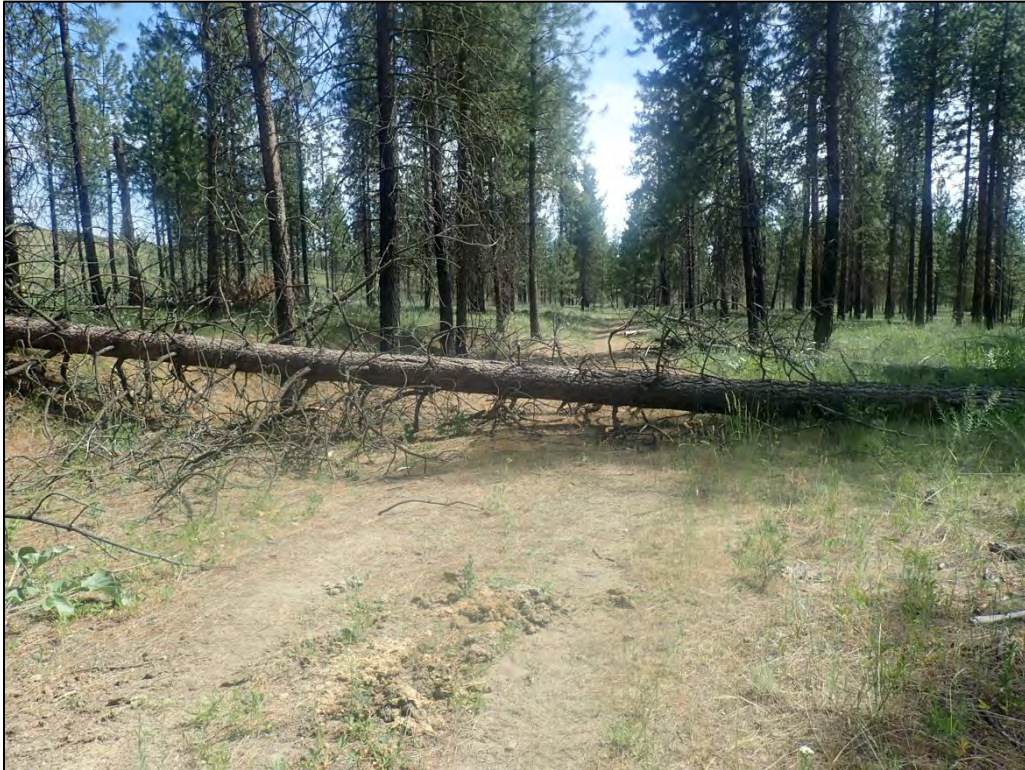
*PL-1. Fallen Tree Along Road*

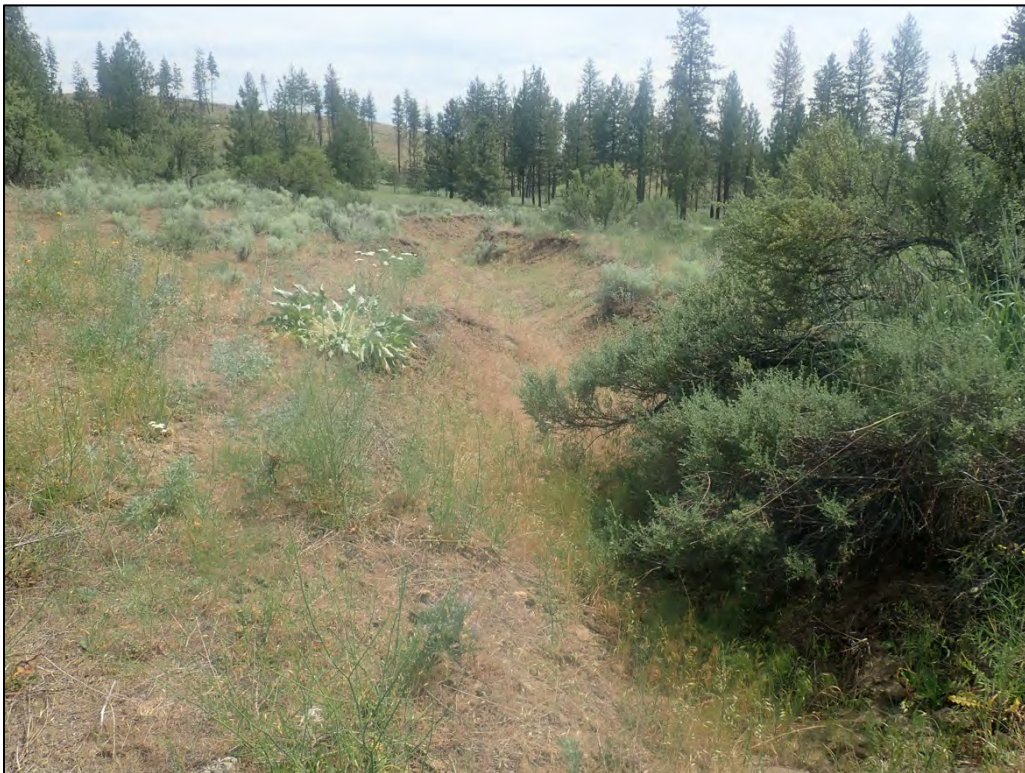
*PL-6. Gully near Swale*

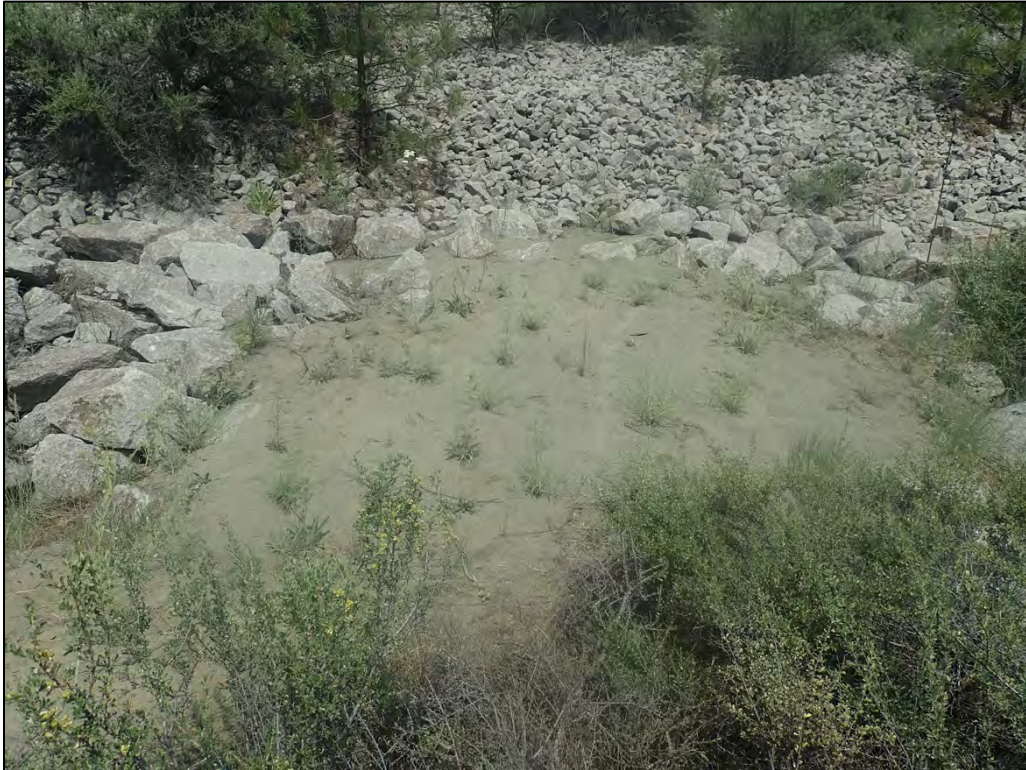
*PL-9. Sand Deposit on Containment Dam*

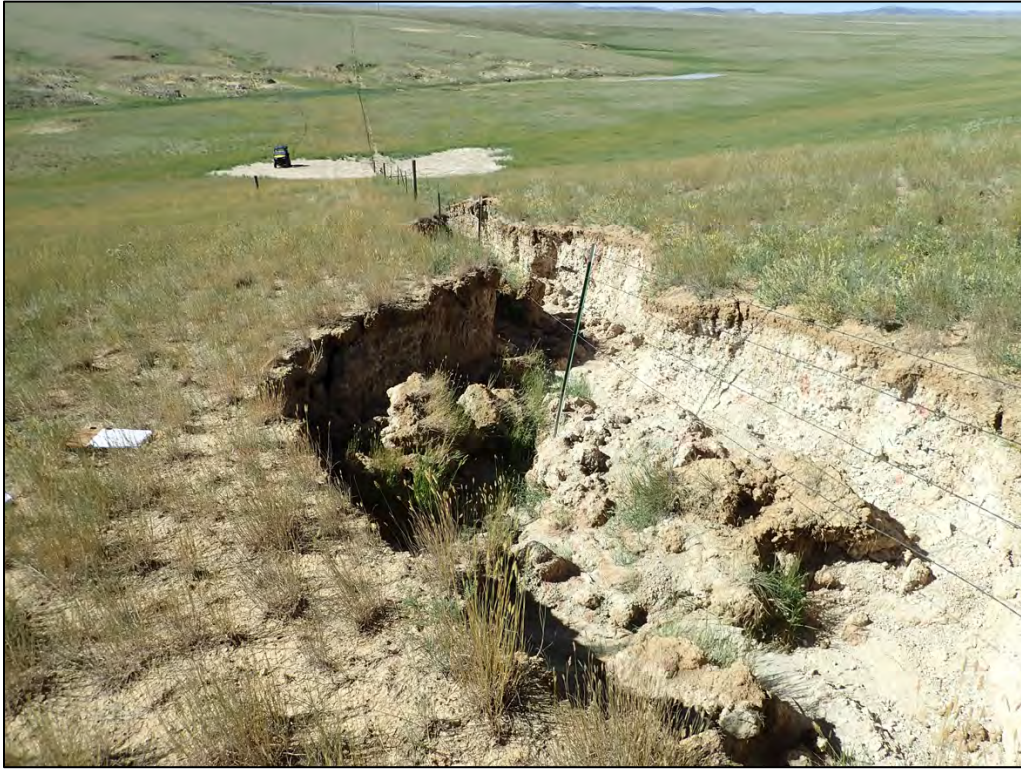
A four-strand barbed-wire fence encloses the site. A grazing license LM granted to a local rancher allows him to graze livestock onsite in exchange for minor maintenance of the perimeter fence. An animal burrow is present under the fence near boundary monument BM-18, and a post is bent on the north side near boundary monument BM-24. These items are minor and will be addressed by the grazing licensee. A large erosional feature (arroyo) has formed underneath the fence on the southern portion of the west boundary (PL-1). The arroyo formed inline with the fence, damaging several sections. Sediment from the erosional event was deposited below the slope break. This section of the fence line was subsequently realigned approximately 30 feet inward (away from the arroyo) in October 2023. Another erosional feature is developing north of the arroyo but is not yet impacting the fence.

*PL-1. Arroyo Under Fence on Lower Reclaimed Slopes*

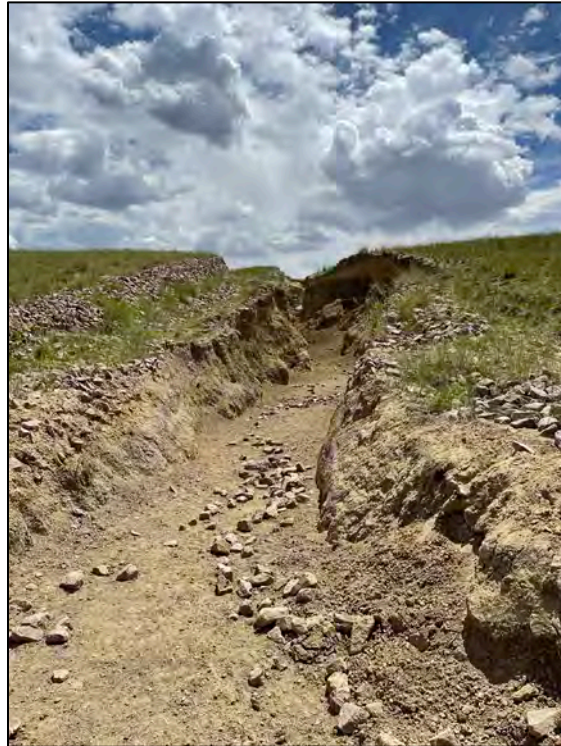
*PL-16. Pit 4 Lower Riprap Armored Drainage Channel Erosion*
