Swiss Federal Nuclear Safety Inspectorate ENSI

Event sequences Fukushima 11032011

in Fukushima Dai-ichi and Dai-ni following
the Tohoku-Chihou-Taiheiyou-Oki earthquake
on 11.03.2011

ENSI-AN-7999
Published 26.08.2011

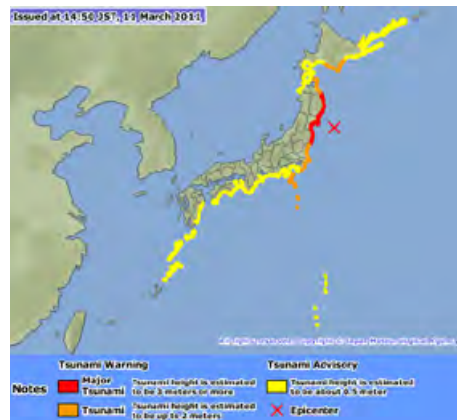
Figure 2: Tsunami warning 11.03.2011, 14:50; source: JMA

On **11.03.2011 at 14:49**, the Japan Meteorological Agency (JMA) issued a tsunami warning (see image 2). At **14:50**, the first alert concerning the arrival and height of the tsunami was issued (Fukushima Pref. on **11.03.2011 at 15:10** expected a tsunami of a height of 3 m, see image 3; see Ref. 27). Later, JMA corrected the height of the tsunami (see Fig. 4).

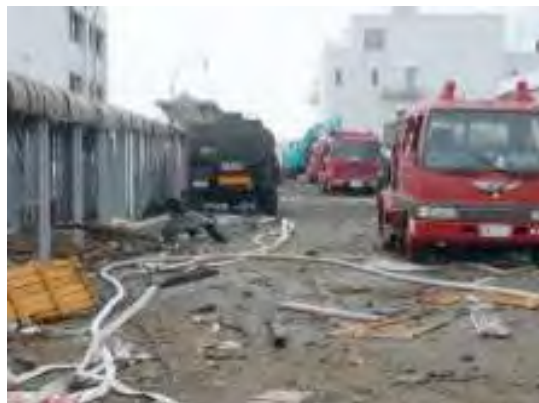
On **12.03.2011 at 19:04**, injection of sea water by means of three fire trucks connected in series (see Figure 10) began.

Figure 10:
Fire trucks for sea water injection;
source: Ref. 44

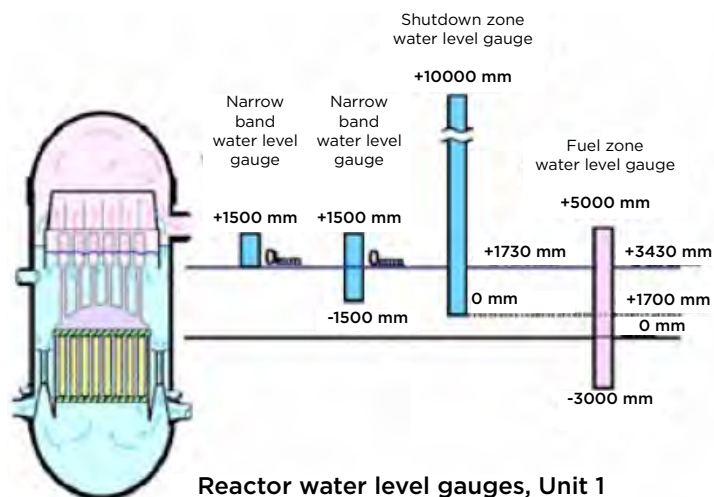
Figure 11: Fill level records, BWR Example Unit 1; source TEPCO

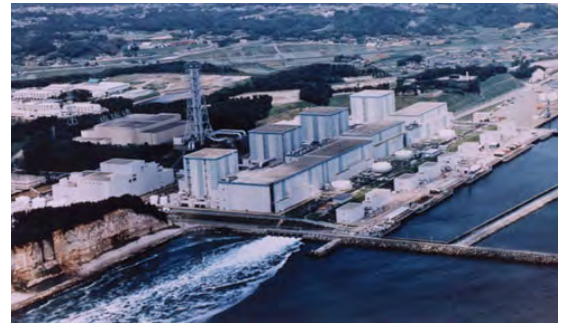
Figure 17:
Overview Fukushima Dai-ni;
source: TEPCO

Caused by the Tohoku-Chihou-Taiheiyou-Oki earthquake on 11.03.2011 at 14:46 (magnitude 9), automatic reactor SCRAM occurred at Units 1 to 4 (see Ref. 1).
