# 2023 Annual Site Inspection and Monitoring Report for Uranium Mill Tailings Radiation Control Act Title II Disposal Sites

December 2023

Legacy  
Management

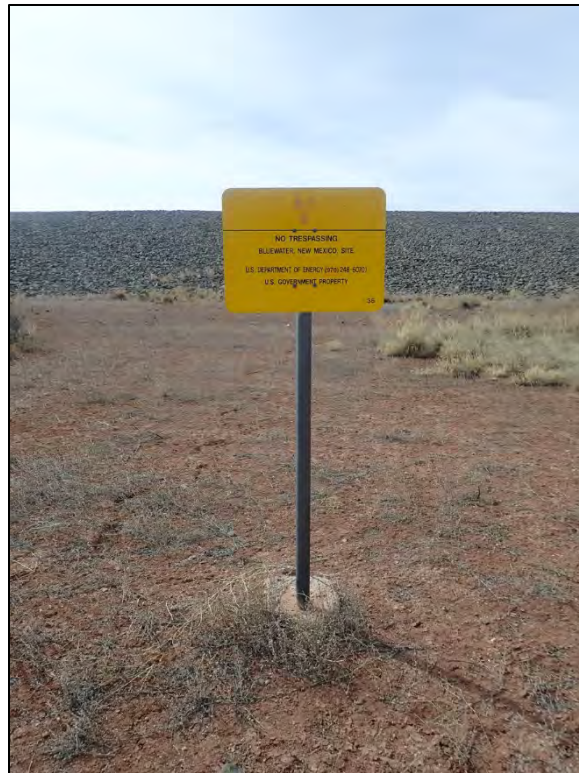
*PL-4. Perimeter Sign P36*

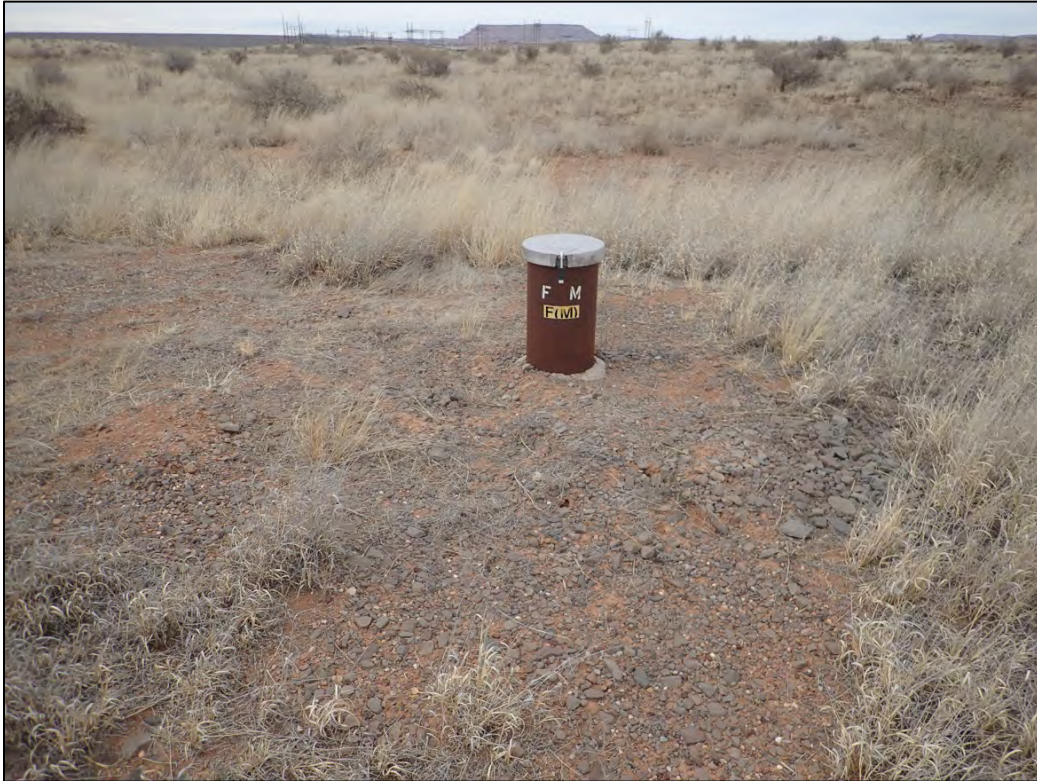
*PL-9. Abandoned Animal Burrows near Monitoring Well F(M)*

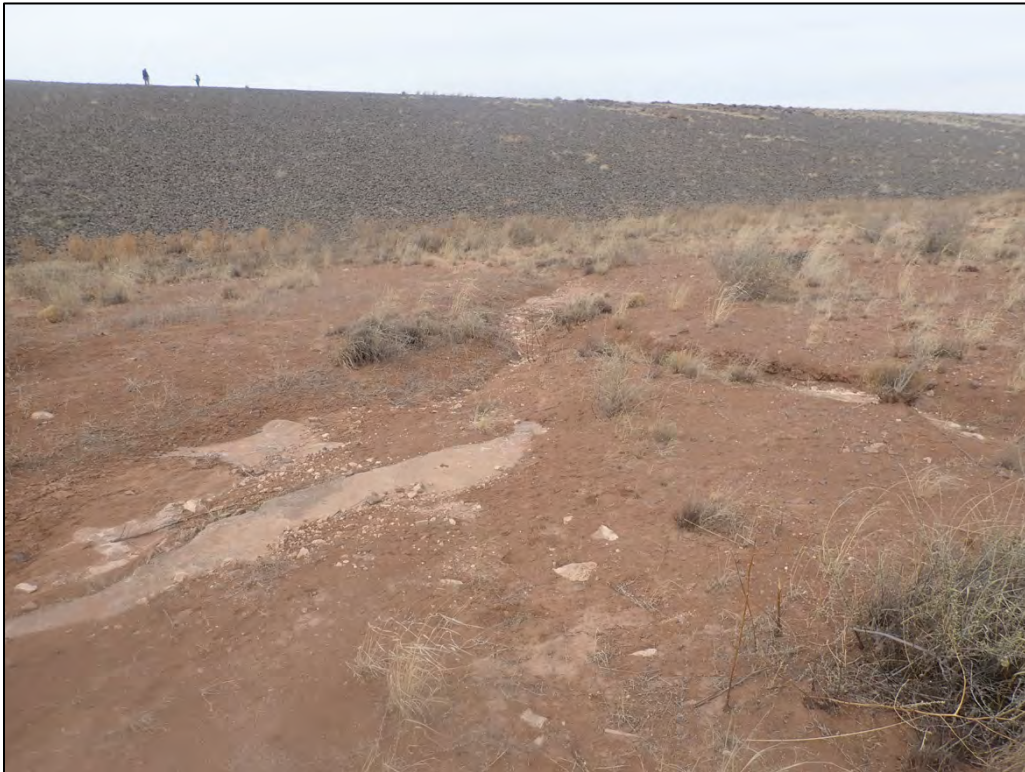
*PL-17. Rilling Between Perimeter Signs P31 and P30*

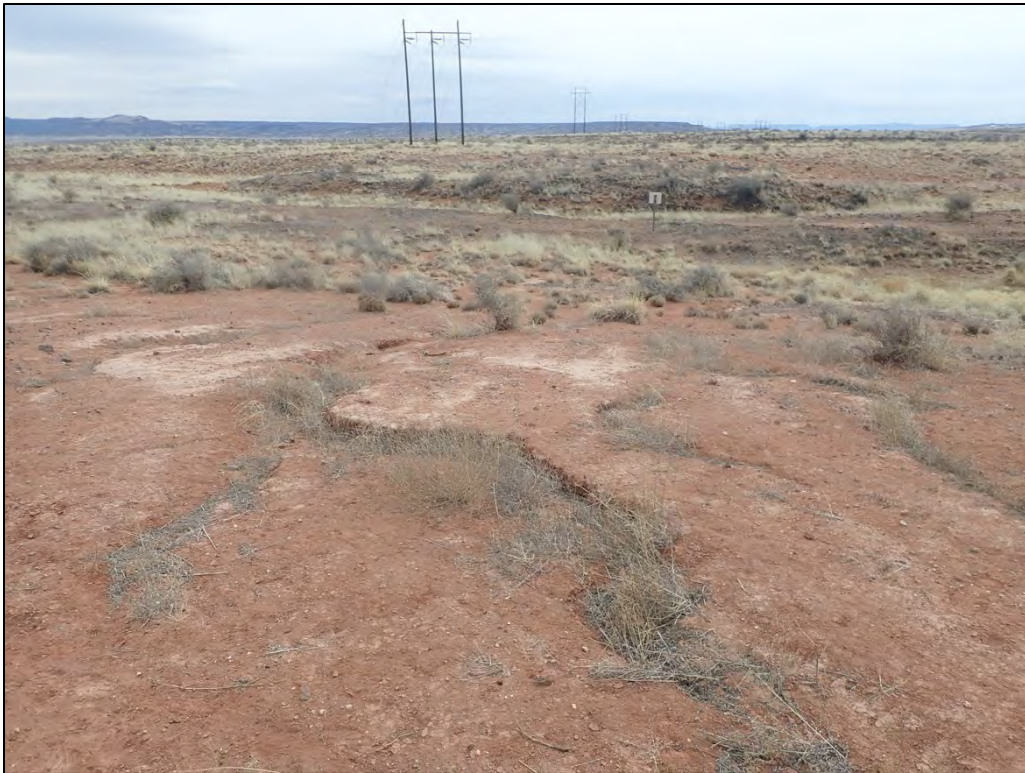
*PL-18. Rilling near Perimeter Sign P24*

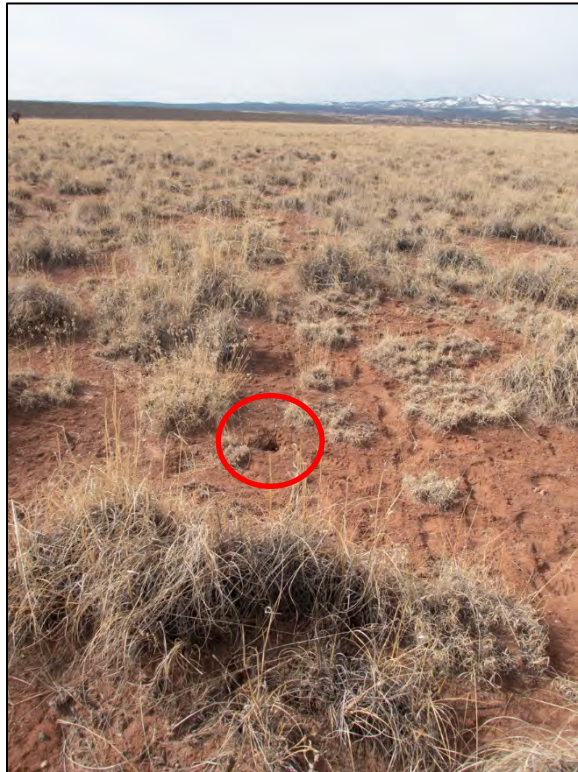
*PL-19. Animal Burrow on Acid Tailings Disposal Area*

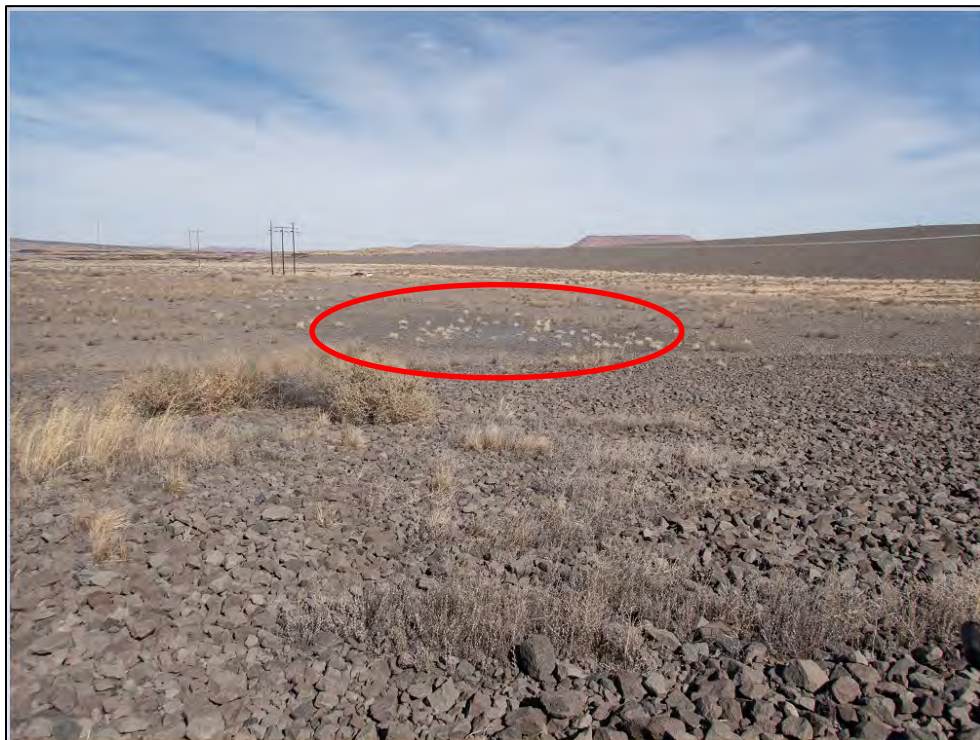
*PL-20. Shallow Depression on Northwest Extension of Carbonate Tailings*

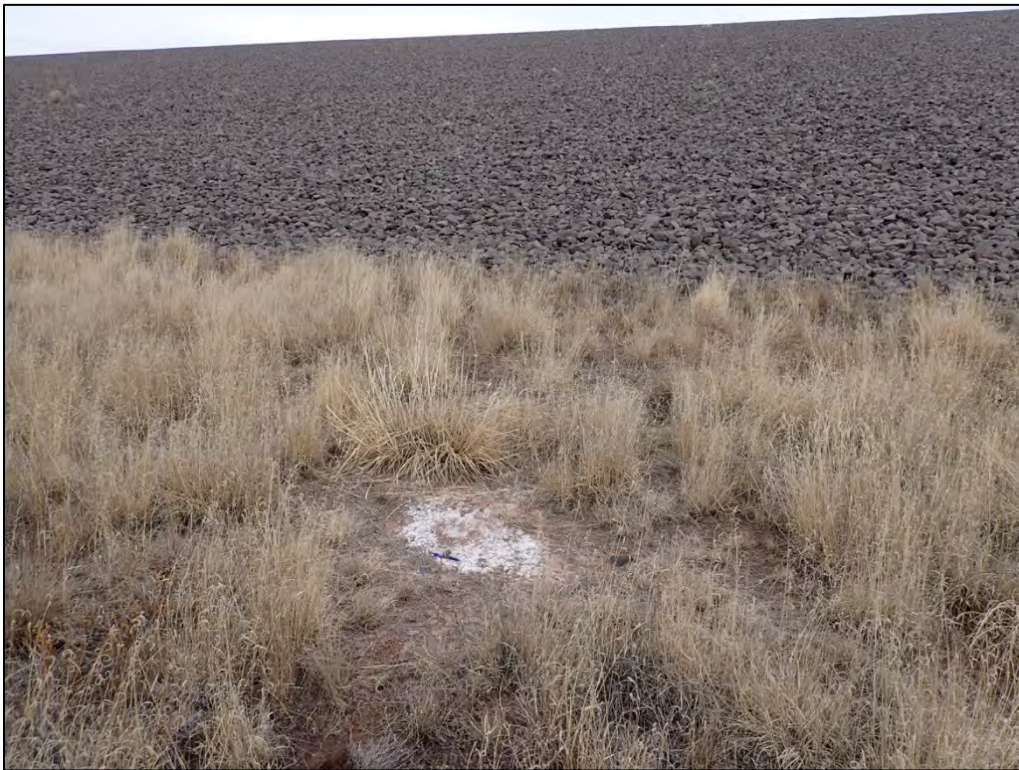
A new ephemeral pond area was observed near the southwest side slope of the main tailings disposal cell near perimeter sign P50 (PL-24). The ephemeral pond was dry when observed. This pond is not currently a concern but will be observed at least 1 additional year.

*PL-24. Dry Ephemeral Pond*

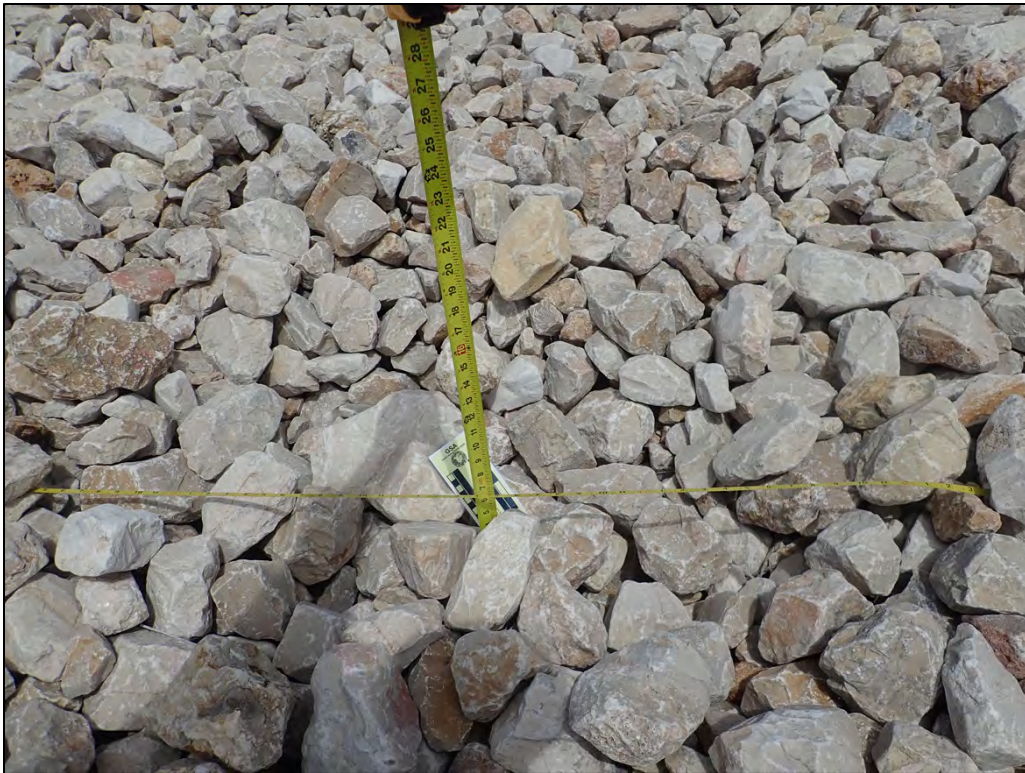
*PL-6. Small Depression No. 2: Depth Measurement*

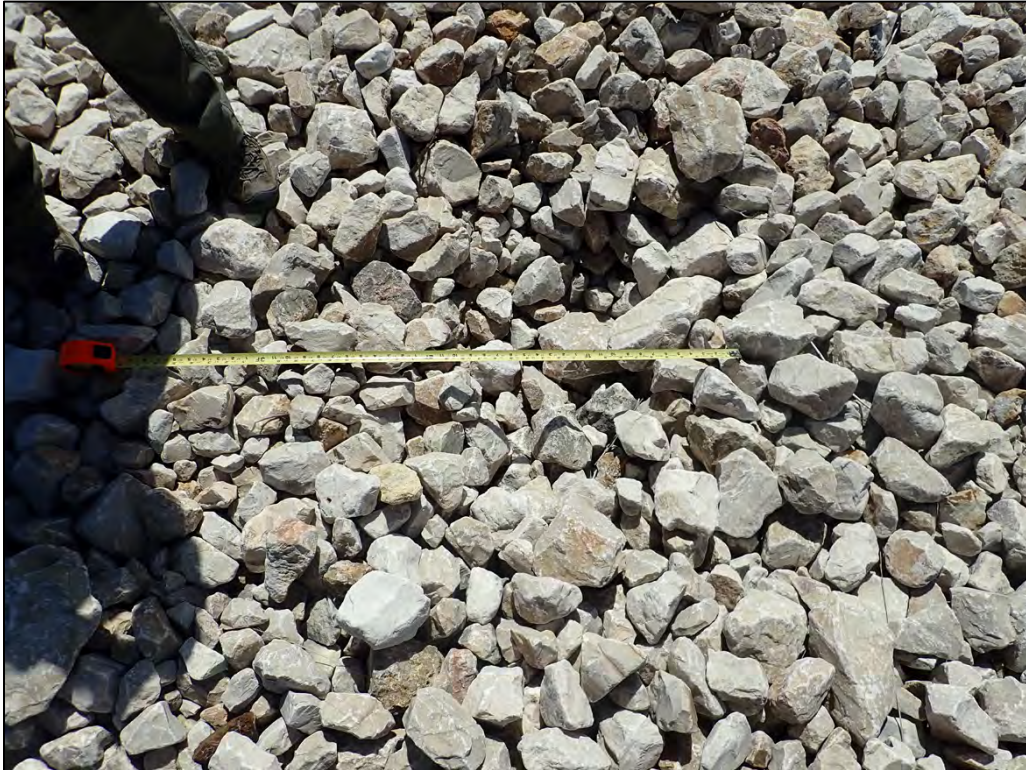
*PL-7. Small Depression No. 3: New*

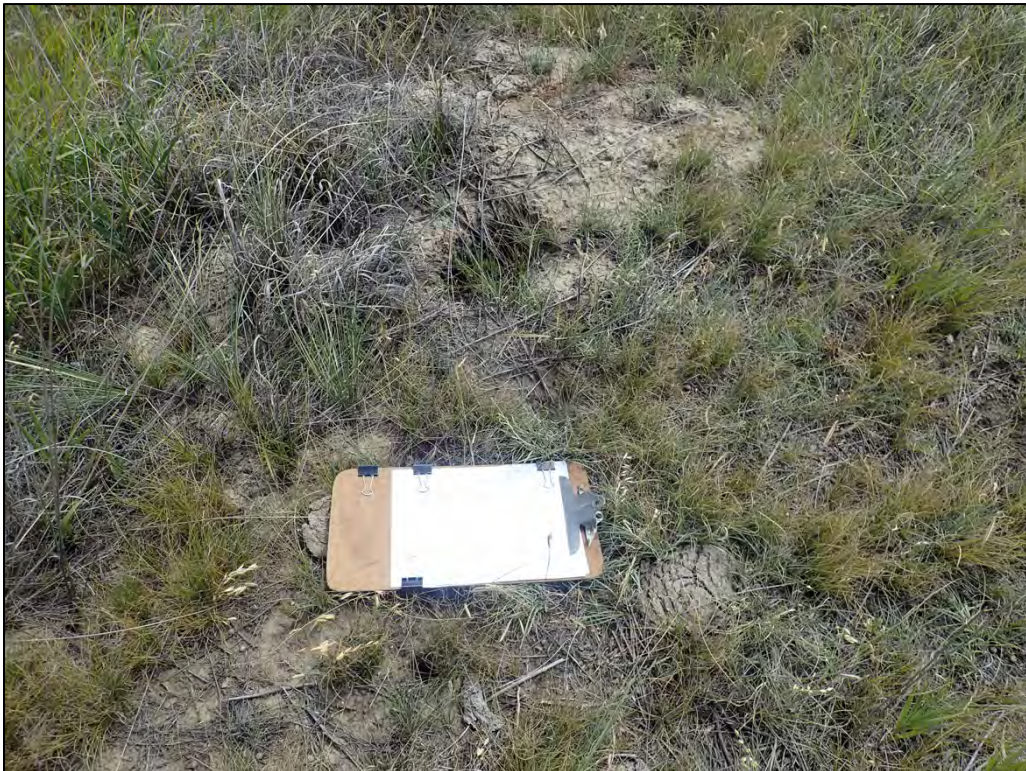
*PL-8. Animal Burrow*

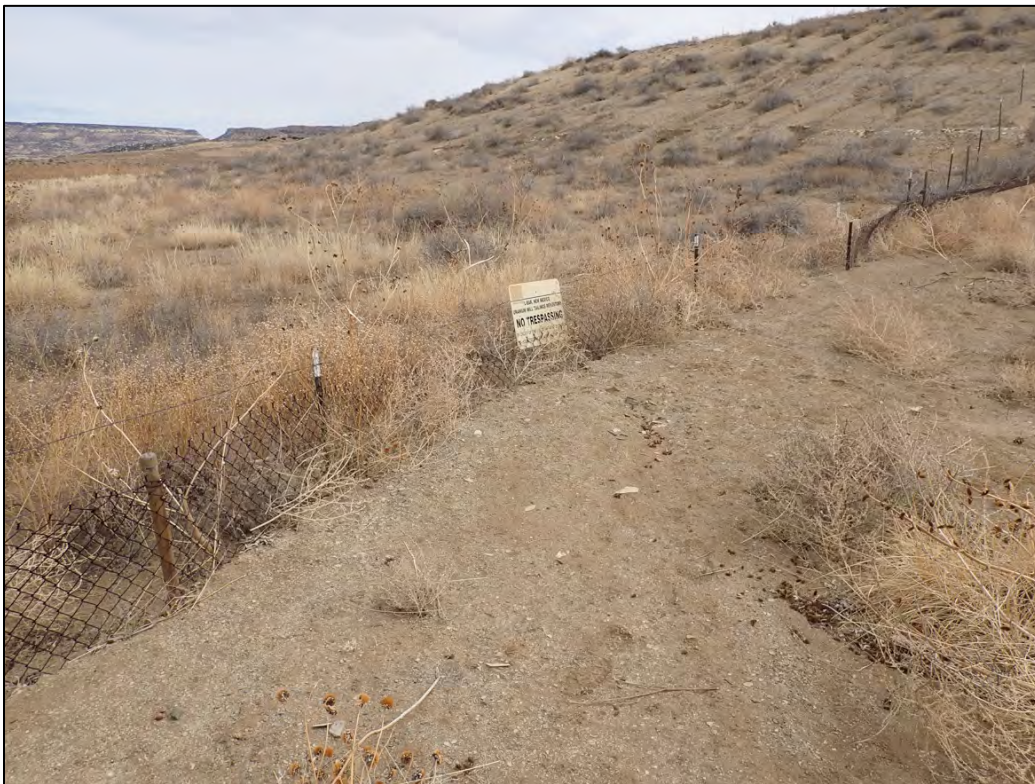
*PL-2. Partially Buried Fence from Sedimentation near Perimeter Sign P18*

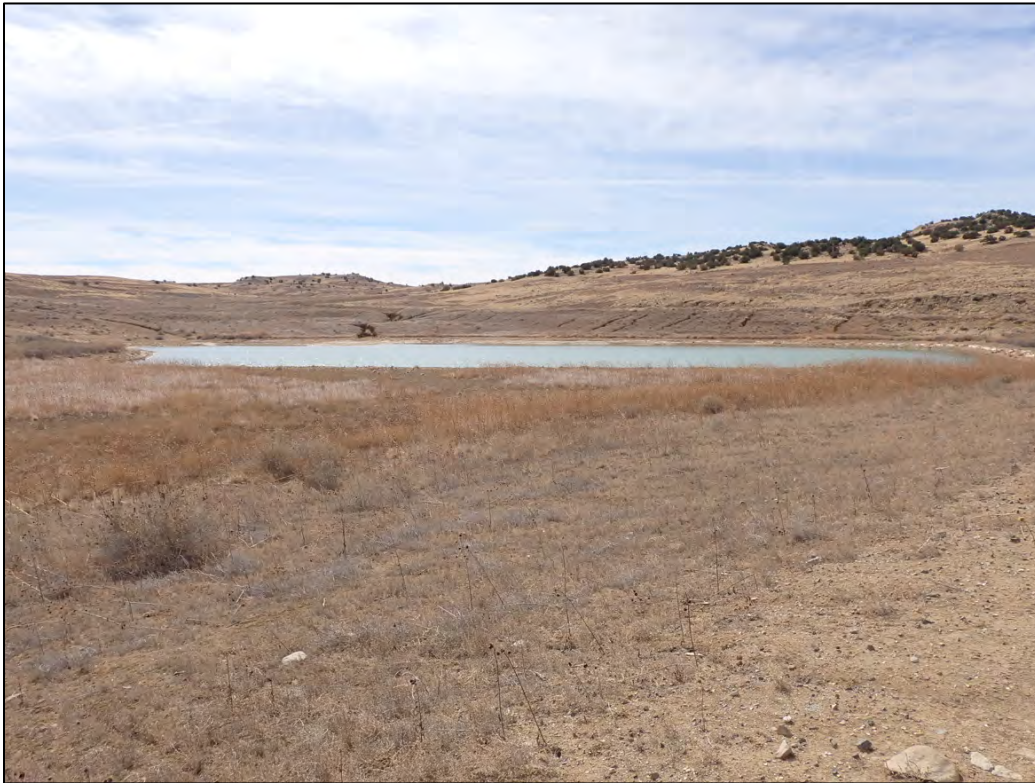
*PL-15. Water in Sediment Trap*

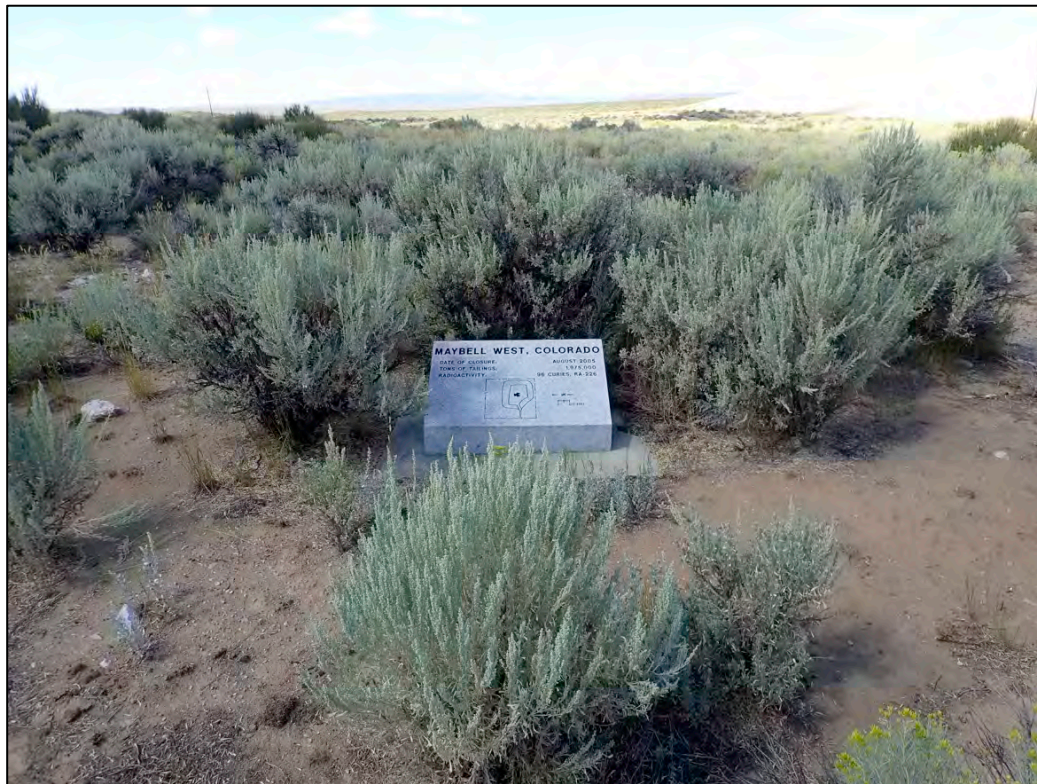
*PL-2. Site Marker*

The site has one granite site marker near the entrance gate (PL-2). There is minimal cracking in the cement at the base of the site marker. It does not affect the integrity of the marker. No maintenance needs were identified.

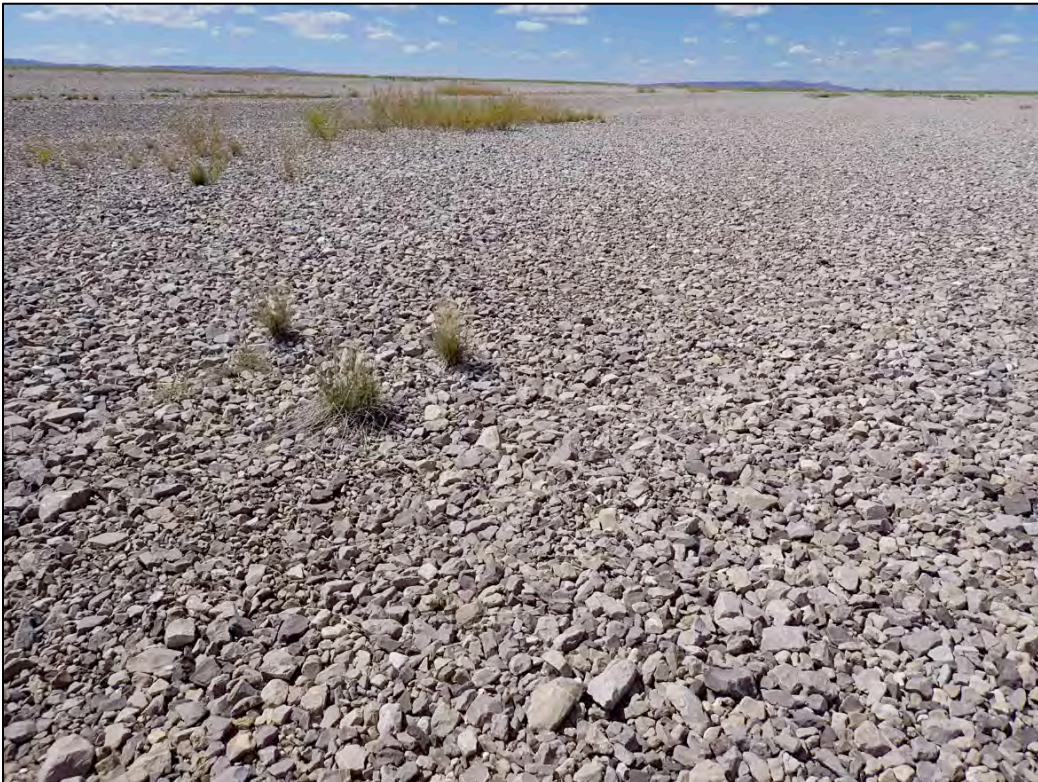
*PL-6. Shallow Depression No. 4*

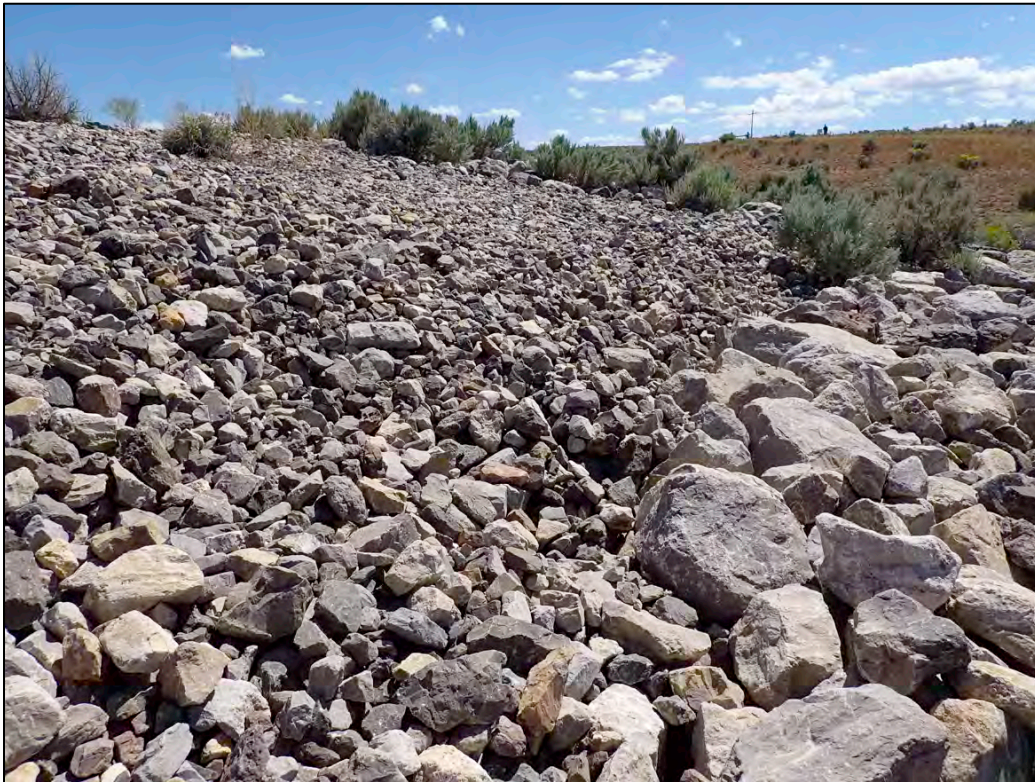
*PL-10. Depressions on Toe of Ancillary Cell*

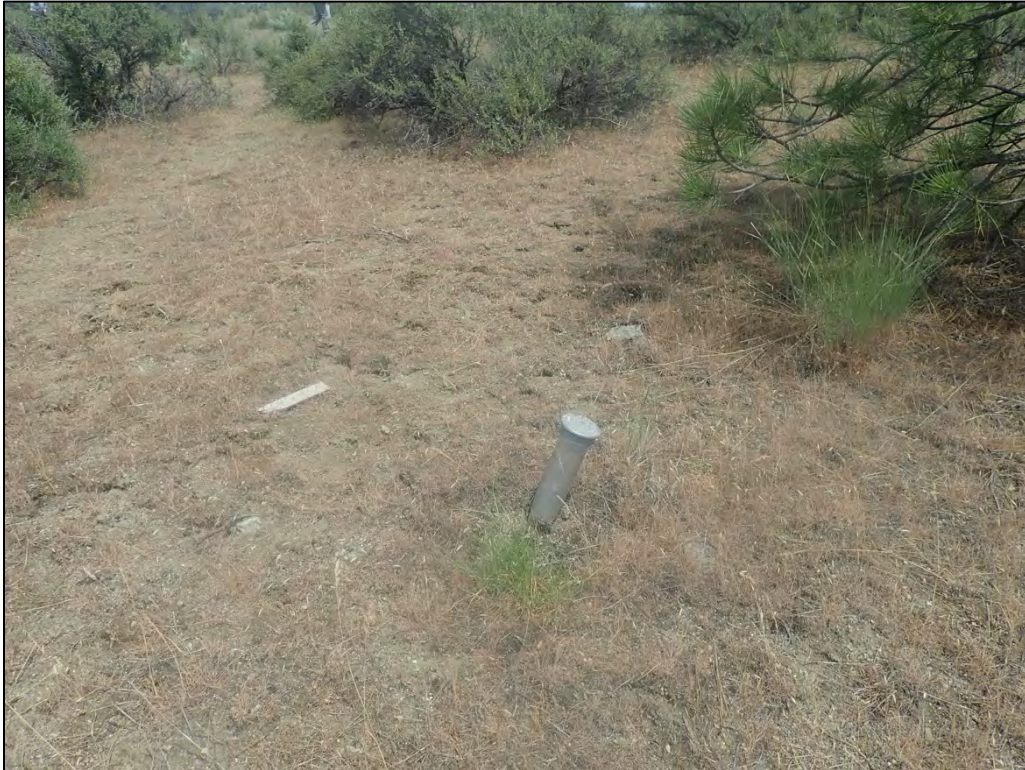
*PL-3. Bent Boundary Monument BM-3A*

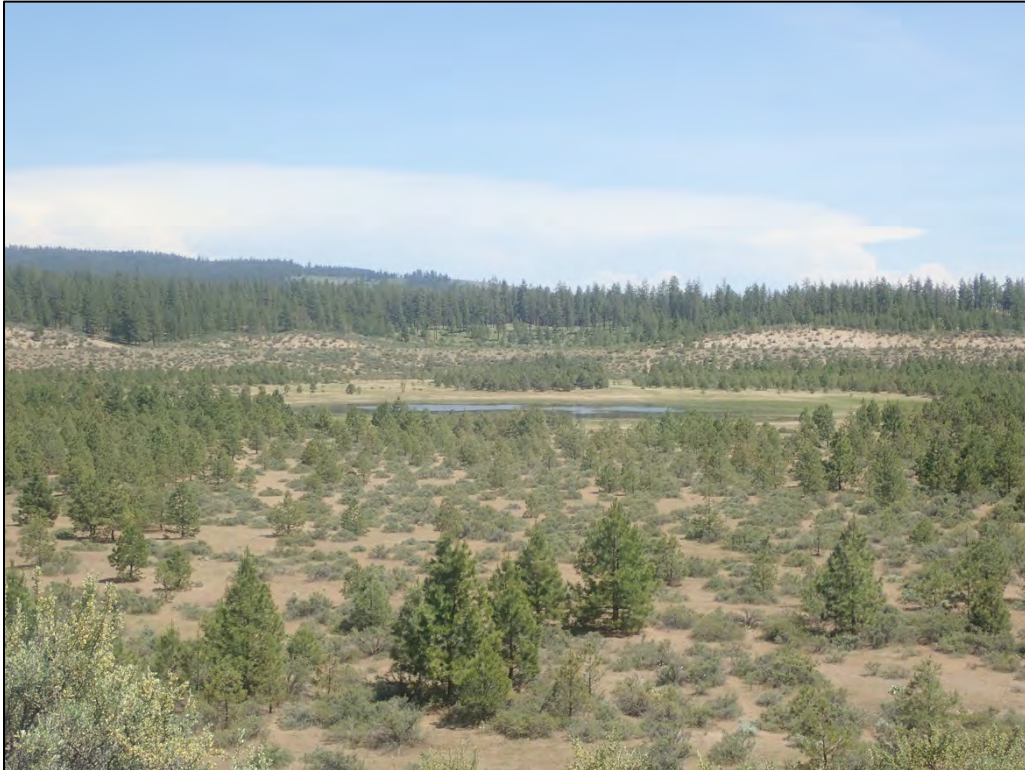
*PL-7. Pond on Disposal Cell*

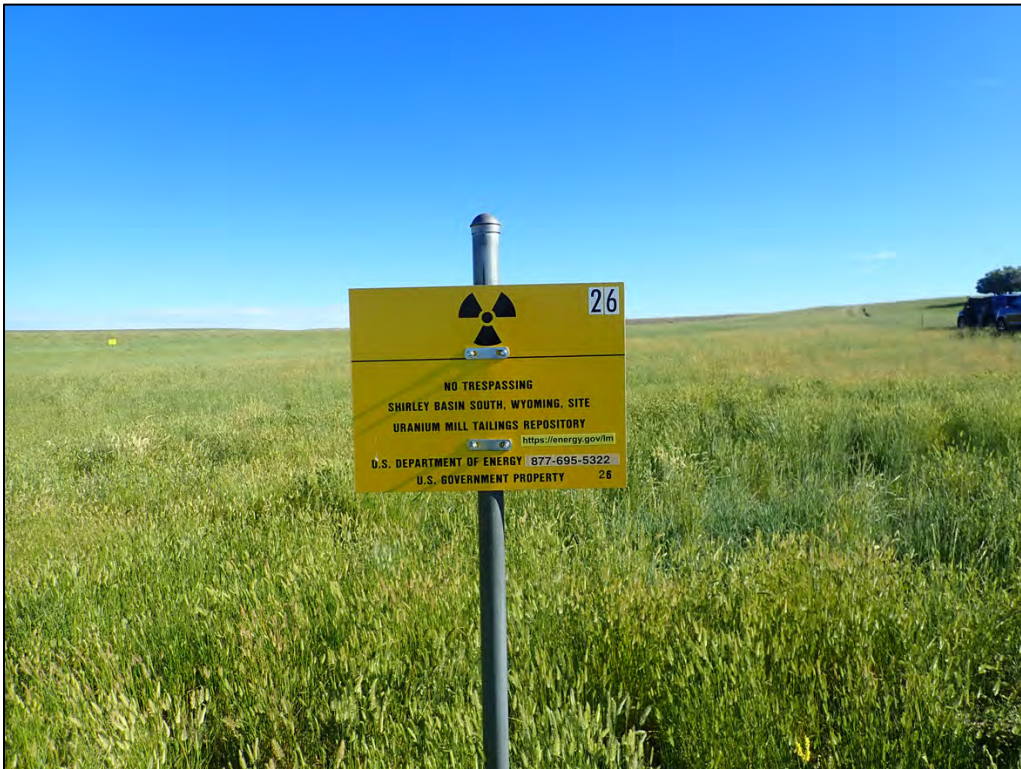
Nine perimeter signs (warning and no-trespassing signs) are posted along the site perimeter at potential points of access (PL-2), and another 25 signs are positioned around the disposal cell. Perimeter signs P1, P2, and P33 have bullet holes but remain legible. Several perimeter signs have exposed concrete at the base but remain stable. No maintenance needs were identified.

*PL-2. Perimeter Sign P26*

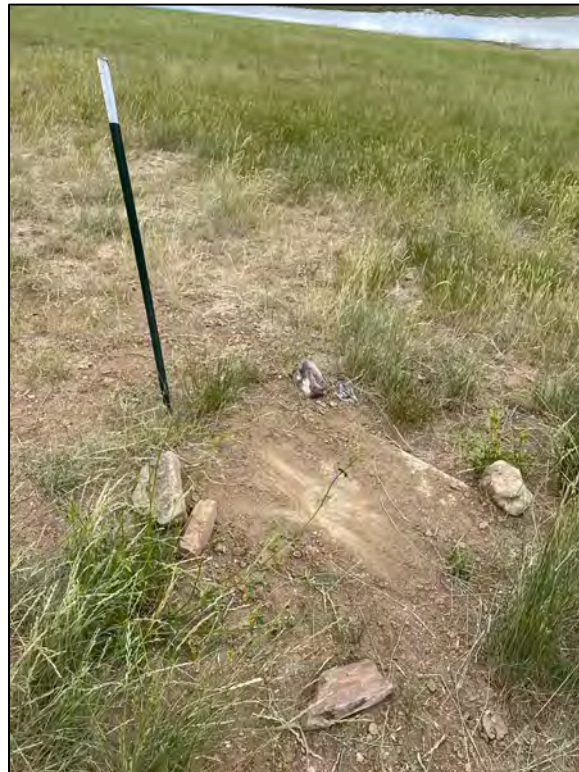
In July 2019, eight permanent aerial survey quality control monuments were installed at the site for an aerial survey of the disposal cell. The quality control monument locations are shown in Figure 6-1. Quality control monument QC-7 was covered by sediment, which was removed during the inspection (PL-4). T-posts were placed near all quality control monuments prior to the 2023 inspection to improve visibility. Concrete is spalling around quality control monument QC-8, but it is still functioning as intended. No maintenance needs were identified.

*PL-4. Quality Control Monument QC-7*

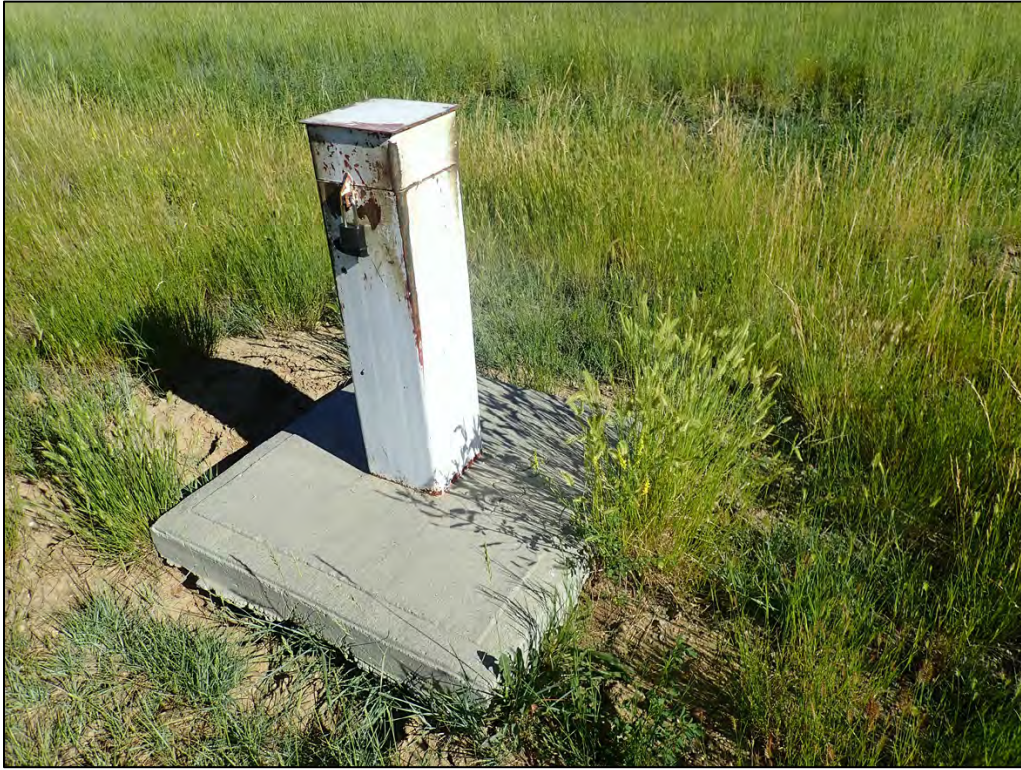
*PL-5. Burrowing Near Monitoring Well 40-SC*
